## Investigating substandard piles in Hong Kong

S.R. Hencher, J.T. Tyson & P. Hutchinson  
*Halcrow China Ltd.*

**ABSTRACT:** Since 1999, several cases have been reported in Hong Kong where piles have been installed poorly or fraudulently.

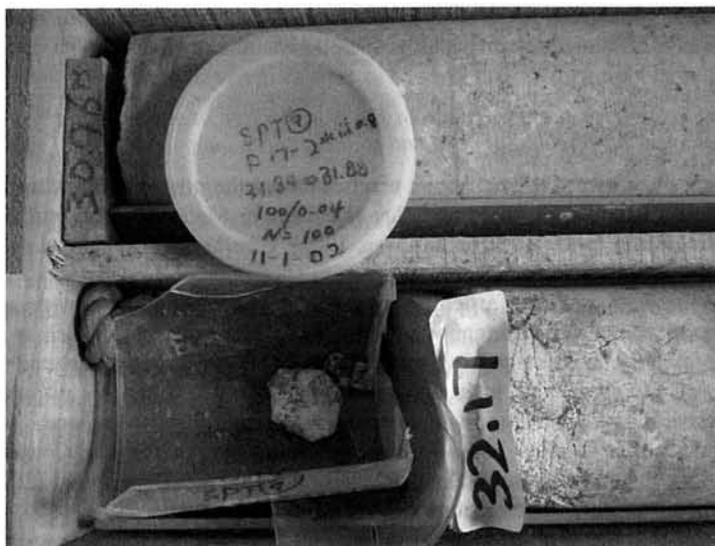
Figure 2. SPT sample from test carried out within rock for recent piling contract.

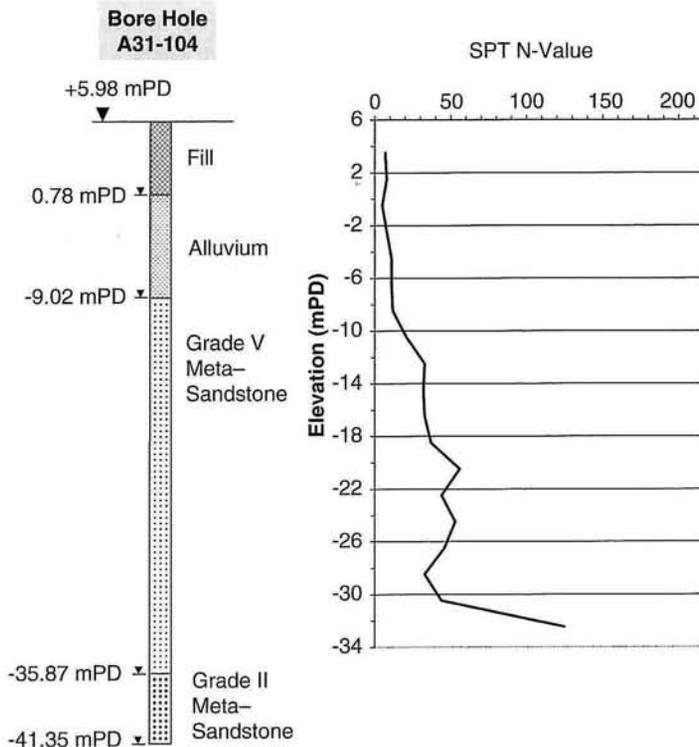
with SPT “N” value increasing gradually to more than 50 at a depth typically of 30 to 40 metres (Figure 4). A foundation advice report in 1996 estimated that piles should be a minimum of 30 metres in length and that, if driven piles were to be used, pre-boring might be required in many cases to get through “hard pans” (stronger layers) at higher levels.

Figure 4. Example of ground conditions at Tin Shui Wai.

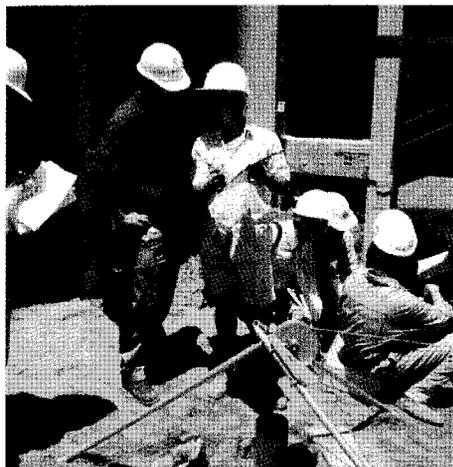
An immediate question concerned the integrity of the working piles. Most of these could not be accessed because of the superstructure but several of those on the periphery could be. The hollow section of the pile allowed investigators, once the top had been located and broken out, to lower a video camera down the hollow part of the pile and visually inspect the condition and measure the toe depths of the piles. Thirty-two piles below Blocks 1 & 2 were inspected in this manner as illustrated in Figure 5.

Significant discrepancies were found between observed and recorded pile lengths for some piles. Indeed, 27 of the 32 surveyed piles were shorter than reported, with 15 more than 1 metre and 5 more than 5 metres too short. It was evident the blow count records recording the driving histories of these piles must have been falsified together with the reported installation depths.

Figure 5. Video inspection underway for one of the working piles.

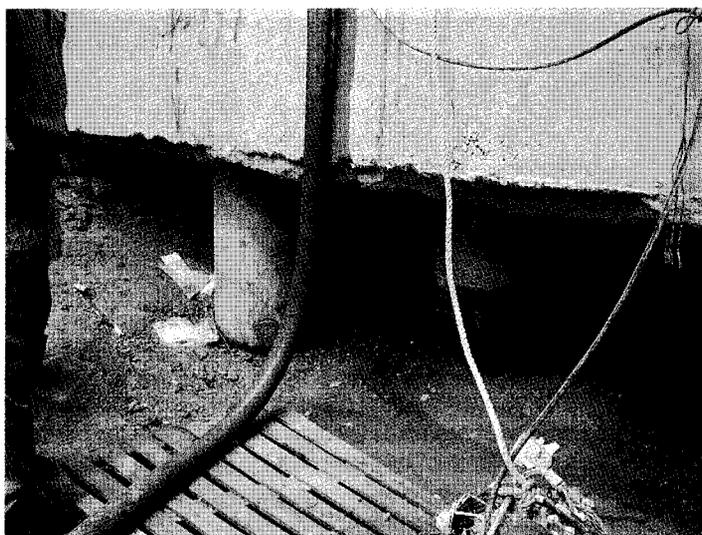
For example, clearly from the point of view of those responsible for making the structures safe, the pile shown in Figure 7 has no bearing capacity and is to be ignored. However, in assessing this pile HCL was conscious that there were various site records available (regarding delivery and driving

Figure 7. "Stub" pile below pile cap.

In the case of the pile shown in Figure 7, probing with steel rods had suggested that there was no pile below the ground (within a metre or so). Nevertheless, in order to investigate more fully, HCL prepared a specification for several holes with pre-defined geometries that should intersect a pile if one actually existed below the location of the stub. Figure 8 shows the investigation underway and Figure 9 shows core recovered from a "buried" pile segment. This indicated that some

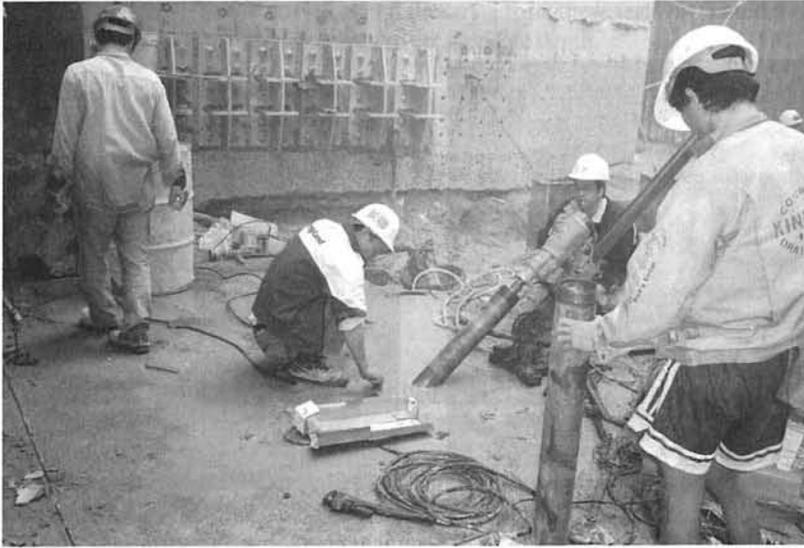
Figure 8. Inclined drilling to search for installed pile below stub pile in Figure 7.

pile segments had been installed as the records suggested, albeit with some questions unanswered. It was also clear that no attempt had been made to connect the “stub” to the buried pile below. The “stub” appears to have been placed to fool inspectors into the belief that a competent pile existed at that location.

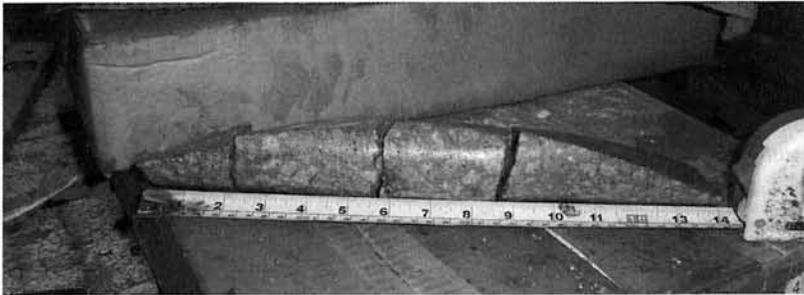
Figure 9. Curved outer surface retrieved from hidden pile by coring.

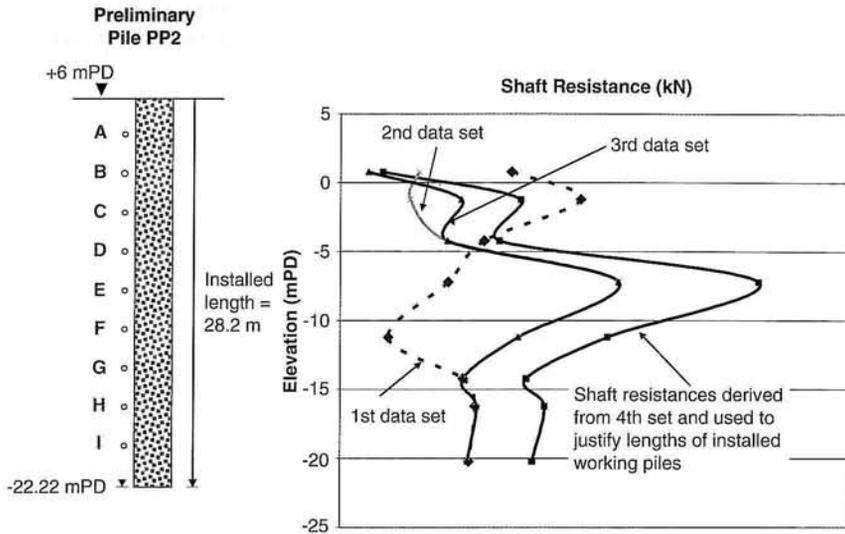
Figure 10. Shaft resistance inferred from strain gauge data (4 sets).

Nine sets of strain gauges were embedded in PP2 at positions A to I as illustrated schematically in Figure 10. Post test, data from each strain gauge were to be analysed to determine the amount of load carried in each stratum. A review of these data revealed numerous inconsistencies both in the test data itself and in the use of the data in pile load capacity and differential settlement calculations. Not least of these was the discovery, by the ICAC, of four different sets of data for the single test. One of the documents issued by the Contractor actually contained three of the four data sets in the same report, with the data presented in such a manner as to appear to present a single set of data.

The four data sets, which comprise what appears to be the original (un-doctored) data and three spurious data sets are shown in Figure 10. It appears that the data were revised (several times) in an attempt to indicate skin friction values higher than actually measured to justify shorter pile lengths than would be possible if the lowest (and probably “real”) set of test data had been used. Using what is believed to be the real set of data for the test indicates the need for piles at least 24.5 m long, whereas some of the reported installation lengths were shorter than this, according to the site records.
