Post-failure movements of a large slow rock slide in schist near Pos Selim, Malaysia

ABSTRACT: This paper describes the results of the monitoring, by total station and photogrammetric surveys, of the movements of a slow compound rock slide from failure in 2003 to December 2006. During this period the head moved downwards more than 21m. Whilst the rate of displacement is declining slightly year on year, for much of the time the landslide mass is accelerating and then decelerating in surges. Evidence is presented of some correspondence between the timing of the surges and the seasonal rainfall pattern. It is inferred from surface observations that the failure involves sliding at the head and in the upper main body of the landslide on joints roughly orthogonal to the foliation, which dips at a shallow angle into the slope. In the central toe zone the landslide slides up and out on the foliation. The failure, which occupies an area of about 8.5ha, has reactivated major pre-existing faults which run obliquely through the landslide mass.

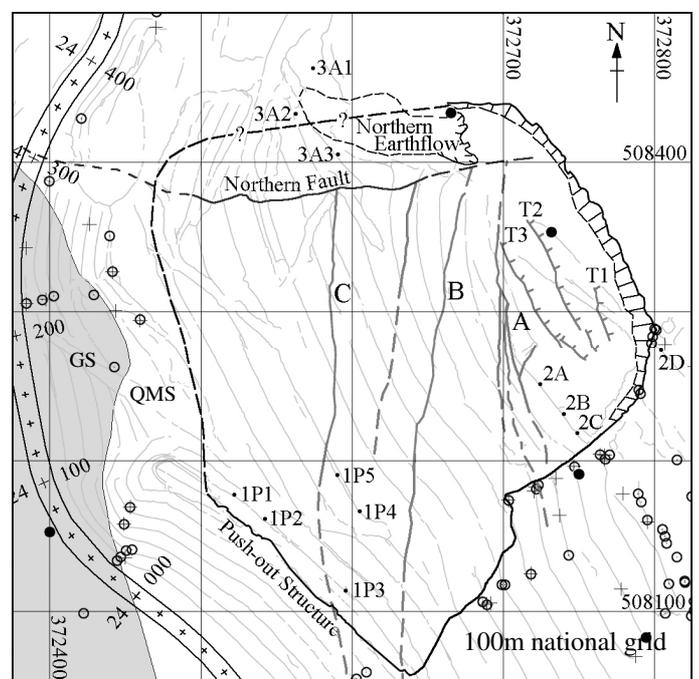
Figure 1 Outline of the landslide superimposed on a simplified geological map of the site; and survey points.

The rock sequence at site is cut by sets of pre-existing faults. The most prominent fault set dips steeply towards the E to ESE and three of these faults can be traced across the landslide (Figure 1, faults A, B & C). The fault planes form counterscarps at outcrop on the landslide and have oblique and vertical striations, suggesting distinct phases of slip. The faults also show signs of recent but pre-landslide movement and have been reactivated during landslide movements. The schists at outcrop are highly jointed with typical joint spacing less than 0.5m (Figure 2). The poles of the joints form a girdle that is roughly orthogonal to the low-dipping foliation (Figure 3). Where unweathered, the schist is generally strong to very strong and most of the rock material currently exposed across the site can be classified as ‘slightly’ to ‘moderately weathered’ (British Standards Institution, 1999: Figure 19).

The main surface features of the landslide are the main scarp, the head graben, the north and south flanks, the counterscarps of the oblique faults (A, B & C etc) and a low-angle push-out structure at the toe zone (Figure 1). Neither the northern flank, which is partly concealed beneath an earthflow, nor the toe of the basal slip surface can yet be fully delineated. The term ‘toe zone’ is therefore used here in preference to the word ‘toe’.

The head graben is crossed by multiple high-angle internal shears with counterscarps at outcrop (T1, T2 & T3 etc).

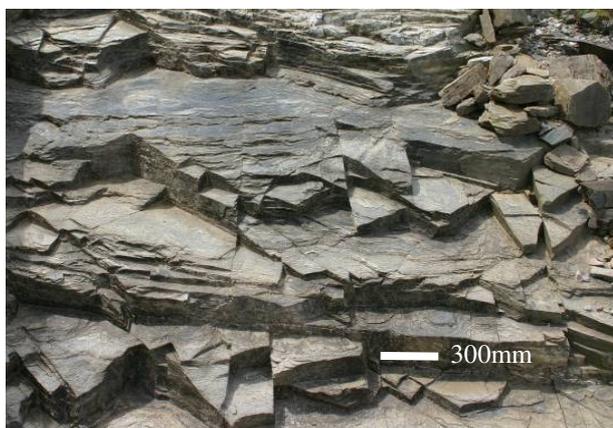
Figure 2 Several joint sets cutting the low-dipping foliation within the *Quartz Mica Schist Unit*.

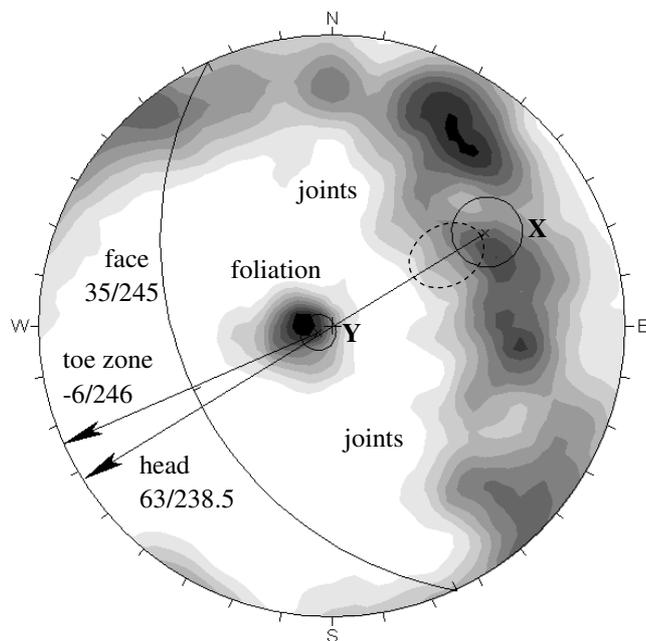
Figure 3 Stereographic projection of poles to joint planes and foliation and surface displacement vectors.

It is instructive to examine the disposition of vectors along the centreline of the displaced mass by means of stereographic projection (Figure 3). The directions of vectors within 100m wide blocks of ground at the highest part of the head (mean 238.5°) and at the toe zone (mean 246°) closely correspond to the dip direction of the face (mean 245°). The disposition of vectors at the highest part of the head coincides with a concentration of joint planes (Figure 3 - X) and at the central toe zone block corresponds to the attitude of the foliation (Figure 3 - Y and Figure 5 inset).

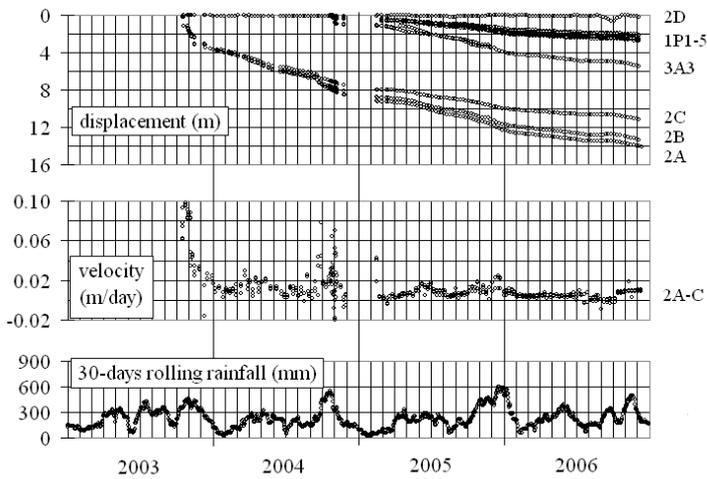
Figure 4 Displacements and velocities from total station monitoring; and rainfall at Stesen Kajicuaca Cameron Highlands.

The total station data give further insights into landslide behaviour. Whilst the overall rate of displacement is declining slightly year on year, for much of the time the displaced mass appears to be either accelerating or decelerating. Five surges are apparent (Figure 4) and comprise an accelerating phase (six to eight weeks) and a decelerating phase (two to three months). The velocity reached during surges at markers 2A-C is generally about 20mm/day (greater in late 2004).

After failure the landslide decelerated until March 2004 and it has since continued to move, for much of the time accelerating and then decelerating in surges. The timing of the surges generally coincides with peaking in the 30-day rolling rainfall (Figure 3), rainfall being measured at the Stesen Kajicuaca Cameron Highlands rain gauge of the Malaysian Meteorological Service, 13km SSE of the site. The bimodal rainfall pattern shown in Figure 4 is characteristic of an inland climatic regime in peninsular Malaysia. It may be that the landslide is responding to rainfall-induced seasonal rise and fall of groundwater levels. Such fluctuation is manifest by intermittent seepage from the southern toe zone. Other causal factors may have contributed to surges: a surge in late 2004 concurred with the removal of 100,000m³ of ground from the northern toe zone of the landslide.

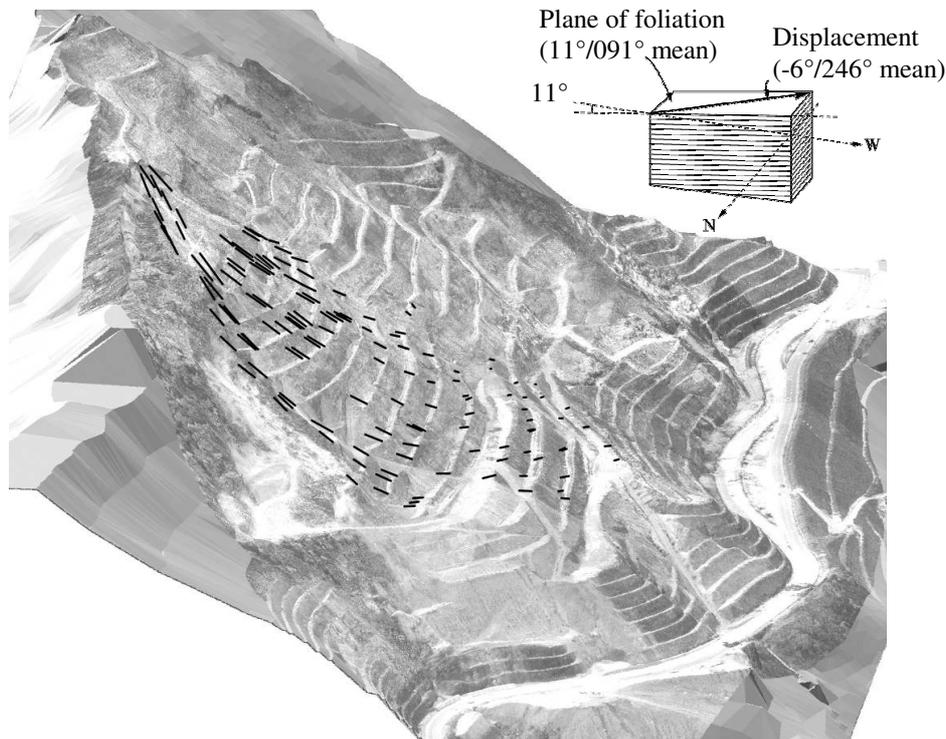
The surface displacement vector data (2003-5) advance our understanding of landslide behaviour. Viewed in plan the vectors are seen to be normal to the slope face contours with lateral extension revealed by radial divergence (north-south spreading), conforming to topography, which takes the form of a subdued ridge. Movements are greater at the head than in the toe zone (compression) and, on any slope face contour, displacements are greater in the north than in the south (rotation). Viewed in cross-section the vectors are seen to plunge at the head of the landslide, to generally lie sub-parallel to the slope in the upper main body and to emerge in the toe zone.

Figure 5 3D visualisation of the excavated hillside showing the surface displacement vectors (2003-5) to scale. Inset: surface movement of the central toe zone block relative to foliation.

The vectors plunge steeply at the head and emerge sharply in the toe zone, the profile suggesting a non-circular basal slip surface (Figure 5). The presence of multiple counterscarps in the head graben (T1, T2, T3 etc. Figure 1) may signify curvature of the basal slip surface (Hutchinson, 1988). There are joints disposed to facilitate slip on such a curved surface (Figure 3 - dashed oval). The landslide is probably a compound slide. An educated guess was
