The investigation of underground streams in a weathered granite terrain in Hong Kong

S. R. Hencher

H. W. Sun & K. K. S. Ho

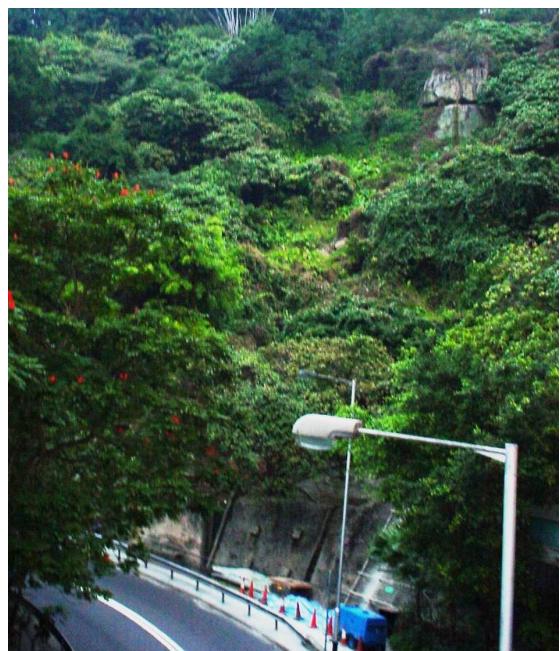
Figure 1. Overgrown hillside on which the cavity appeared.

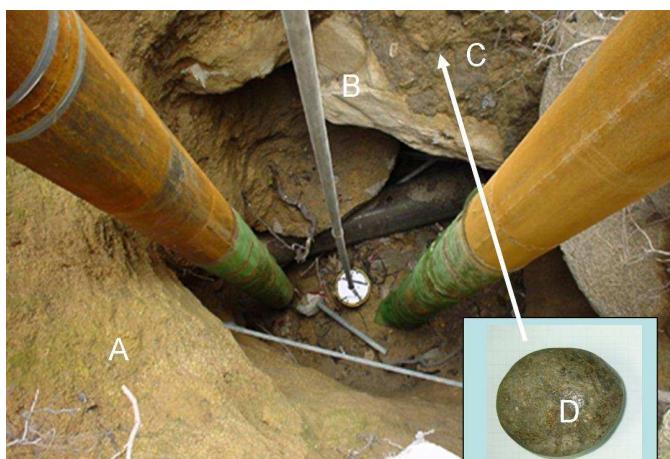
Figure 3. View down the cavity with various casings for subsequent instrumentation. A is insitu HDG, B colluvial boulders, C a zone of alluvium containing a volcanic "erratic" (D).

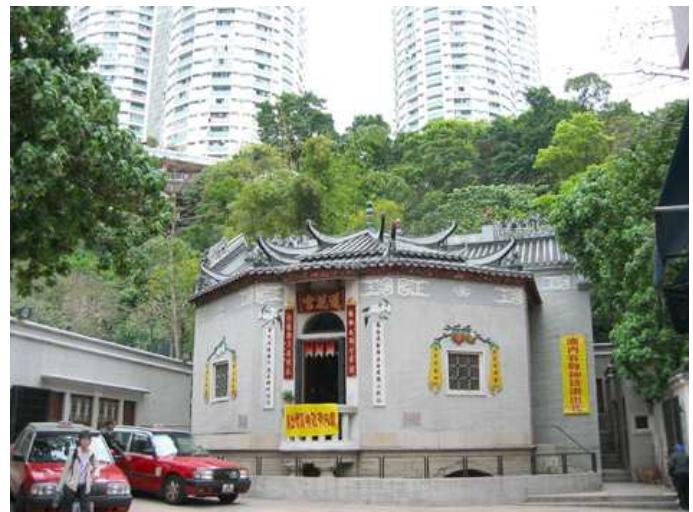
Figure 4. Temple at foot of slope in 2002.

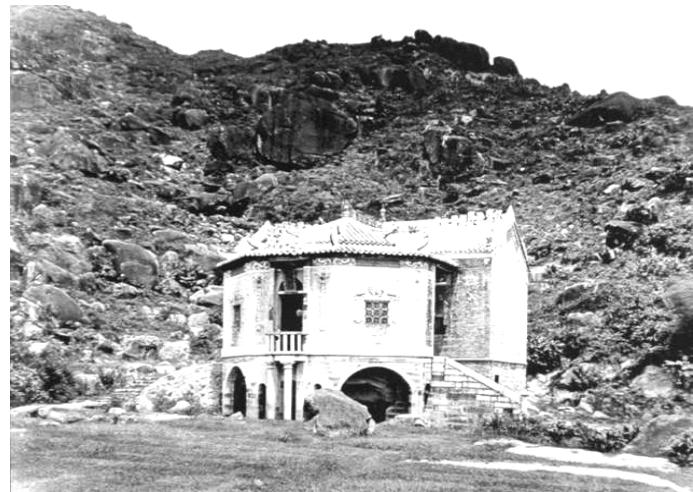
Figure 5. Same temple in 1869 - then close to the coastline.

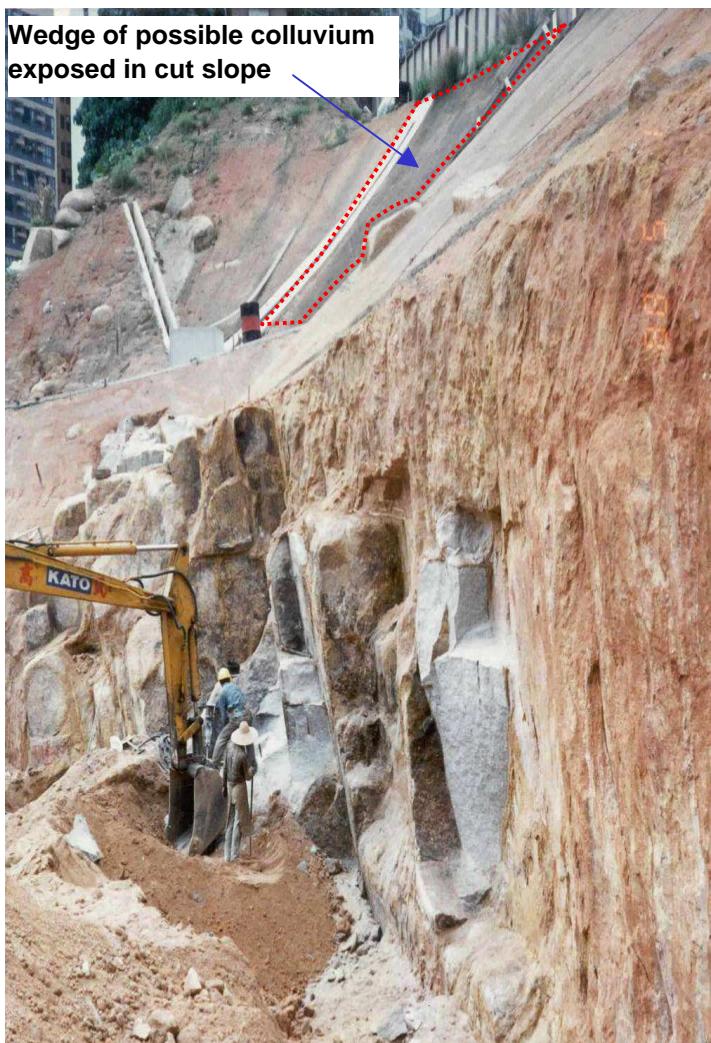
Figure 6. Apparently undisturbed weathered granite profile with corestones exposed during 1987 construction of bus station below Yee King Road, Wedge of possible colluvium in line with the subsequent Cavity above the road.

Natural erosion pipes had been observed below Yee King Road during the construction of the bus station (Figure 6), and a major spring issues below, in line with an incised stream channel (A) that is truncated at the Upper Cliff and disappears underground at the Lower Cliff (Figure 8). Water could be heard running underground at that location.

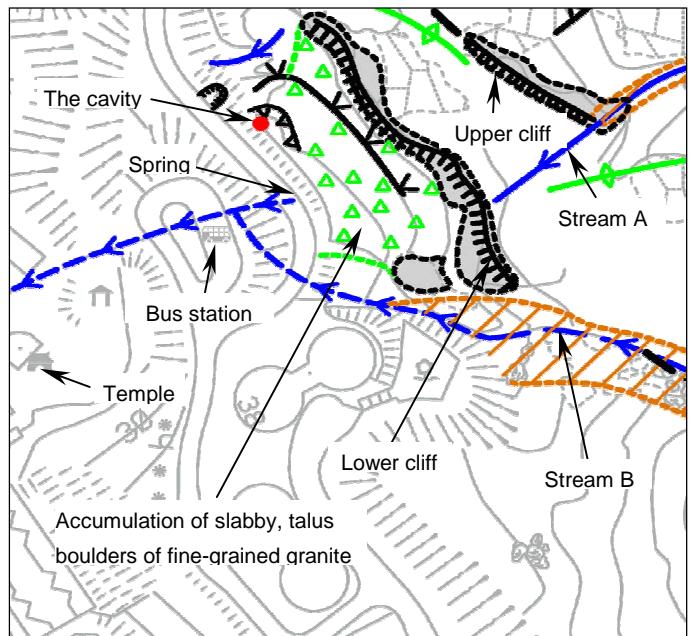
Field mapping was undertaken to establish the key geomorphological and geological features at the subject site (Figure 7). In particular two extensive rock cliffs were identified above the relatively flat, boulder-strewn area surrounding the cavity. The Lower Cliff (Figure 8) consists of medium-grained granite over-lain by fine-grained granite and the contact is almost horizontal. The Upper Cliff consists of all fine-grained granite. Many of the large slabby boulders in the area near the cavity in Figure 7 are fine-grained granite and appear to have been displaced vertically downwards by tens of metres from their original in-situ outcrop locations, with little tilting. It was postulated that this landform was essentially the result of erosion of the more weathered, coarser-grained granite, underlying the fine-grained granite and essentially undermining the fine-grained granite.

Figure 7. Geomorphological map of main features.

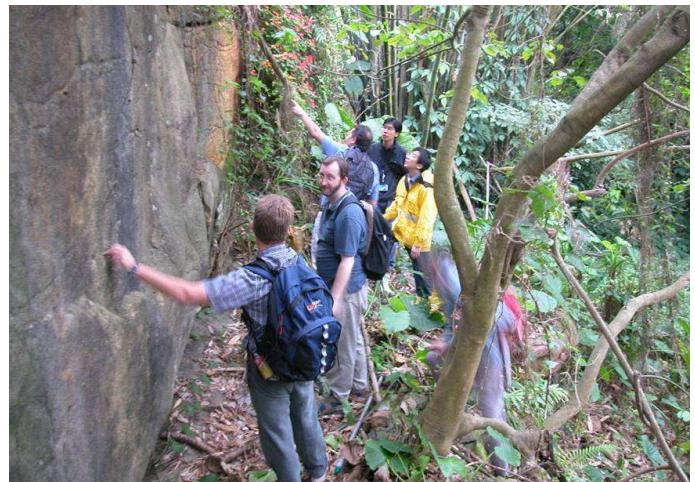
Figure 8. Examination of massive, almost un-jointed, vertical Lower Cliff to rear of area including the cavity.

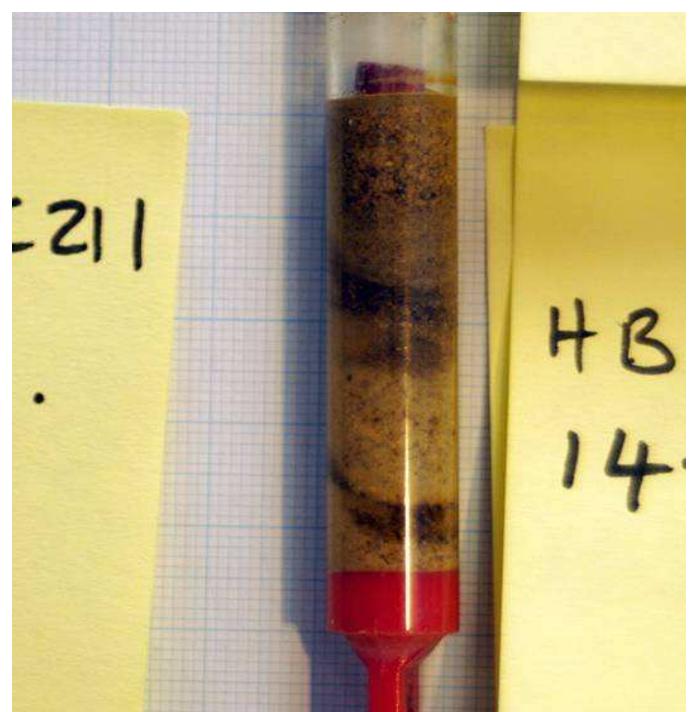
Figure 9. Layered soil sample in Halcrow Bucket.

ing a ground investigation close to the cavity in 1996 (see Figure 9). These sediments were layered and graded and indicated several distinct events involving pulses of sediment-laden water passing from a high level, down the standpipe, past the buckets and exiting at the deeper stream level. Figure 10 is a schematic representation of the likely hydrogeological condition.

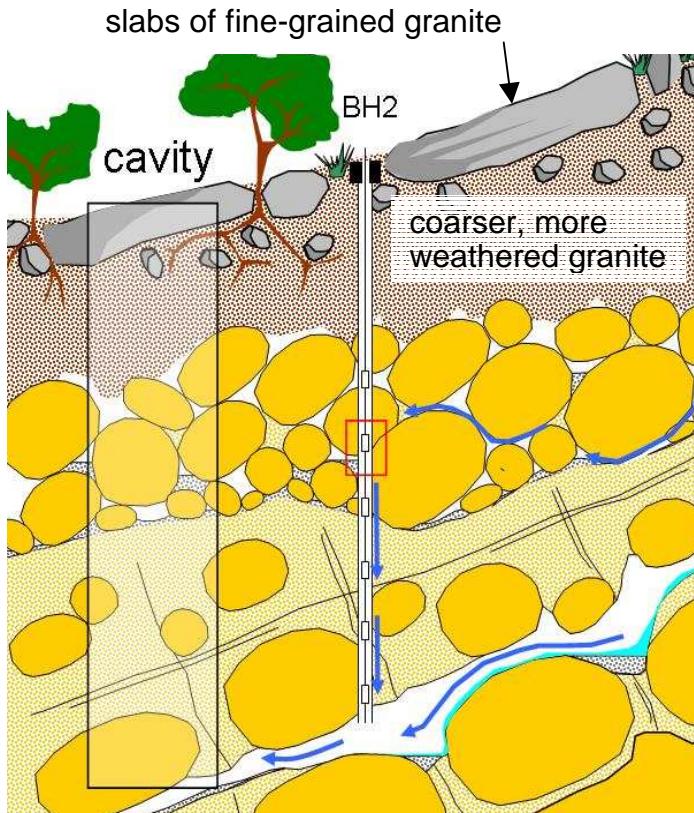
Figure 10. Hydrogeological model for the cavity.

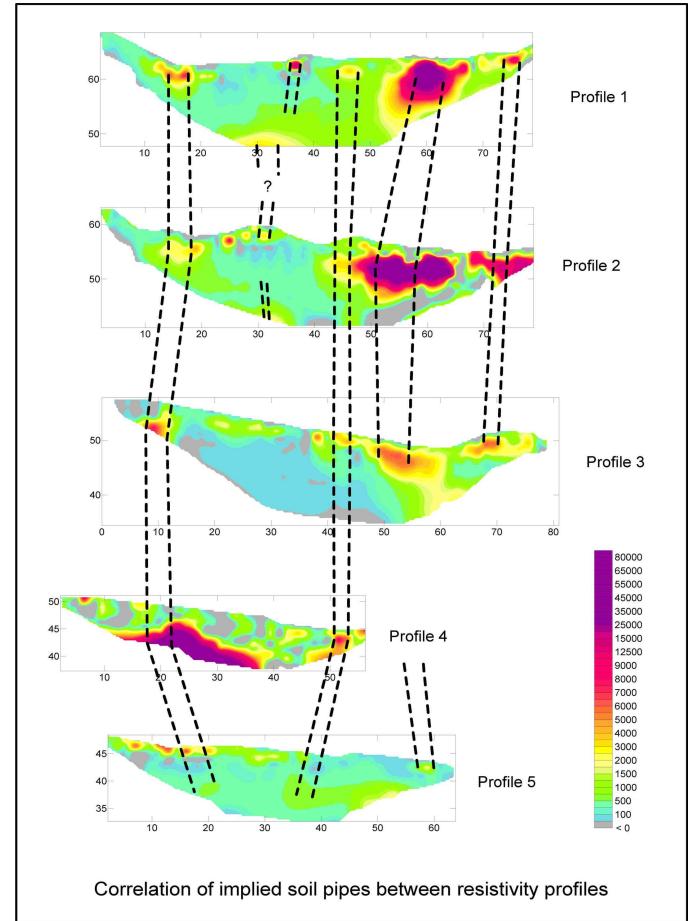
Figure 11. Resistivity data across the slope indicating likely locations of voids.

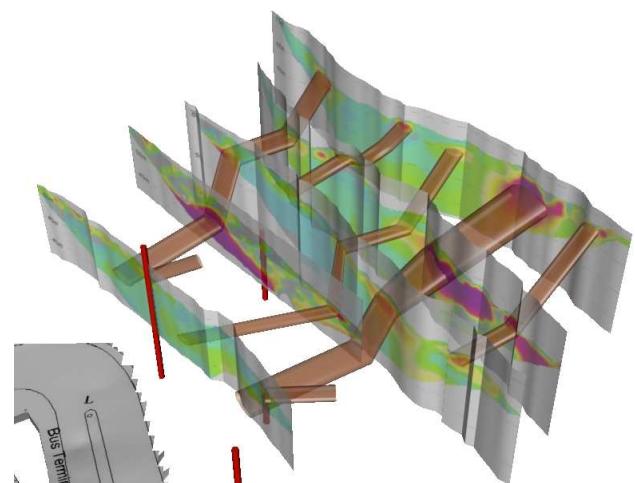
Figure 12. Interpreted 3D model of site with underground streams.

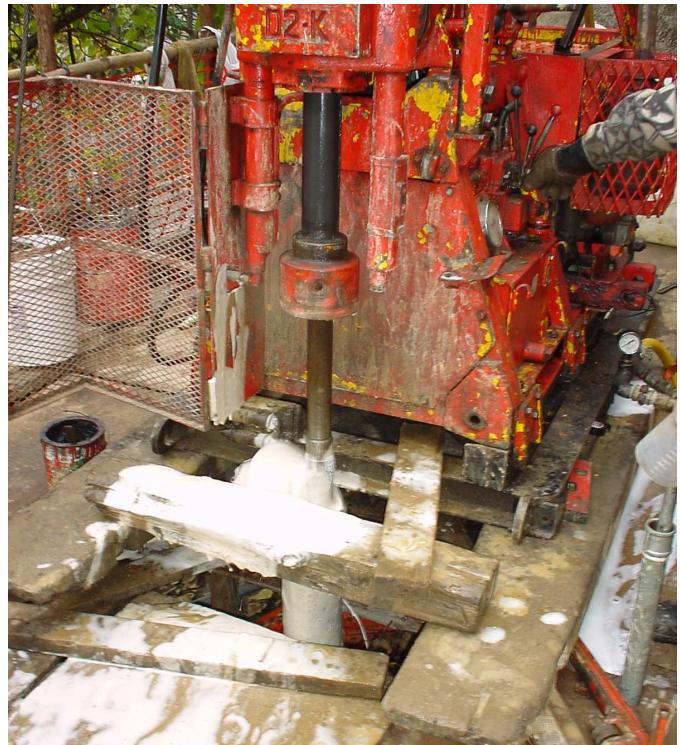
Figure 13 shows foam flush drilling in action. One of the key questions to be addressed by these boreholes was whether there were signs of disturbance at depth below the stream levels. Deep natural erosion pipe systems have been identified in Hong Kong, especially in association with large landslides (Hencher, 2006). All Mazier samples were split and logged carefully but little evidence was found of any disturbance or the existence of streams below the levels as identified by geophysics and confirmed through lack of core (and loss of drilling flush) as compared with core loss in the drillholes. The largest void discovered by drilling was about 3.15 m vertically between 5 and 8 m depths. CCTV cameras were used to explore some of the cavities down the boreholes. A cross section across the site, developed on the basis of all available data, is shown in Figure 14.

Figure 13. Foam drilling at Yee King Road. During the 2002 investigation, most of the drillholes showed no groundwater at the levels of the underground streams.

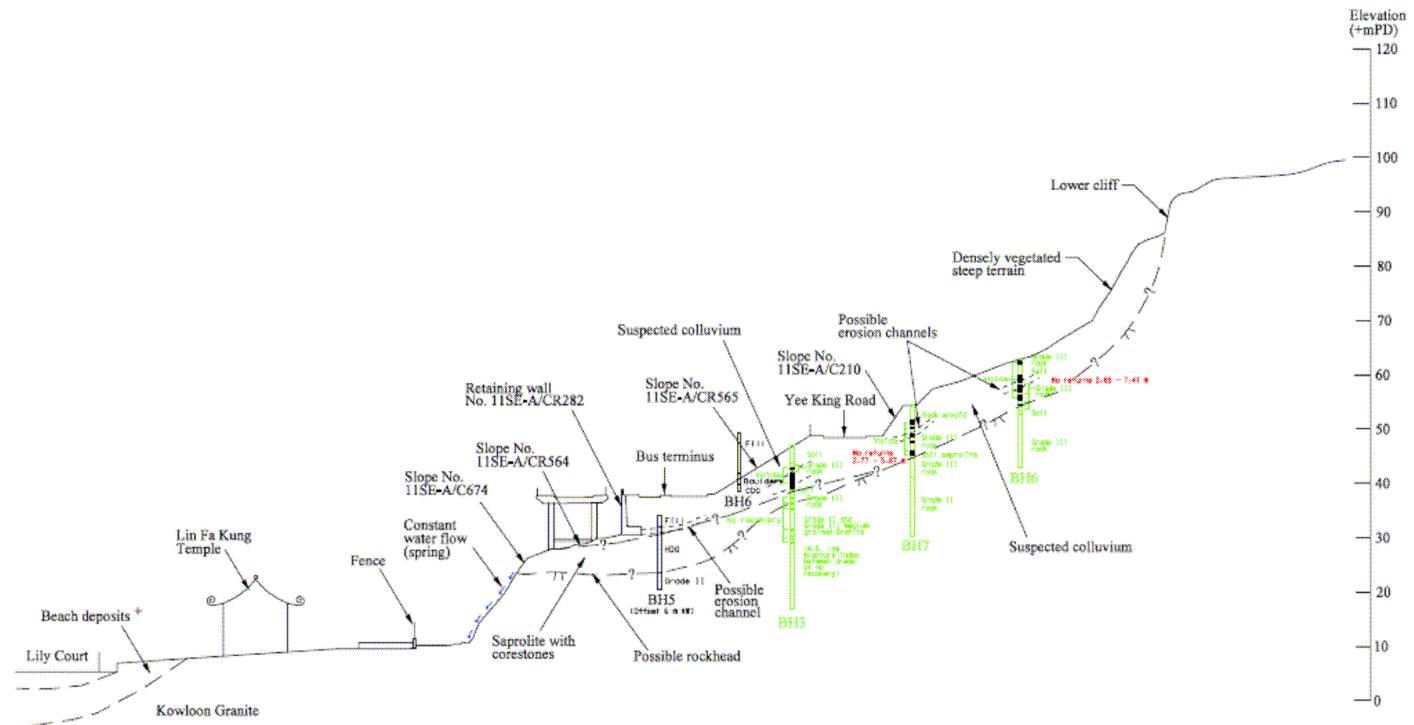
Figure 14. Cross section through site. Cavities identified in boreholes are indicated
