# Back analysis of landslides to allow the design of cost-effective mitigation measures

Steve Hencher (Halcrow China Ltd.; University of Leeds, UK) · Su Gon Lee (Seoul University, Korea) · Andrew Malone (University of Hong Kong)

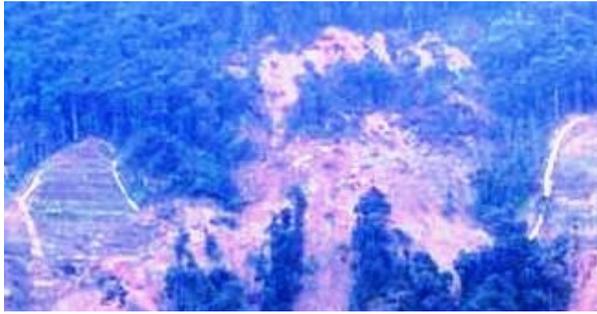
The Pos Selim landslide is a currently active landslide in Malaysia. Some details are provided by Malone et al (2008). The landslide occurred in one of the many large and steep cut slopes along the new 35km section of the Simpang Pulai – Lojing Highway project and it is pertinent to ask the question why it occurred there rather than somewhere else? Failure occurred early on in the cut slope and affected the natural slope above the cutting (Figure 1). Progressively the slope was then cut back in response to further failures until the works reached the ridgeline about 250m above the road (Figure 2). The slope has continued to move with huge tension cracks developing near the crest with vertical drop at the main scarp of more than 20 metres in three years.

Fig. 1 Pos Selim Landslide, August 2000

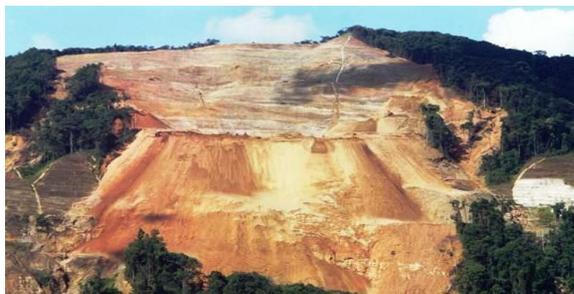
Fig. 2 Pos Selim Landslide, 2002

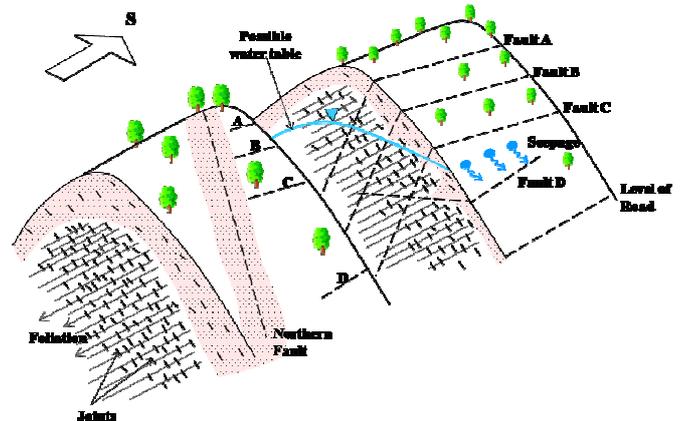
Clearly at the site there are some predisposing factors that are causing instability whereas many other equally steep slopes along the 35 km of new highway show no similar deep seated failures. The general geology of the site is schist but the main foliation actually dips into the slope at about 10 degrees so the common mode of failure associated with such metamorphic rocks of planar sliding on daylighting, adverse schistosity or on shear zones parallel to the schistosity (Deere, 1971) is not an option to explain this landslide. Following detailed face mapping by geologists, review of displacement data and examination of the various stages of failure, a model was derived that can be used to explain the nature of the failure, the vectors of movement and the fact that it has not yet failed catastrophically but is bulging at one section of the toe (Figures 3 & 4). Key aspects of the geology are frequent joints that are oriented roughly orthogonal to the schistosity, three persistent faults cutting across the failure and another major fault to the north of the landslide area. The derived model is of a mechanism of sliding on the short, impersistent joints that combine with offset sections of schistose fabric to form a shear surface. The shearing forces are largely balanced by sliding friction on joints, along the transverse faults and schistosity in one part of the toe where the failure is kicking out. Resistance is also provided by the dilating mass towards the right side toe of the slope (facing). One possible option for remediation that can be derived from this model therefore involves strengthening that toe area by anchoring or otherwise buttressing.

Fig. 3 Block model of main geological features

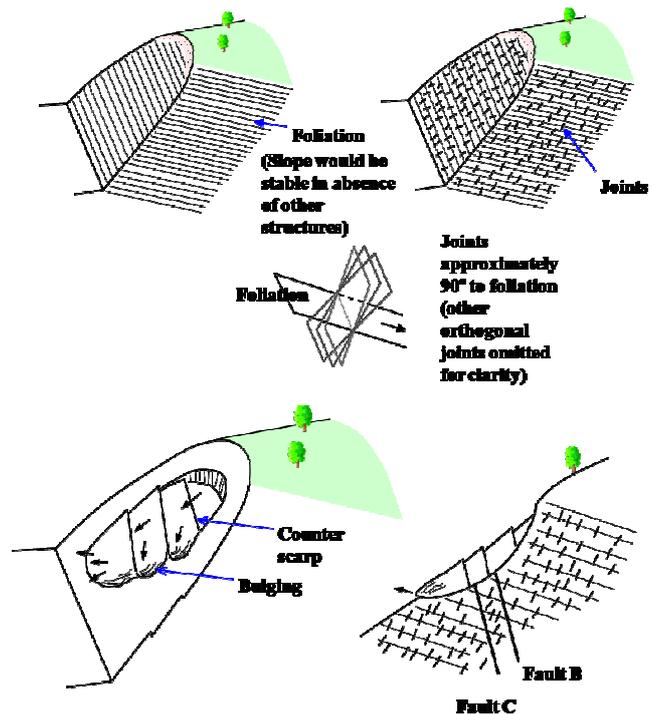
Fig.4 Schematic model for the Pos Selim landslide.

Currently there is some minor evidence that groundwater is playing a part in the failure (some seepage) and therefore it has been recommended that long, trial raking drains be installed at points of seepage in such a way that they also allow water pressures to be monitored within the slope (a cost-effective combination of ground investigation and remedial measure).

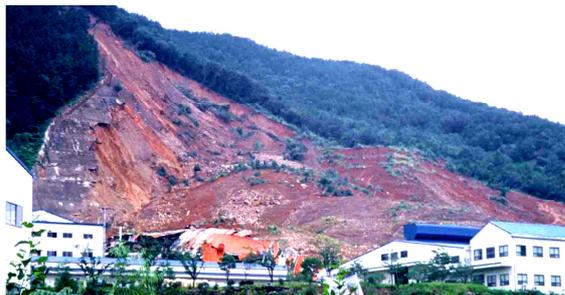
**Fig.5** Large scale failure near Busan, Korea

deficient and the slope failed during construction. The slope continued to fail progressively until it finally collapsed catastrophically in August 2002 during heavy rainfall.

During the series of retrogressive failures leading to the final collapse there were 11 successive inspections and reassessments of stability over 9 years. Various techniques were employed in turn in attempts to stabilize the slope using piles, ground anchors and soil nails. Drainage was attempted and retaining walls constructed. As a result of the repeated failures the height of the cut slope was increased from 45 m to 145 m with associated costs rising from 3.3 million to 26 million US dollars. It was not until the complexity of the geology and specifically the importance of fault control was properly identified that the slope could be finally understood. Various assessments prior to then had tried analysing the slope as a soil and one late review attributed the landslide to natural disaster (triggered by a typhoon) without acknowledging the failure of previous studies to go about the investigation in a scientific manner. This example demonstrates that without proper investigation, even after significant failure has occurred, the success or otherwise of remedial measures cannot be relied upon.

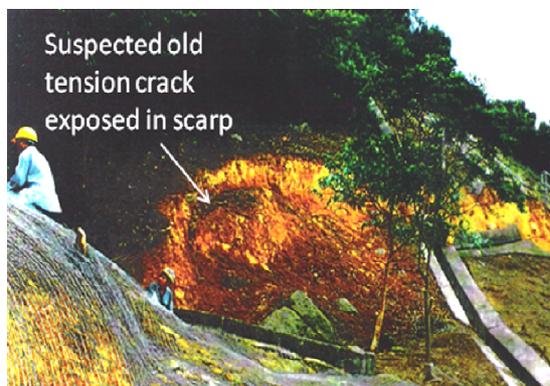
**Fig.6** Evidence of previous movement in 1997 scarp

Signs of previous movement were found during the investigation of the 1997 landslide as illustrated in Figure 6 (HAP, 1998). Detailed mapping of trial pits showed however that the 1997 failure was not a simple reactivation of the earlier landslide but it was still suspected that the location of the 1997 failure was related to the previous distress. Boreholes were put down specifically aimed at achieving 100% recovery using Mazier sampling with foam flush (no in-situ tests were conducted during drilling). Some boreholes were inclined upwards back into the failure scarp. All samples were examined and described. No samples were taken for strength testing because it was considered that current knowledge of the shear strength of such materials was sufficient for numerical simulation and that detailed geological examination was more important for explaining the details of this landslide.

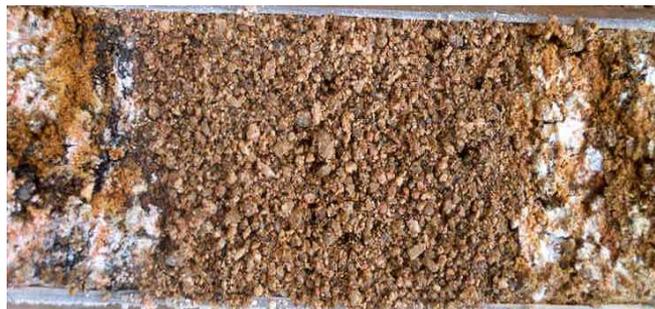
**Fig. 7** Alluvial sand recovered in Mazier sample

One of the key findings from the investigation was the presence of numerous infilled natural pipes found in borehole samples. Pipe infill included single sized sand (Figure 7) and graded sands (deposited in still water) at great depth within the decomposed granite that makes up the bulk of the slope. It was clear that there was a well developed underground stream system at the landslide site. A leaf was found in one sample and this was dated using  $^{14}\text{C}$  enrichment values as 1958 to 1960. It was concluded that the presence of the underground stream and lake system allowed an explanation of deep groundwater recharge over a period of several days and delayed failure. Delayed groundwater response was observable in some piezometers but it was recognised that such observations might be very localised depending on whether or not a particular borehole tapped into an active part of the stream system. Such variation in groundwater flow became evident during the installation of soil nails as part of the remediation works. In order to install the nails, dewatering

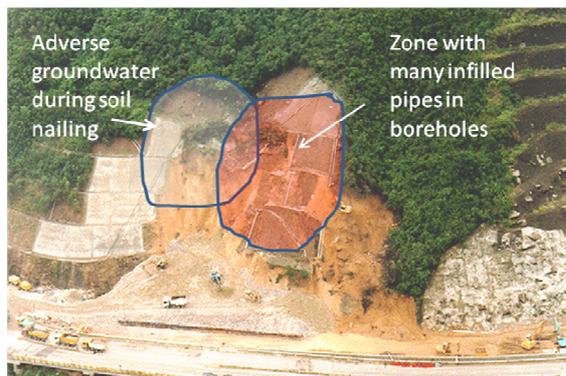
recently been investigated and modified to try to improve its stability. This failure was also delayed in that the first major movement occurred four days after heavy rain. The slope continued to deteriorate and eventually, about a month later, collapsed during heavy rain so that the debris blocked both carriageways of this important road. Back analysis of this failure was aimed at explaining why the failure occurred as it did, at that location but also specifically to offer some explanation for the delayed response to heavy rainfall. In terms of why the failure occurred at that location, this seemed to be linked to the fact that the site was the location of previous failure dating back to the 1940's. This had been identified during investigation of a failure in a nearby slope in 1982 (Hudson & Hencher, 1984).

**Fig. 7** Ching Cheung Road Landslide 1997.

was carried out using 14 wells which extracted 1.2 Ml during the nailing contract. One single well accounted for more than 40% of that volume (HAP, 1999). Interestingly, and totally compatible with the emerging model, in one area of the slope, despite dewatering, water flowed from soil nail holes, some holes collapsed and it was observed that there was a degree of interconnection. The area of problems during soil nailing was not the same as where the majority of sediment choked pipes were encountered during ground investigation (Figure 8). It was interpreted therefore that the underground stream system had migrated with time and was still changing continuously; the sediment filled system represented natural pipes and hollows that had clogged and collapsed during dry spells. Given later intense rainfall and infiltration, other routes for throughflow developed as an open system.
