The Delayed Failure of a Large Cutting in Hong Kong

R. R. Hudson and S. R. Hencher

Engineering Development Department, Geotechnical Control Office, Kowloon, Hong Kong

SYNOPSIS A large cutting in decomposed granite failed after five days of dry weather following an extremely intense rainstorm in August 1982. The history of the slope and surrounding area is described and three theories that might explain the delayed nature of the failure are proposed.

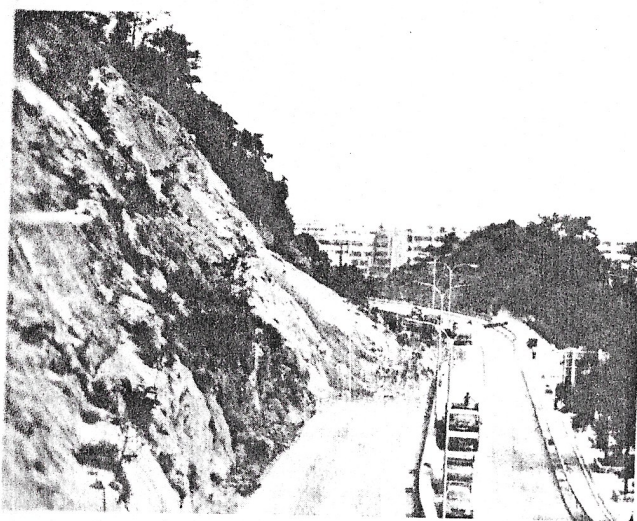
On 24th August 1982, a section of slope cut at 55° in weathered granite on Ching Cheung Road in Northwest Kowloon failed (see Figure 1). The landslide was unusual for Hong Kong in that it occurred on a dry day, 5 days after an intense rainstorm and in a noticeably 'dry' manner. Furthermore, two well-documented large, catastrophic failures occurred in nearby slopes in 1972 and similarly in an atypically dry, granular manner after up to 10 days without rain.

Figure 1 - General view of the failed slope taken on 24.8.82

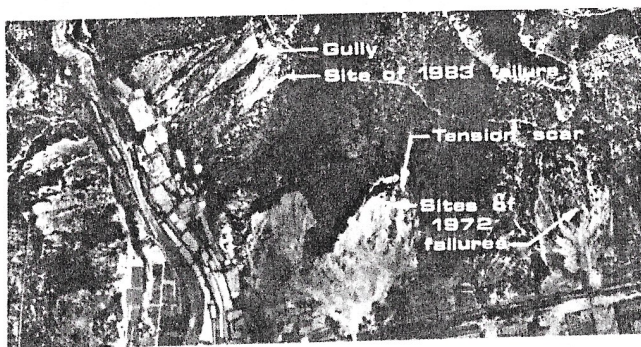
Aerial photographs are particularly useful in this case and three are presented as Figures 2, 3 and 4. In 1949, the area comprised scrub-covered hills of decomposed granite exhibiting severe erosion, e.g. the major gully just north of the 1982 failure location. Uncontrolled borrowing operations were causing severe slope problems and in one case, a major tension scar is evident at the head of a discrete landslide.

Figure 2 The area in 1949

Alternatively the delayed failure may have been caused by a delayed loss of strength of materials but this has not been confirmed by the few specialised tests carried out for this study. Such a solution is attractive however in that it has wider application and is less dependent upon localised geology. The noted surface erosion, especially the major gully (Figure 2), indicates the generally weak and friable nature of the granite.

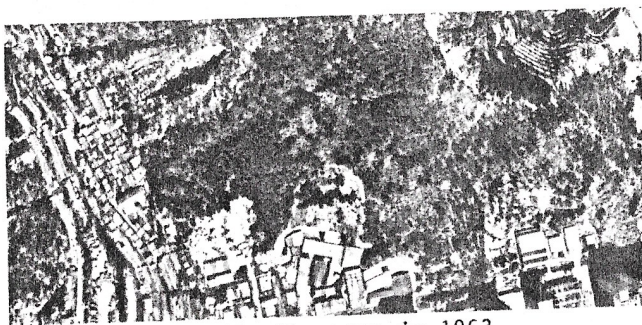
By 1963 buildings had been constructed at the foot of the landslide which surprisingly had not moved further.

Figure 3 The area in 1963

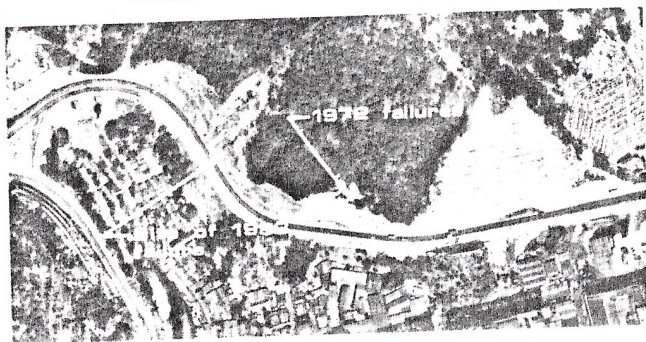
The remedial works to the failures of 1972 can be seen clearly in Figure 4. The locations coincide with the previous distress and the minor scar may have involved reactivation of the pre-1949 landslide. There are no signs of distress at the location of the 1982 failure however.

Figure 4 The area in 1972

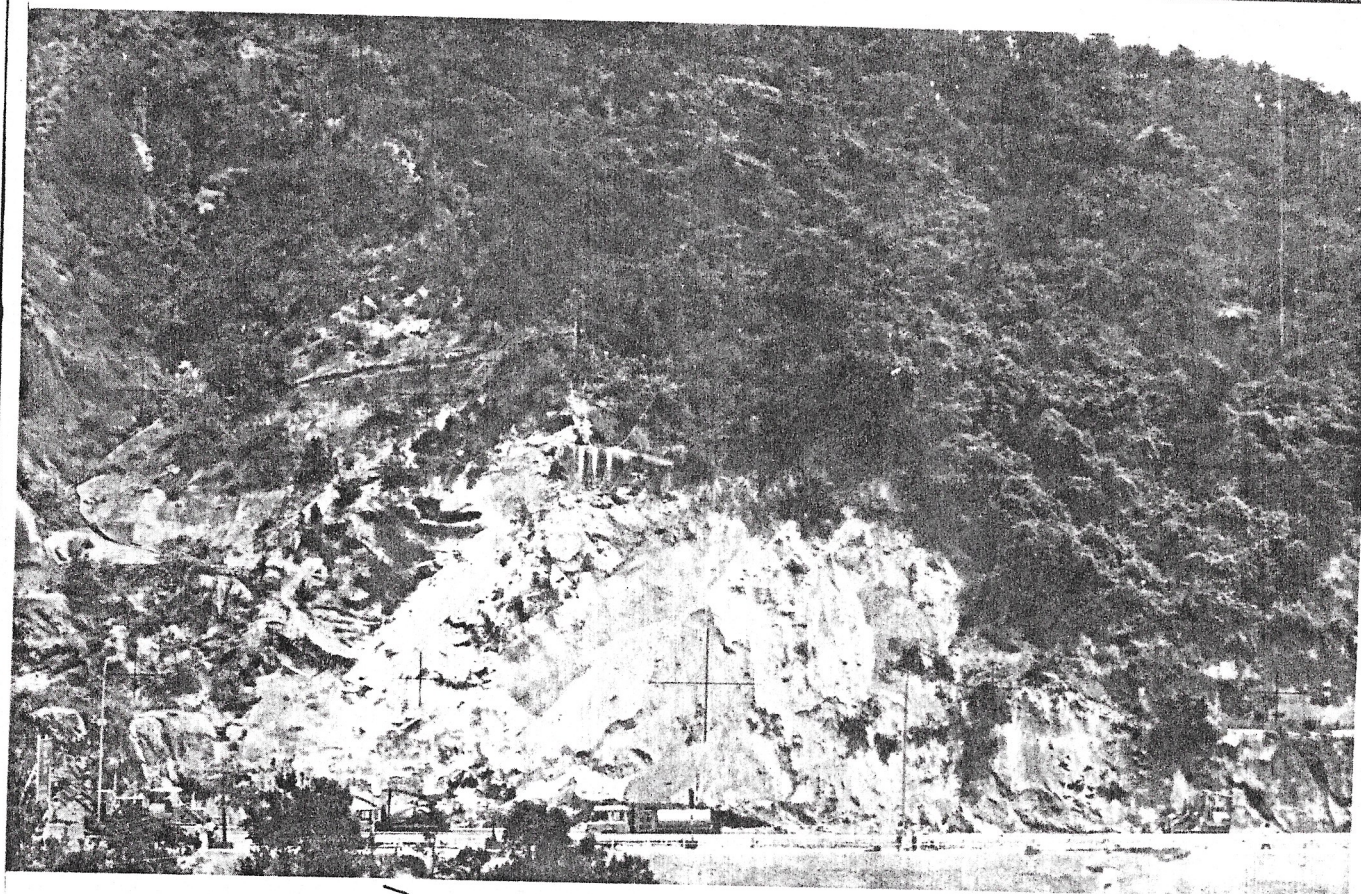
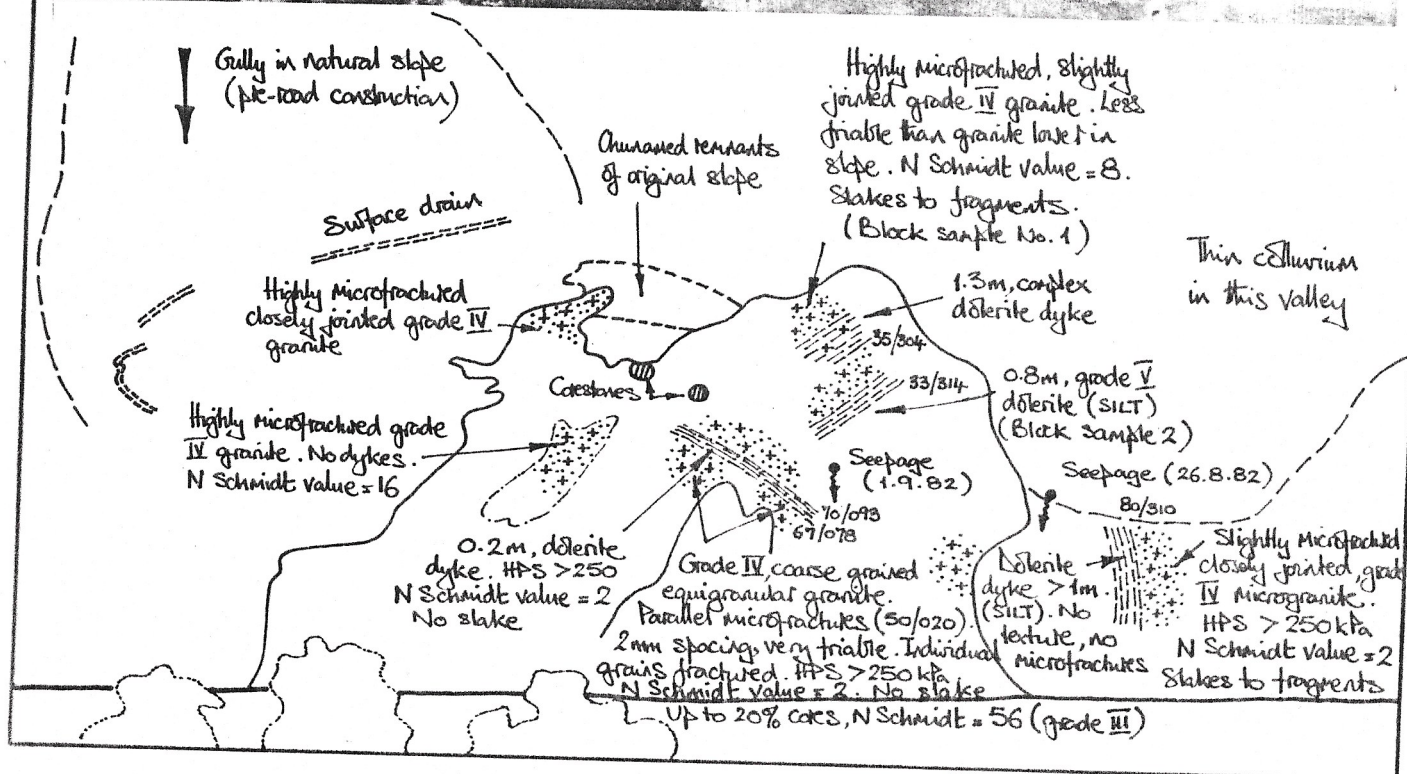
Exposed areas of slip scar were examined and described as illustrated in Figure 5, using the methods outlined by Hencher & Martin (1982). The failure occurred in highly decomposed granite (grade IV) with rare corestones of stronger granite. The granite is coarse-grained and is extremely friable due to extensive microfracturing which predates the failure (as shown by examination of resin-impregnated thin sections). The granite is intruded by a series of irregular but persistent dolerite dykes, decomposed to a relatively impermeable silt and their possible role is discussed below.

The failure occurred in a dry manner and no seepage was seen on the day of the failure. Following initial clearing operations, however, water was found ponded on the road beneath the debris and later two minor seepage points were noted high up within and outside the failure scar (Figure 5).

Figure 5 - View and annotated diagram of failure

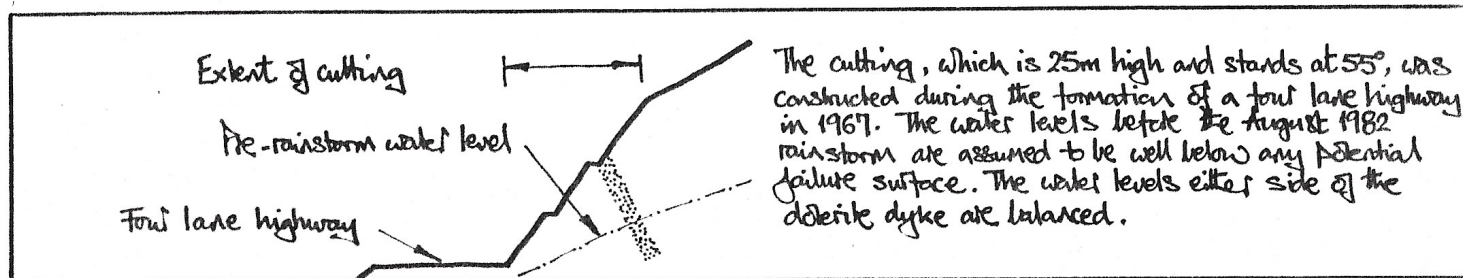
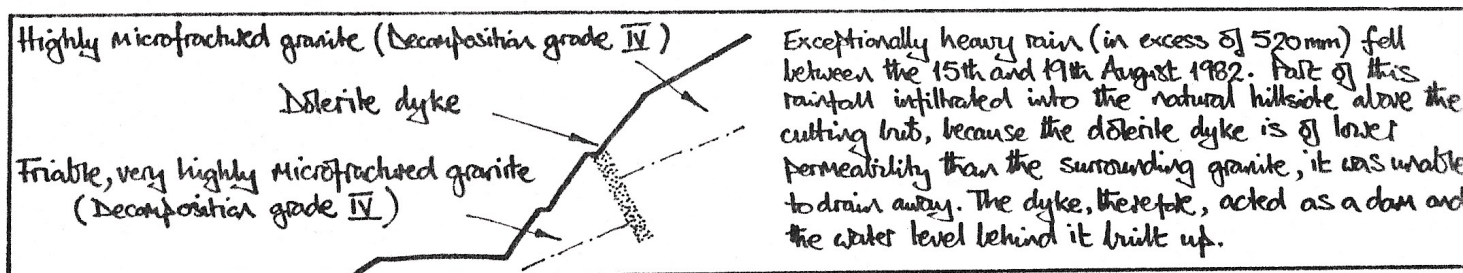
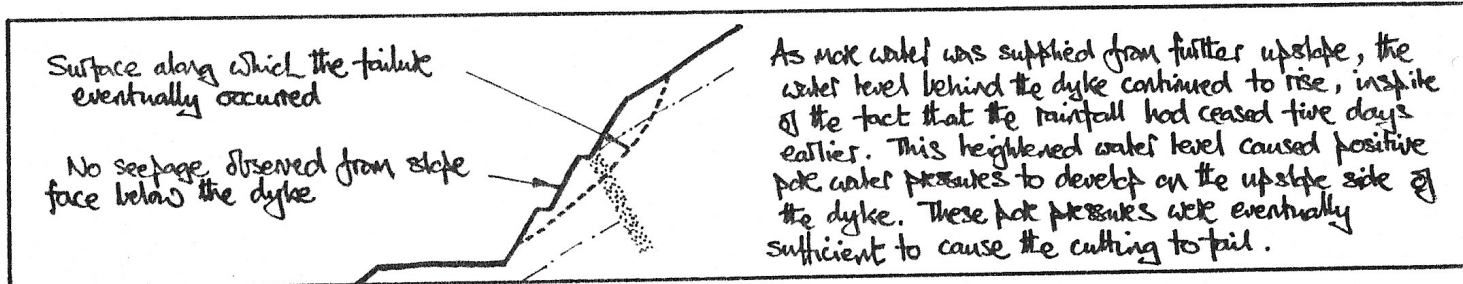
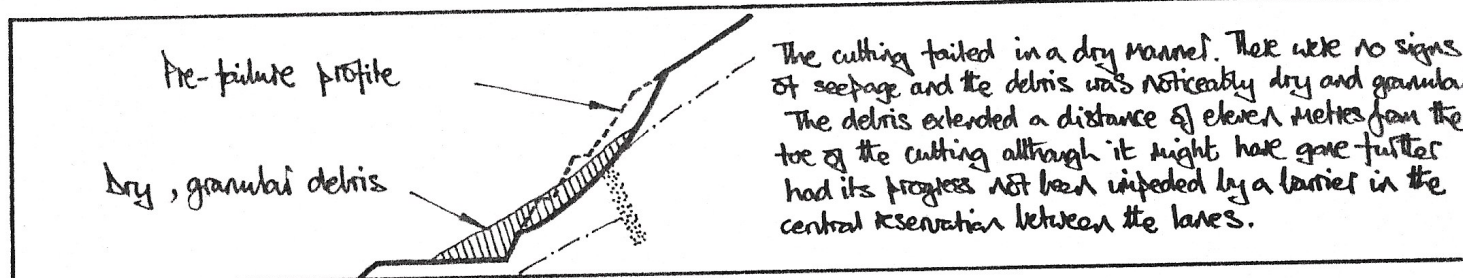
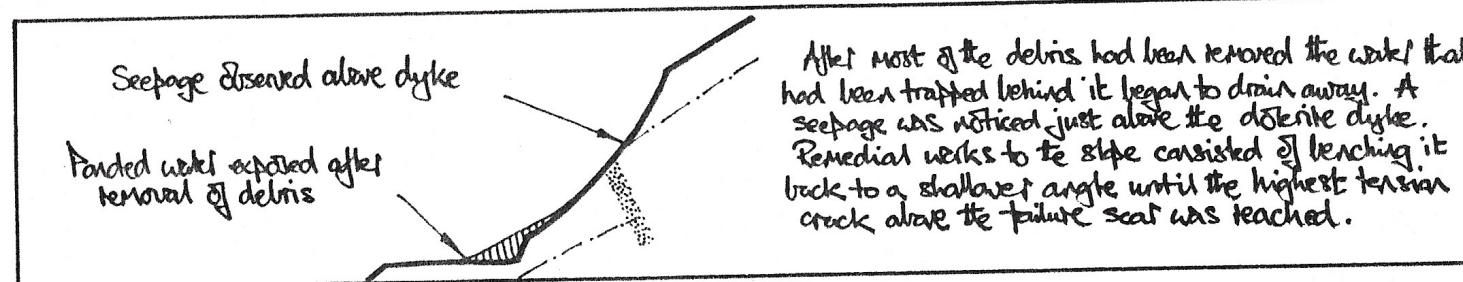
A theoretical explanation for the failure on the basis of a delayed rise in groundwater table is presented schematically in Figure 6. Analysis using Janbu's Rigorous method (Janbu, 1973) with strength values obtained from conventional testing, showed that the change in conditions from Figs. 6(b) to (c) could result in a reduction in Factor of Safety from 1.3 to 1.0.

The reasons for failure have not been established clearly. The delayed nature can be explained theoretically on the basis of a delayed rise in groundwater behind a dolerite dyke acting as an aquiclude. This theory however is unsatisfactory in that similarly complex geological solutions would be required to explain the two 1972 failures, and analyses carried out by authors of previous reports could not justify a delayed rise of up to ten days on the basis of assumed infiltration and storage characteristics. Perhaps other aspects such as previous instability were important and the delayed nature was only coincidental.

Figure 6 - Diagrammatic explanation for failure based on damming of groundwater
