Landslide mechanisms in Hong Kong

S. R. Hencher and S. G. Lee

Geological Society, London, Engineering Geology Special Publications
2010, v.23; p77-103.

Abstract: This paper reviews the nature and mechanics of landslides in the weathered terrain of Hong Kong. The vast majority of landslides are very shallow (a few metres depth) and occur during intense rainstorms. Deeper-seated landslides, in contrast, may occur days or weeks after intense rainstorms. The time of occurrence of landslides can be linked to hydrological and hydrogeological factors, and a hydrogeological grouping of landslide mechanisms is introduced related to timing in a storm. A relationship is presented that links intensity of landsliding to 24 h rainfall. The gradual deterioration and internal erosion of slopes prior to detachment is discussed and allows some realistic opportunity for identifying progressive major landslides. In particular, the growth of natural piping systems and infilling of dilated fracture networks are recommended as important indicators of landslide development. The conclusions are supported by case examples of slope failures, the study of some of which has been taken to a forensic level.

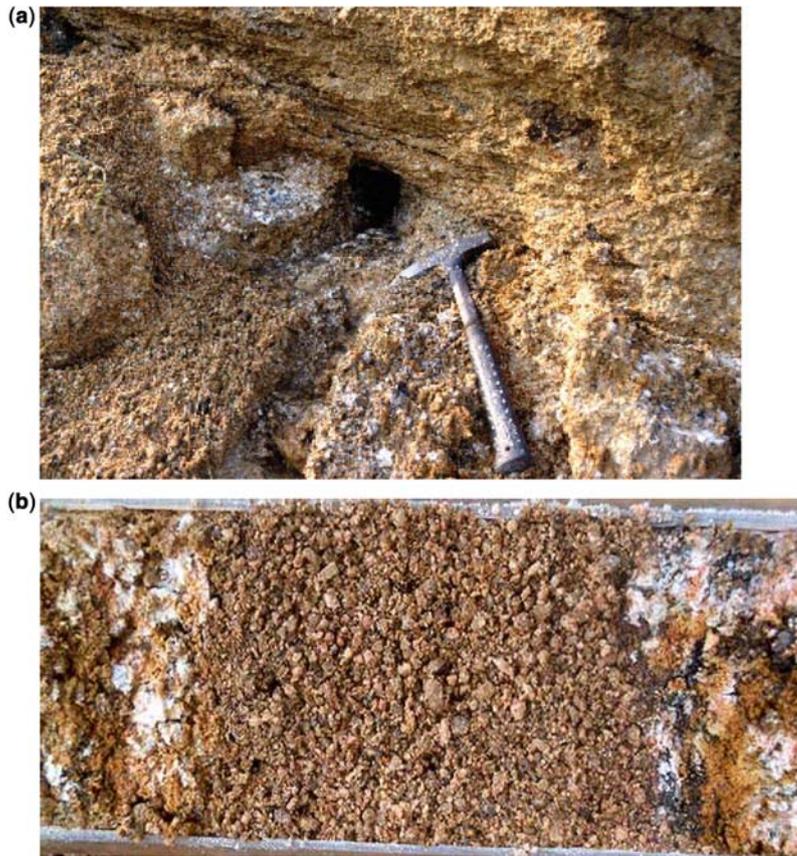
Fig. 16. (a) Natural pipe through decomposed granite exposed in landslide at Tsing Yi (2); (b) alluvial sand sandwiched between decomposed granite within continuous Mazier sample from depth at location of Ching Cheung Road landslide, 1997.

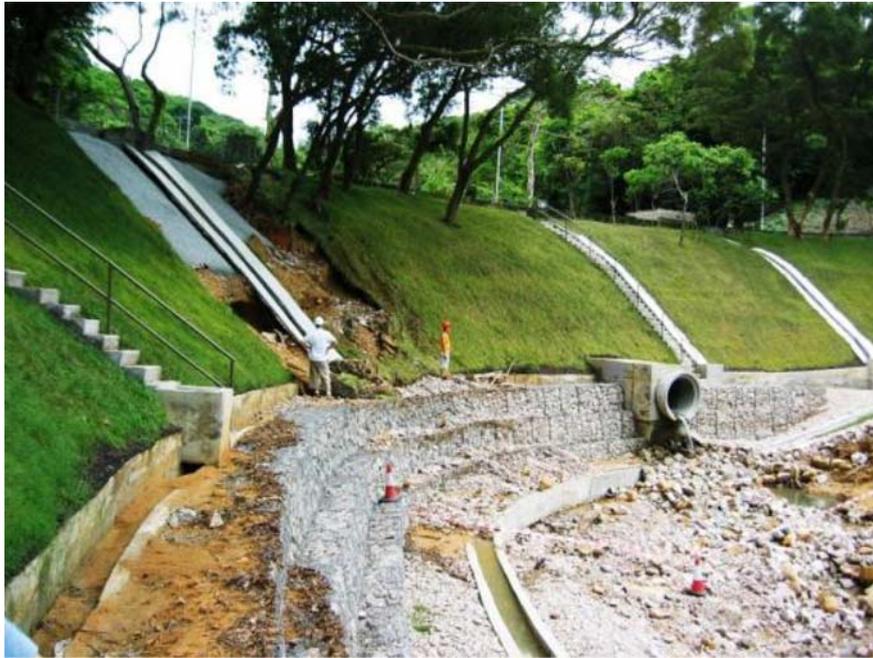
Fig. 22. Washing out of newly constructed fill slope on Lantau Island following blockage of drains and flooding of the road above combined with an inability of surface channels to carry such large quantities of water.

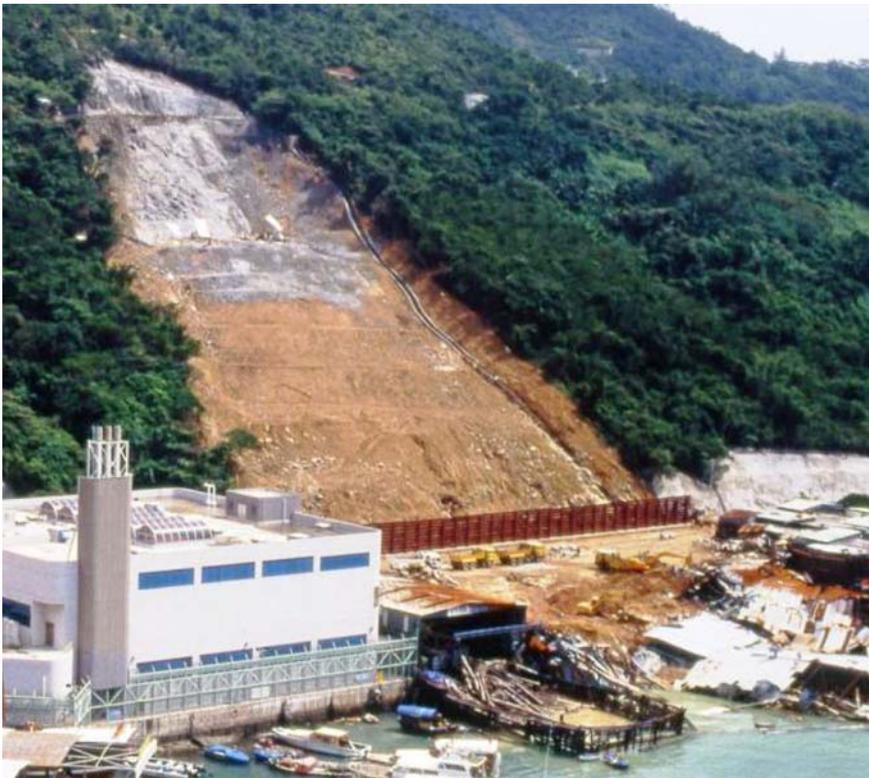
Fig. 23. Site of the Shum Wan Road landslide of 1995 that killed two people and was considered to have been triggered by flow down roads at the head of the landslide exacerbated by blocked drains (GEO 1996). Photograph following preliminary remediation works and with continuing ground investigation.

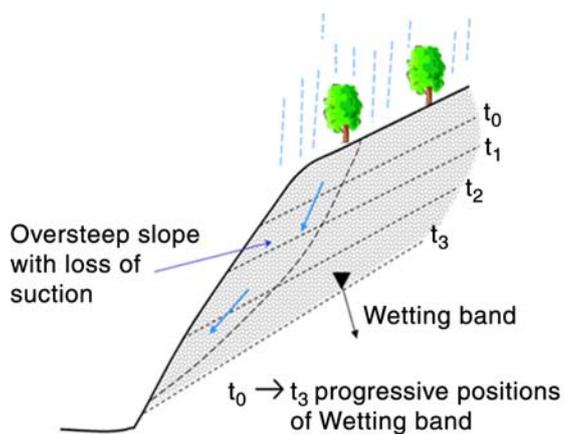
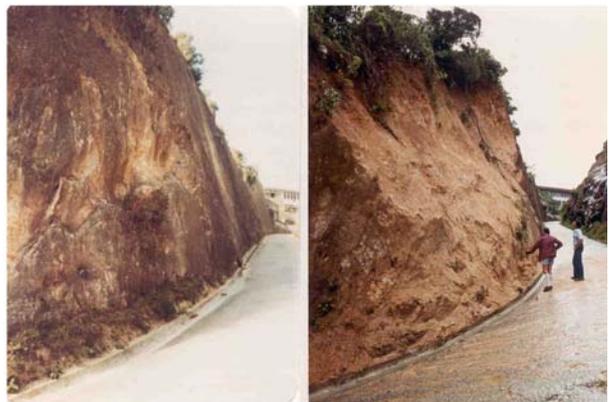
Fig. 24. Loss of suction as a result of wetting (saturation) of partially saturated material. Photographs on the right are of Chung Hom Kok failure in highly decomposed granite (Schmidt hammer rebound values up to 17) before and after failure (Hencher 1983c; Hencher *et al.* 1984).

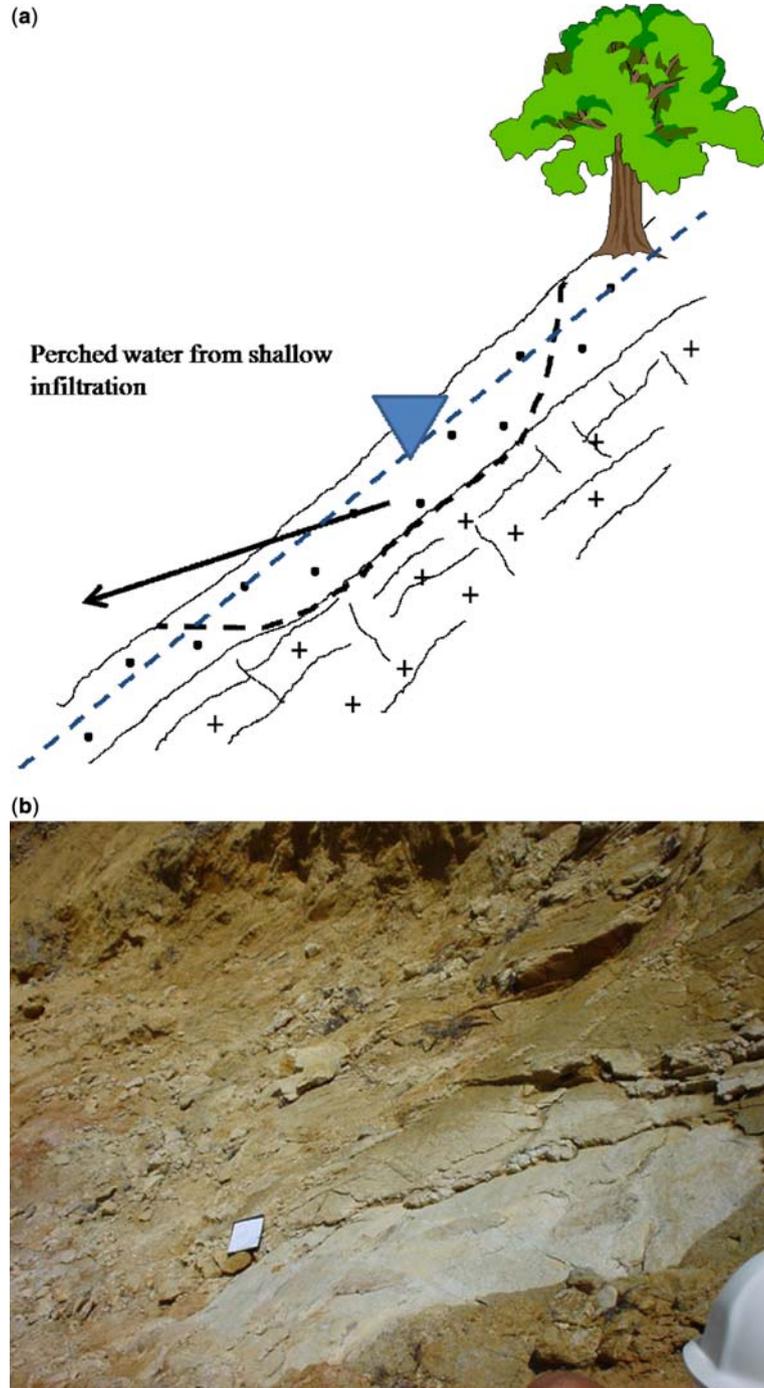
Fig. 25. (a) Schematic representation of perching of water above shallow rock head. (b) Debris trail from landslide above Leung King Estate (Halcrow China Ltd. 2001). In the foreground, in front of the clip board is exposed the pale grey, underlying wall of an extensive sheeting joint. The rock above the sheeting joint is discoloured as the result of many years of intermittent movement and deterioration prior to final detachment, as explained in detail by Halcrow China Ltd. (2003) and Hencher (2006).

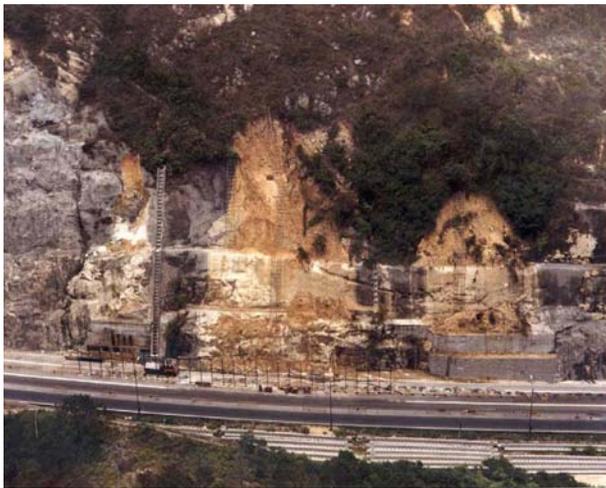
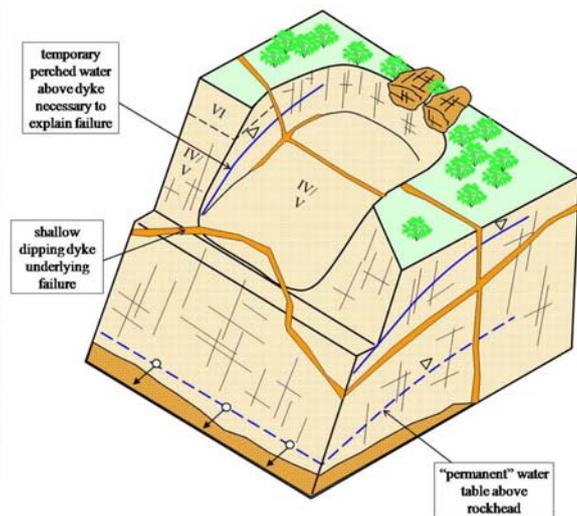
Fig. 27. Tuen Mun Highway landslide, 1982. The landslide was discussed in detail by Hencher (1983a, 2000) and Martin & Hencher (1984).

Examples of this type of failure have been reported by Hencher (1983*a, d*), Hudson & Hencher (1984), Martin & Hencher (1984) and Au (1986). The slope illustrated in Figure 27 is on the Tuen Mun Highway in Hong Kong. Post-failure investigation and analysis established that positive pore-water pressure was necessary to explain the landslide yet a piezometer through the landslide scar and field observation established that the main groundwater level a few days post-failure was much deeper than the failure surface. A series of decomposed dolerite dykes with lower permeability than the granitic country rock were mapped through the slope with a disposition such that the development of perched water was likely during high rainfall, and it was deduced that this was the triggering factor for the failure (Hencher 1983*a*). An example of groundwater being partitioned as in Figure 26*b* was identified at Ching Cheung Road (Fig. 28) (Hencher 1983*e*; Hudson & Hencher 1984). A thick dyke with water seeping above it was mapped within the failure scar, and

its presence was used to explain various unusual aspects of this failure, which occurred on a dry day, 4 days after an intense storm.

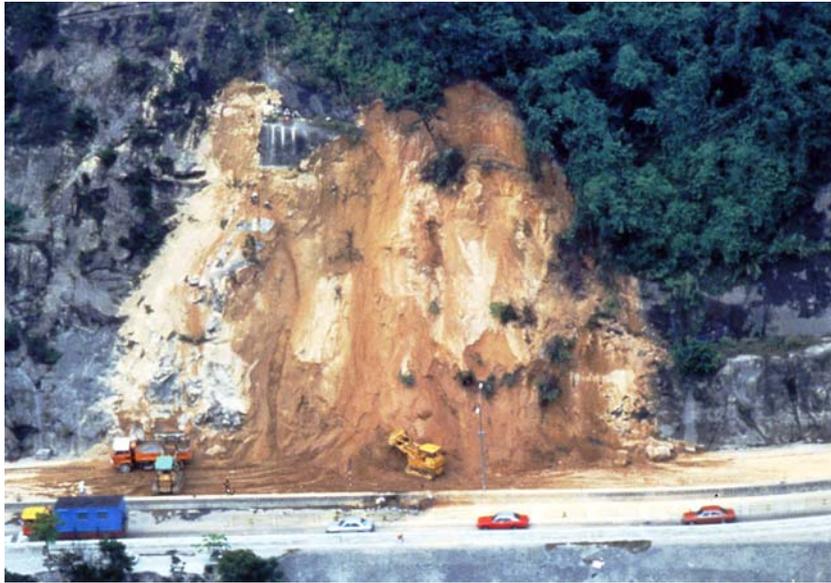
Fig. 28. Landslide in a section of Ching Cheung Road, 1982, that failed 4 days after heavy rain. A steeply dipping, thick decomposed dolerite dyke was mapped across the failure scarp with water seepage from above, after the failure.

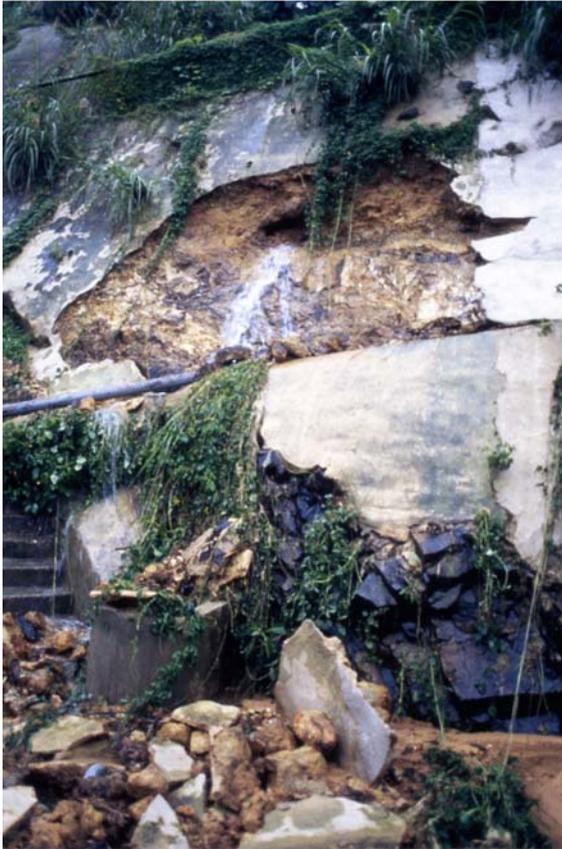
Fig. 29. Above, high-permeability zone allowing rapid through flow and build-up of potentially artesian pore pressure. Below, photograph of slope on Chai Wan Road, 1982 with large pipes at boundary between colluvium and underlying volcanic rock.

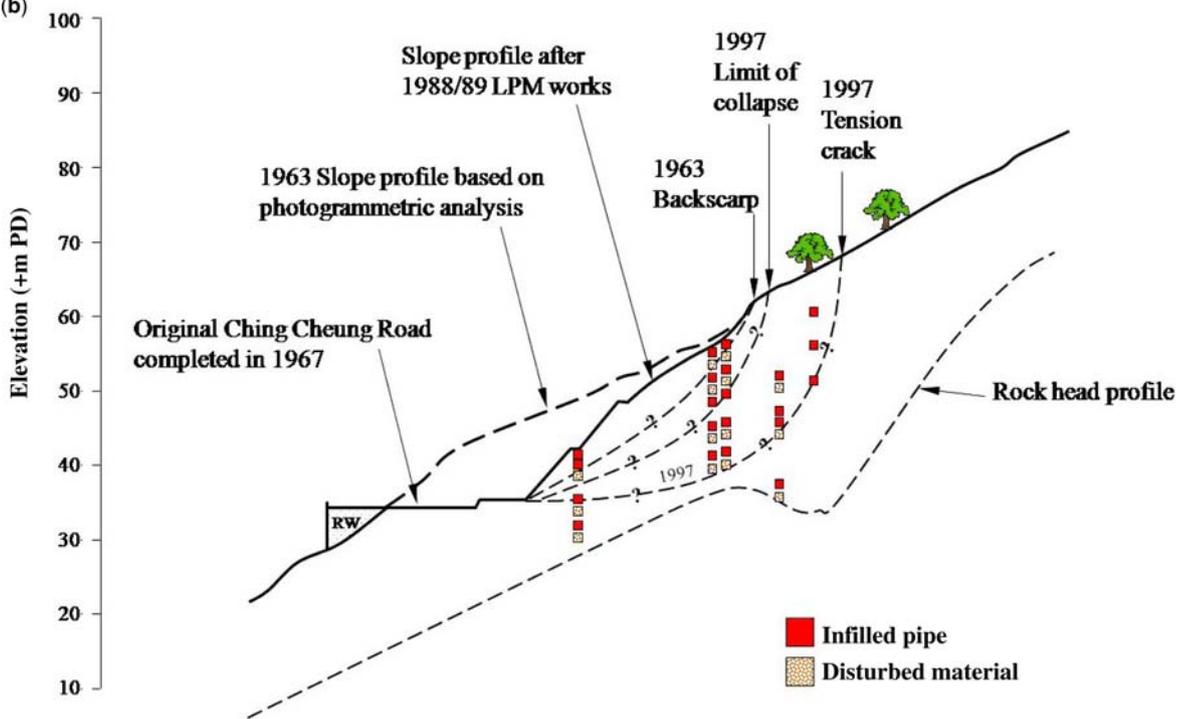
Fig. 30. (a) Rise in groundwater table from time t_0 to t_3 . (b) Cross-section of the Ching Cheung Road landslide of 1997. (Note the number of choked natural pipes sampled in each borehole and that they extend to considerable depth (even below the 1997 slip surface), which indicates the length of recharge path to the groundwater table.)

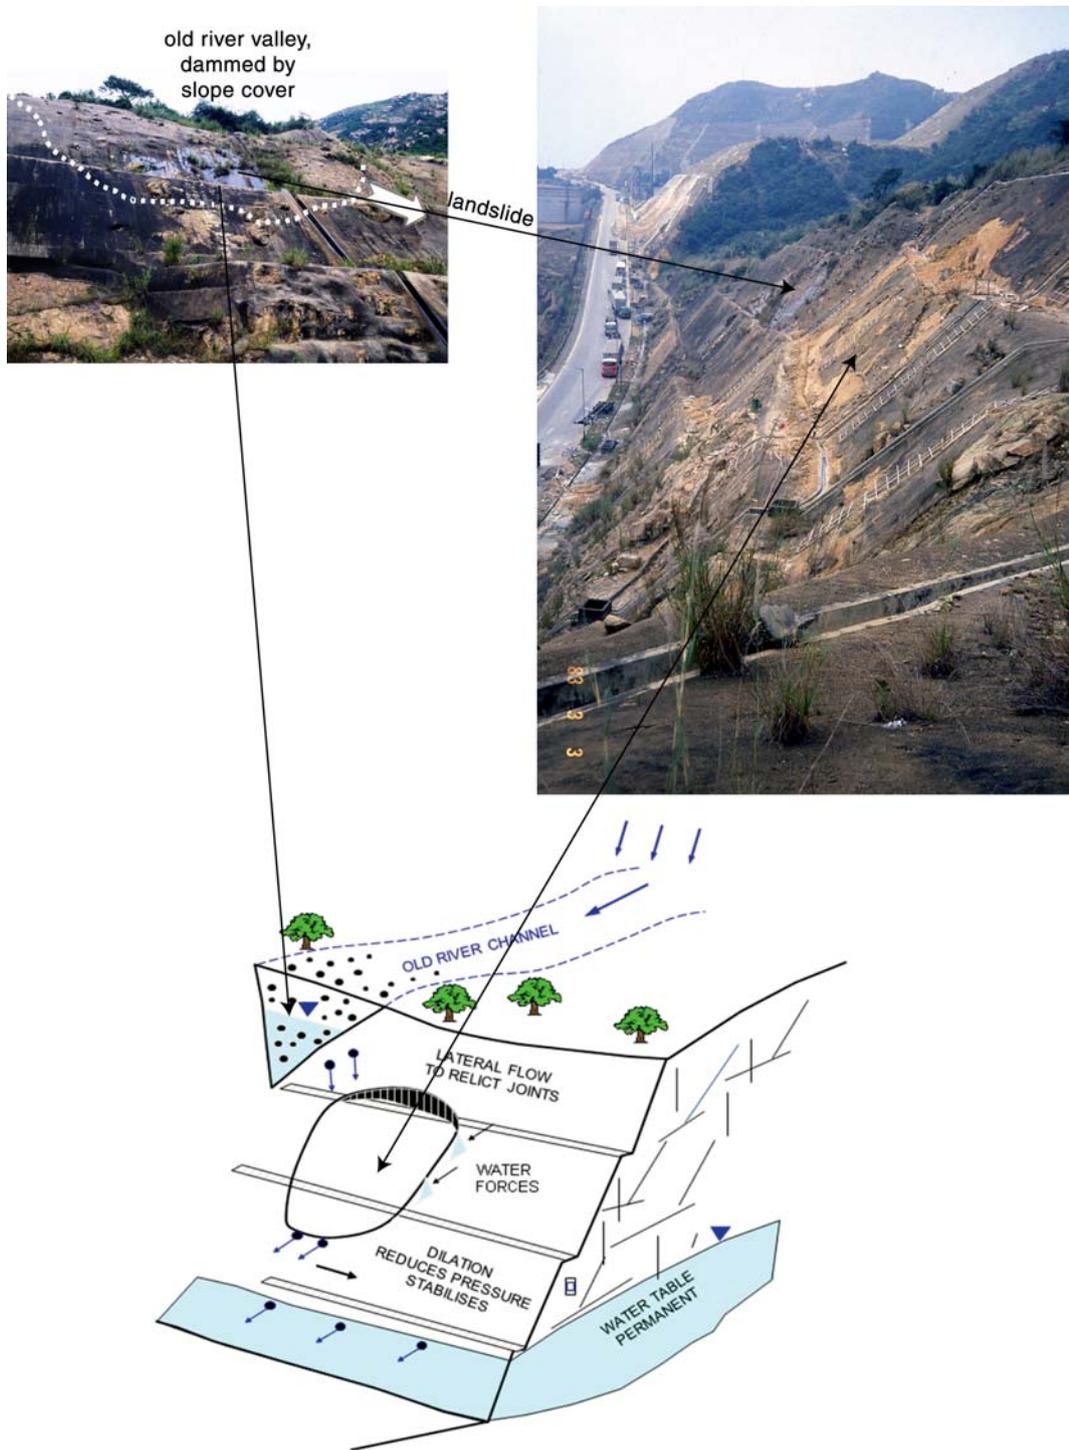
Fig. 31. Tsing Yi (2) landslide.

The failure illustrated in Figure 31 comprised the dilation and partial detachment of a section of a cut slope in 1982 (Choot 1983). Water was seen issuing from the toe of the distressed area several days after rainfall, and an area to the left and above the failure was observed to be very wet and vegetated. A few days later water issue ceased from the zone of the failure. It was deduced that heavy rainfall on the natural hillside above the slope had flowed towards an old river valley, choked with boulders, which emerged in the upper left side of the cut slope (the wet and vegetated zone). During formation of the slope the valley cross-section had been dammed by a hard surface cover. Consequently, as water flowed down the old river, water pressure built up behind the concrete cover and this in turn led to a rise in water pressure within the relict joints in the adjacent zone of cut slope where the failure took place. The reduced effective stress and consequent decrease in shear strength combined with active cleft water pressure led to some initial translational movement on relict joints (about 0.5 m at the toe). The translation movement along the adverse joint sets involved dilation of the rock mass and increased permeability, and this in turn resulted in a drop in driving water pressure and cessation of movement as illustrated in Figure 31.
