REPEATED COLLAPSE OF CUT SLOPES DESPITE REMEDIAL WORKS

S. G. Lee

S. R. Hencher

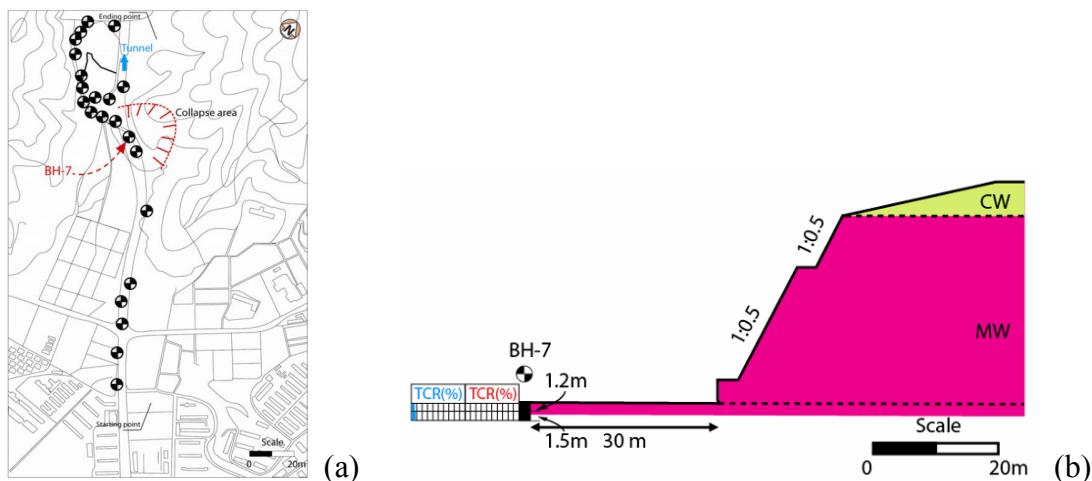
Boreholes were not put down specifically at the cut slope for the original design (Yoo 1991); a borehole investigation (terminated 1m into moderately weathered (MW) rock) was conducted for bridge foundations 30m away from the cut slope. Upper soils were only 1.2-1.7m thick. Underlying the soil, MW rocks were collected as rock fragments; $TCR \leq 10\%$, $RQD = 0$ (Figure 3). The 40m high slope was then designed with a 1:0.5 (63°) standard gradient, based on the Korean construction standards (KEC 2001; MOCT 2004) for the design of cut slopes as follows: moderately weathered to fresh rock 1:0.5 (63°), highly weathered rock 1:1 (45°), and soil 1:1.2 (40°) to 1:1.5 (34°) depending on rock material strength.

Figure 3: (a) Location of boreholes for design of the structures relative to the failed slope and (b) assumed cross section for the slope

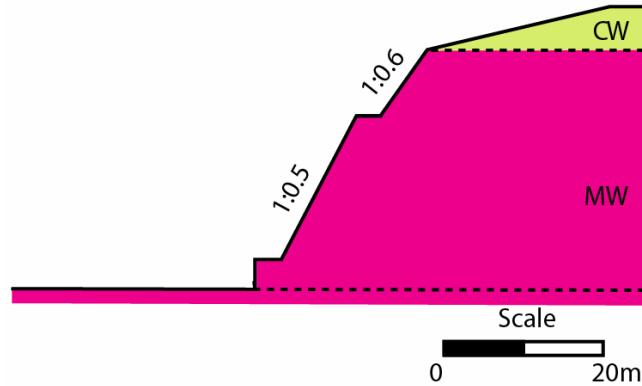
work and the geological conditions are described in some detail in Kim (1993). Vertical joints were commonly developed within bedding units; thickness of sandstone layers was typically 300-400mm with thin (10-20mm) highly weathered (HW) intercalated shale layers. Stereographic projection analysis indicated possible toppling failure; the upper part of slope was therefore redesigned with a gentler gradient of 1:0.6 (59°) (Figure 4).

Figure 4: Result of 1st cut slope safety inspection (reduced gradient of the upper part to 1:0.6).

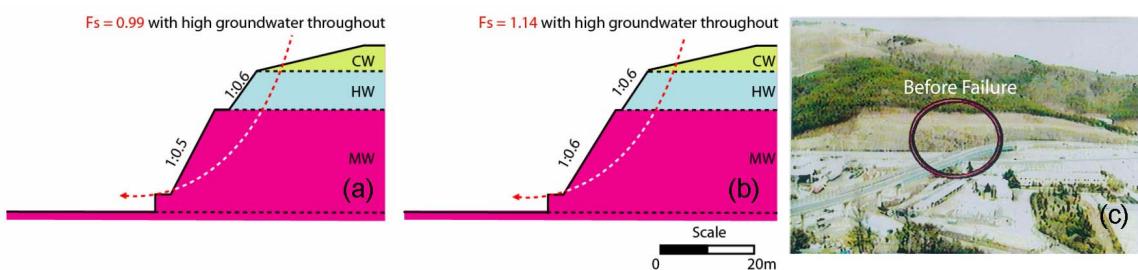
Further collapses of the cut-slope occurred infrequently after completion in May 1995 and, according to the field geological survey conducted for the safety inspection in December 1995 (Chae 1995), some small-scale wedge mechanisms were identified but the risk of bedding plane translational failure was not analyzed. The possibility of circular failure was also considered high ($F_s = 0.99$), so for stabilization, it was suggested to reduce the gradient of the lower part of the cut-slope gentle to 1:0.6 (59°) ($F_s = 1.14$). In addition, the surface of cut slope was to be covered with wire-mesh and vegetated shotcrete (Figure 5).

Figure 5: Result of cut slope stability review in 2nd safety inspection. (a) MW slope by 1st safety inspection (1:0.5), (b) MW slope by 2nd safety inspection (1:0.6) and (c) status of reinforced cut-slope after 2nd safety inspection (before 3rd collapse)

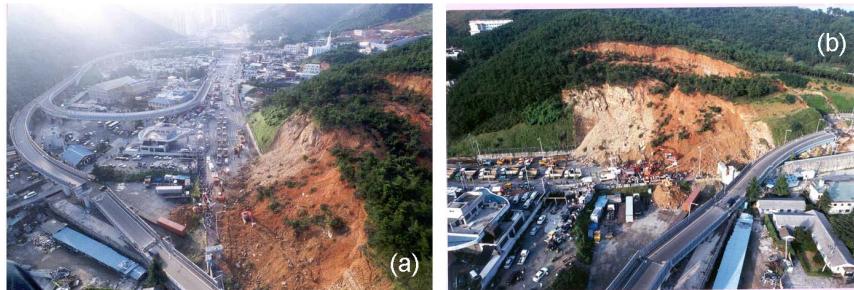
Heavy rain occurred in September 1999. The accumulated rainfall for 2 days before failure was 100mm; maximum rainfall per hour on the day of the failure was 39mm (KMA 1999). Such rainfall intensity is considered dangerous according to landslide triggering data of Korea (KFS 1993). A 3rd large scale collapse developed along a bedding plane inclined at $15\text{--}20^\circ$ and filled with clay. This failure resulted in the burial of 10 vehicles and destruction of a bridge (Figures 6 & 7). As this important road was to be re-opened urgently, a temporary

Figure 6: Scene soon after major landslides. (a) Side view and (b) front view

protective wall was installed using H-piles and landslide debris removed (toe-cutting); collapses occurred continuously in October 2000 and January 2001 during the works.

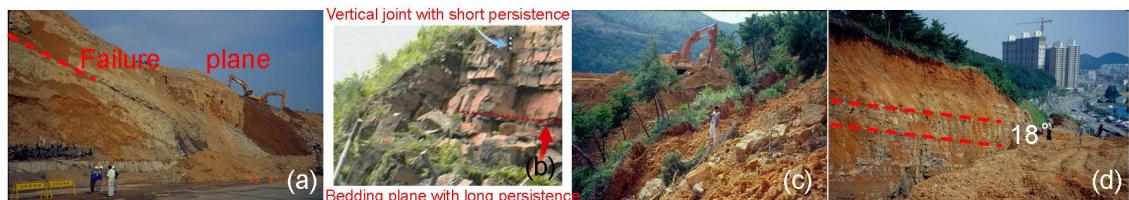
Figure 7: Geological characteristics of failure planes. (a) Failure plane from side, (b) bedding plane from the bottom, (c) tension cracks at the top, (d) bedding planes exposed in tension cracks.

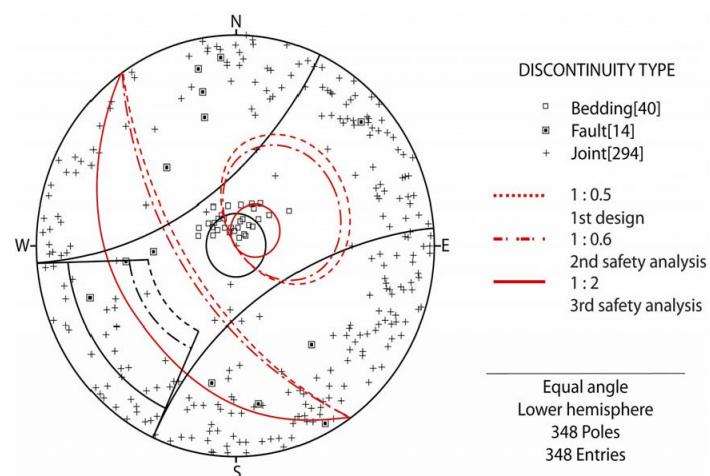
Figure 8: Stereographic projection for fracture data - mostly bedding and orthogonal joints (Choi & Paik 2002).

- (2) Once the nature of the geology had been broadly established (it was not difficult), the application of kinematic analysis was poor, totally overlooking the possibility of translational failure on low angle but weak bedding surfaces and poor understanding of the limitations of the stereographic projection method (Hencher 1987; Hencher & Knipe 2007).

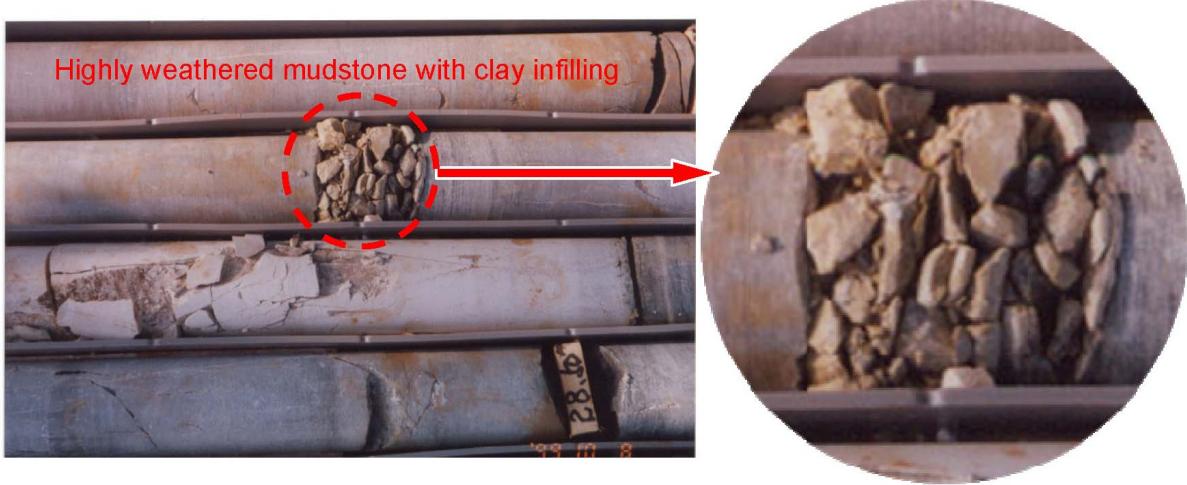
At the 3rd safety inspection by a professional institute (Han 1999), boreholes were put down at 8 locations to 22-35m depth and direct shear tests carried out on clay samples which gave reported strengths of $\phi = 21.4^\circ$, $c = 11\text{kPa}$ at natural moisture content and $\phi = 16.8^\circ$, $c = 11\text{kPa}$ where saturated.

Figure 9: Photograph of core of HW shale with clay filling developed at 26 m deep in MW-SW sandstone (Han 1999)

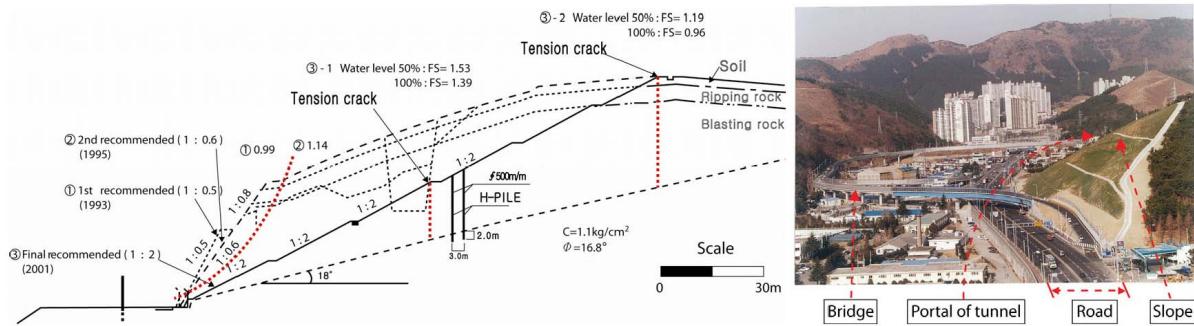
Figure 10: (a) Result of 2nd safety inspection and (b) scene of completed remedial works

The failure mechanism was identified as bedding plane slip involving clay infill. A more gentle gradient (1:2.0 (27°)) was proposed together with reinforcement H-piles to provide $F_s = 1.4$ which is higher than $F_s = 1.2-1.3$ normally adopted because of the importance of the slope (Figures 8 to 10).

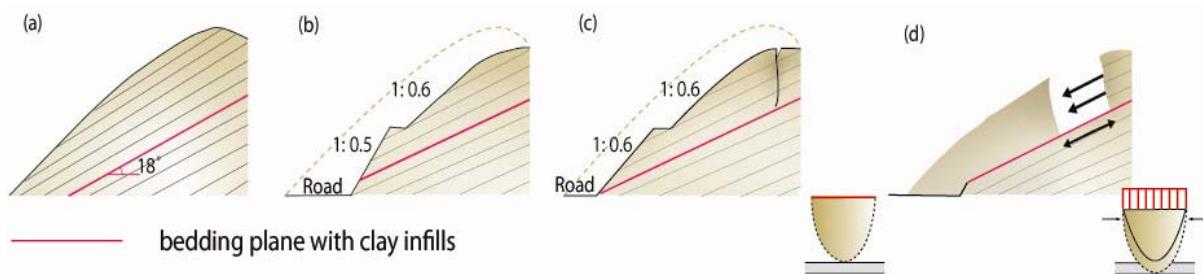
- (3) Rock cut slope collapses are commonly the result of infiltration of groundwater into tension cracks developed to the rear of cut slopes; analysis of aerial photographs shows that tension cracks were already developed at the back of cut slope by the time of 2nd safety inspection in 1995 (Figures 11 & 12). The failure type of the cut slope was misjudged as a circular failure of soil rather than translational bedding plane slip in the 2nd safety inspection despite the Fs for such a mechanism to be low as 0.84 when fully saturated. A contributing factor to the history of collapse was that remedial works were carried out in a hurry with no identification of the basic cause.

Figure 11: Process of collapse from original design to final catastrophic failure.
 (a) Original ground before cutting work, (b) after cutting work (1995),
 (c) initial development of tension cracks at the back of rock masses
 (1995-1999) and (d) creation of large landslide (1999).

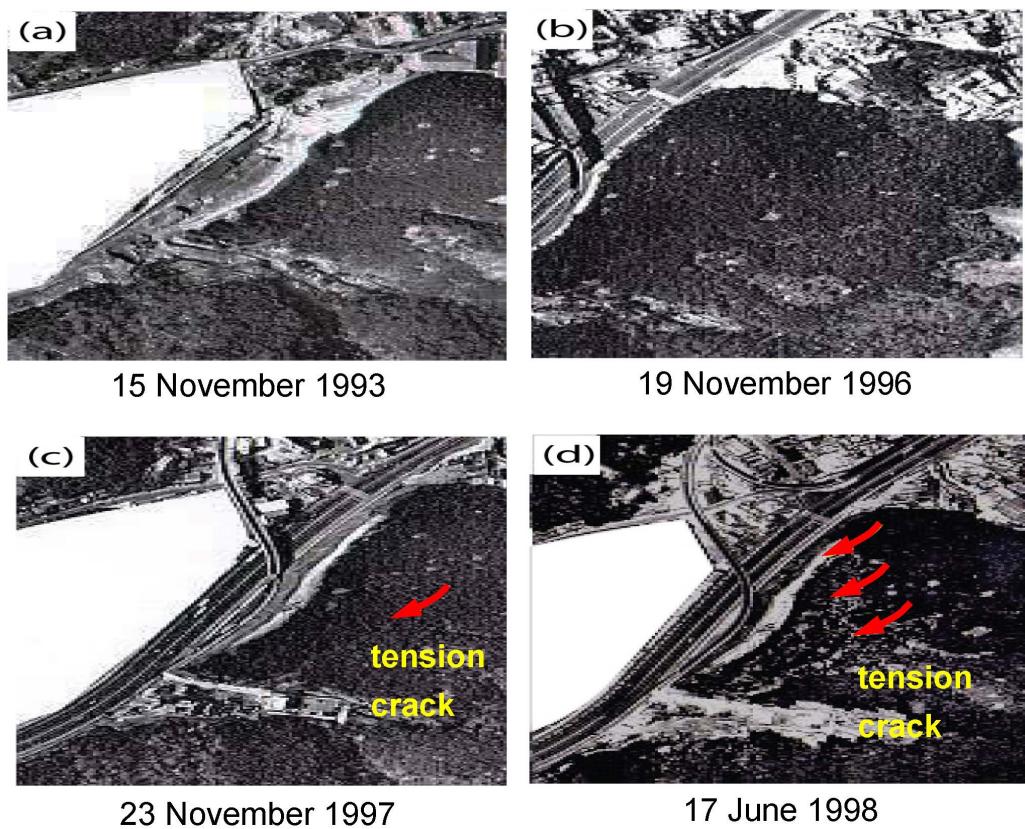
Figure 12: Aerial photographs of the landslide area before the major landslides in September 1999; (a) 15/11/93 (b) 19/11/96 (c) 23/11/97 (d) 17/06/98.

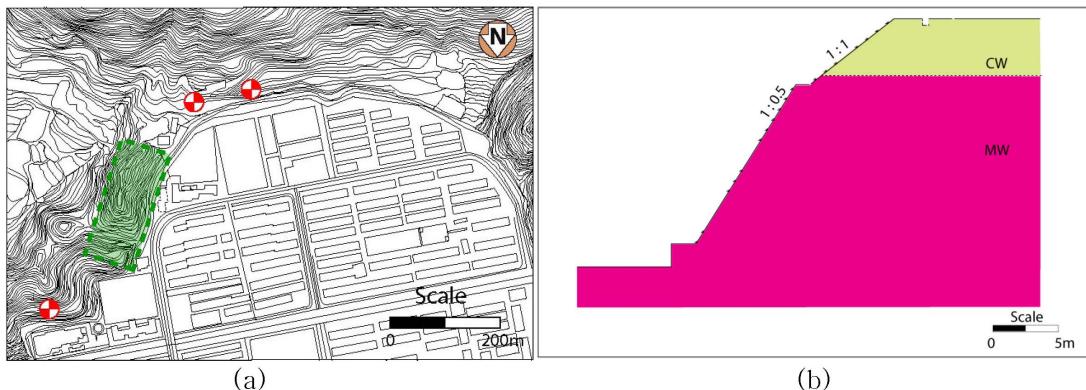
For the original design in 1994, no boreholes were carried out despite the large scale of cutting (20~30m high slopes, 250m wide). Instead, borehole data 300m away from the site was assumed to be relevant; the area was considered to comprise completely weathered (CW), HW, and MW rock. The lower part of the cut-slope was designed to have a 1:0.5 (63°) standard gradient with vegetated surfaces (Cho 1994) (Figure 14).

Figure 14: (a) Location of boreholes used for design; (b) cross section (assumed geology)

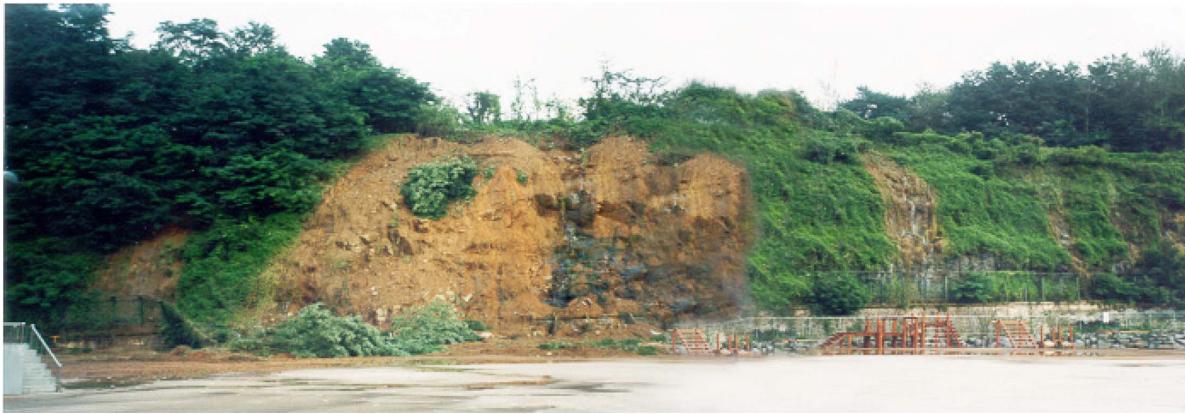
Part of the cut slope collapsed during heavy rainfall in July 1998. The failure apparently occurred along the boundary between soil and MW rock (Figure 15). One borehole was proposed at the location of the collapse to terminate up to 2m into slightly weathered rocks. Rock bolts were proposed in some sections considered prone to planar failure. Otherwise, the lower part of the cut slope was considered safe with a 1:0.5 (63°) gradient. The upper part of the cut slope was proposed to be cut at a gradient of 1:1 (45°) (Park 1998) (Figure 16).

Figure 15: Cut slope collapses in August 1998. Front view after landslide (Lee 2001)

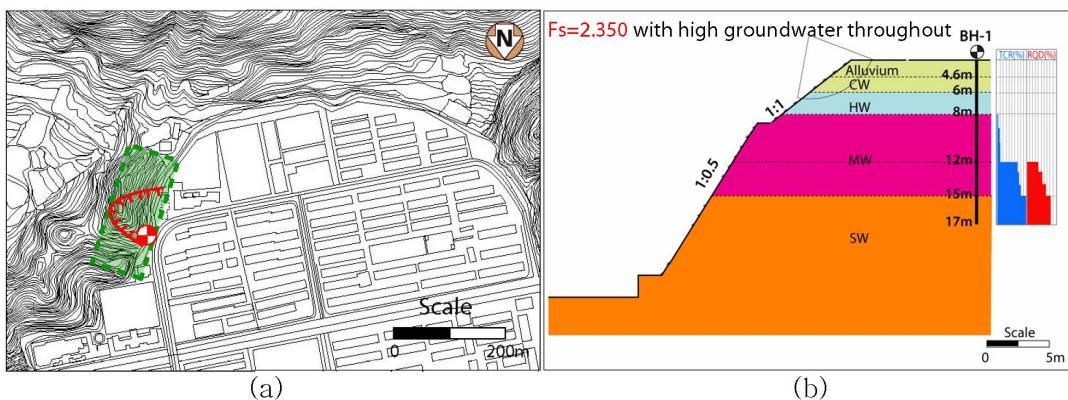
Figure 16: Location of boreholes and cross section following 1st safety inspection.
 (a) Location of borehole investigation and (b) cross section.

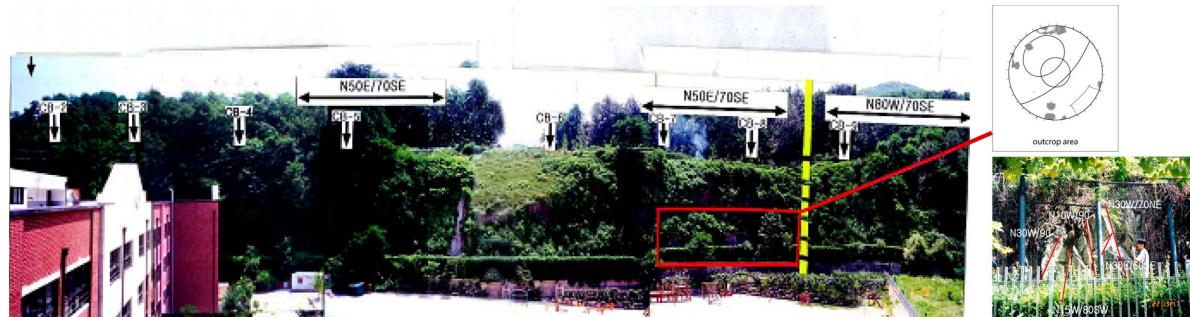
Despite much of the cut slope being covered with vegetation, exposed areas of slope were mapped geologically (Figure 17). In addition, 13 boreholes were put down to the height of the cut slopes and logged using TV cameras (Figure 18). In addition, 2 lines of field seismic refraction survey were performed at the ground surface of the upper part of the cut slope. A 3D stratum model (Figure 19) was created through integrated analysis of the surveyed data including the videos from the boreholes. The investigation allowed the joint fracture network to be characterised and several faults were located. It was also found that the boundary between soil and rock in the whole cut-slope area was inclined towards the school. Shear strength tests were performed on the boundary between soil and rock together with a variety of other laboratory tests at natural and saturated moisture conditions (Lee 2001).

Figure 17: Panoramic photograph of Daemo primary school slope (Lee 2000)

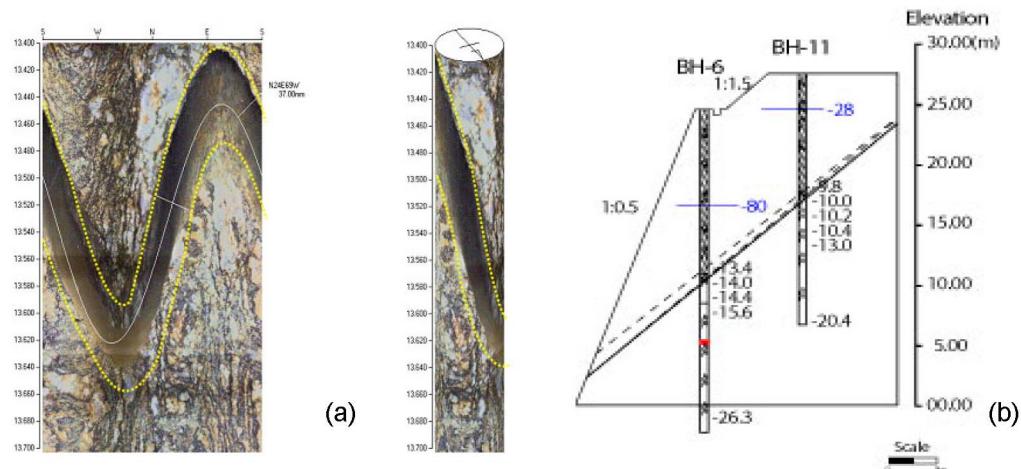
Figure 18: Results of borehole investigation. (a) Fault zone observed by borehole camera (BH-9) and (b) vertical section view interpreted from two boreholes (Lee & Geum 2002).

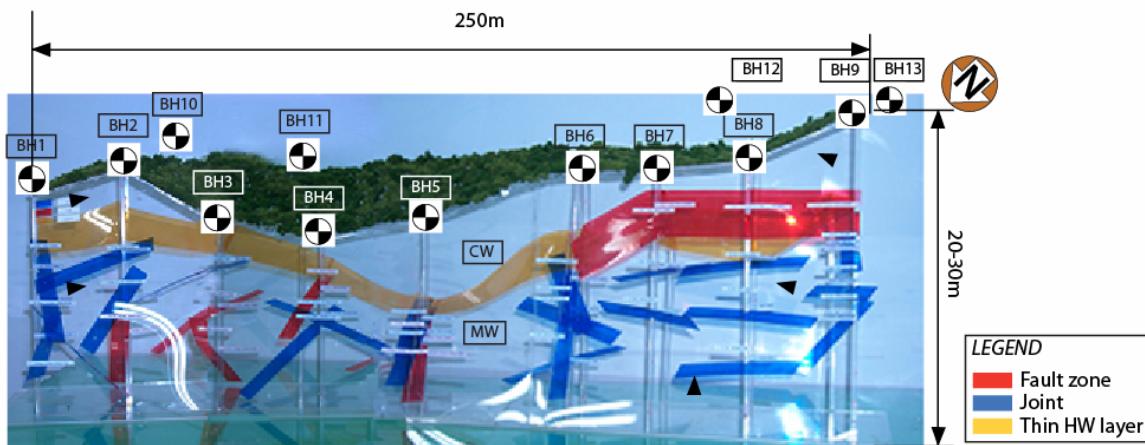
Figure 19: 3D geological models based on borehole camera interpretation (Lee & Geum 2002)

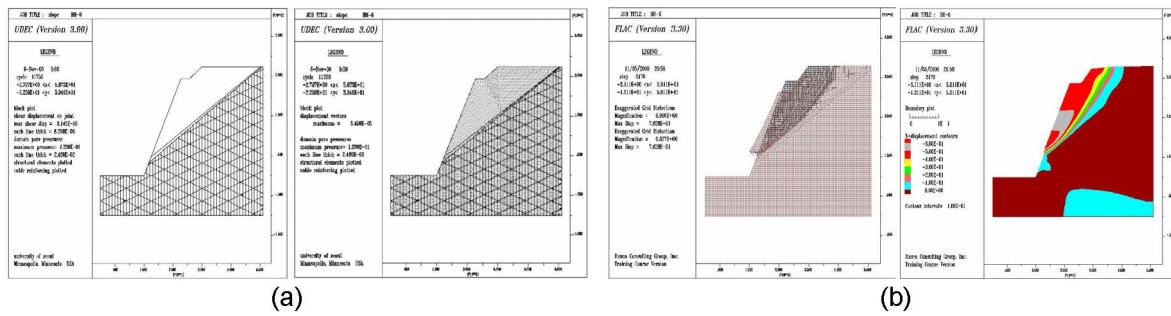
Using numerical analysis by DEM (distinct element method), failure mechanisms involving discontinuities were found to be relatively stable. Displacement analysis by FDM (finite difference method) showed that displacement was greatest at the boundary plane between CW and MW rock (Figure 20). Considering both translational and circular failure mechanisms along the boundary of CW and MW rock by limit equilibrium, it was

Figure 20: Result of numerical analysis of cut slope stability by (a) DEM and (b) FDM (Lee 2000).

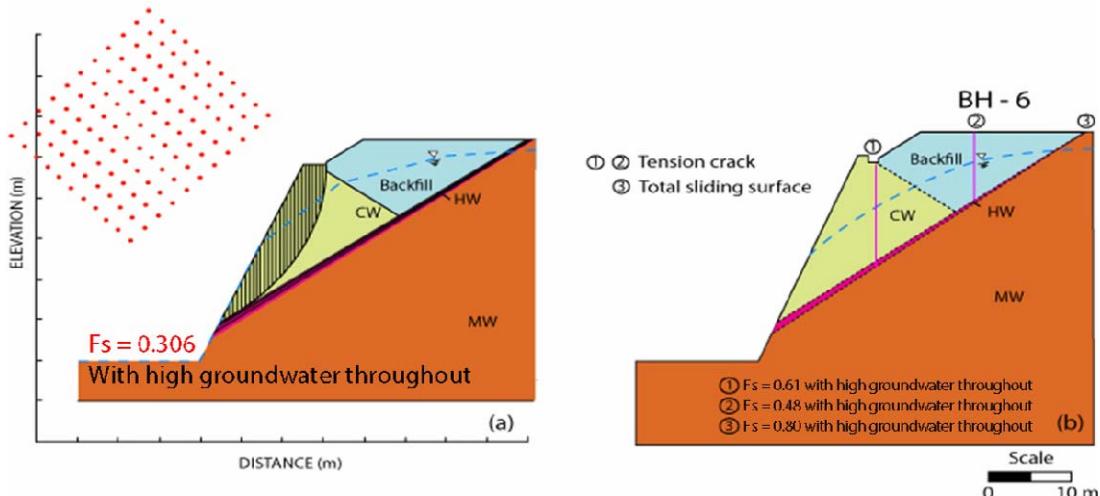
demonstrated that there was a concern for stability under high groundwater conditions (-3m from ground surface which equates to a 100-year frequency 3-day consecutive rainfall analysis). It was therefore proposed to reduce the gradient (1:1) and apply anchoring/nailing to satisfy both circular failure and planar failure conditions (Figures 21 to 23).

Figure 21: Original slope (at the highest water level). (a) Circular failure in soil and (b) plane failure along the boundary of soil and rock (Lee 2000)

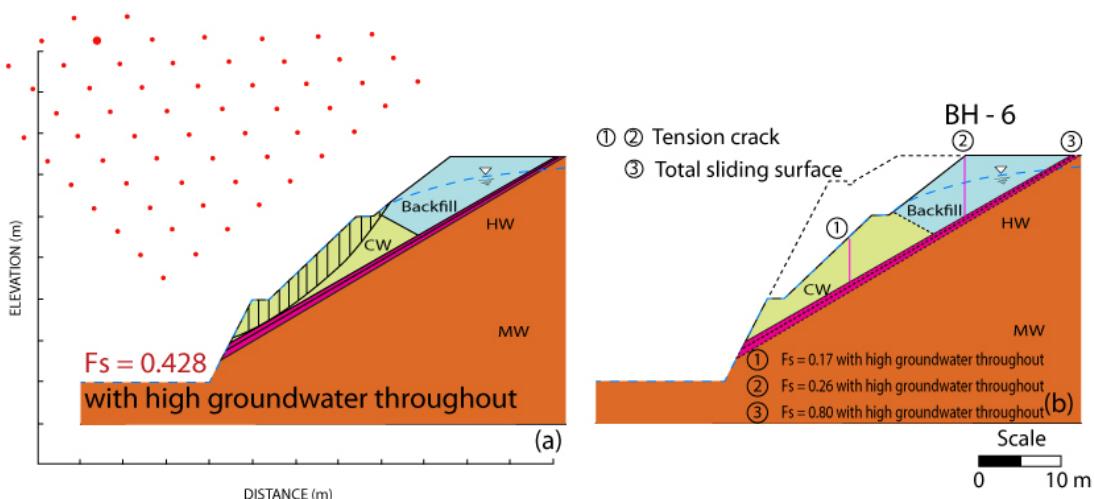
Figure 22: Cut slope (1:1, at the highest water level). (a) Circular failure in soil and (b) plane failure along the boundary of soil and rock (Lee 2000)

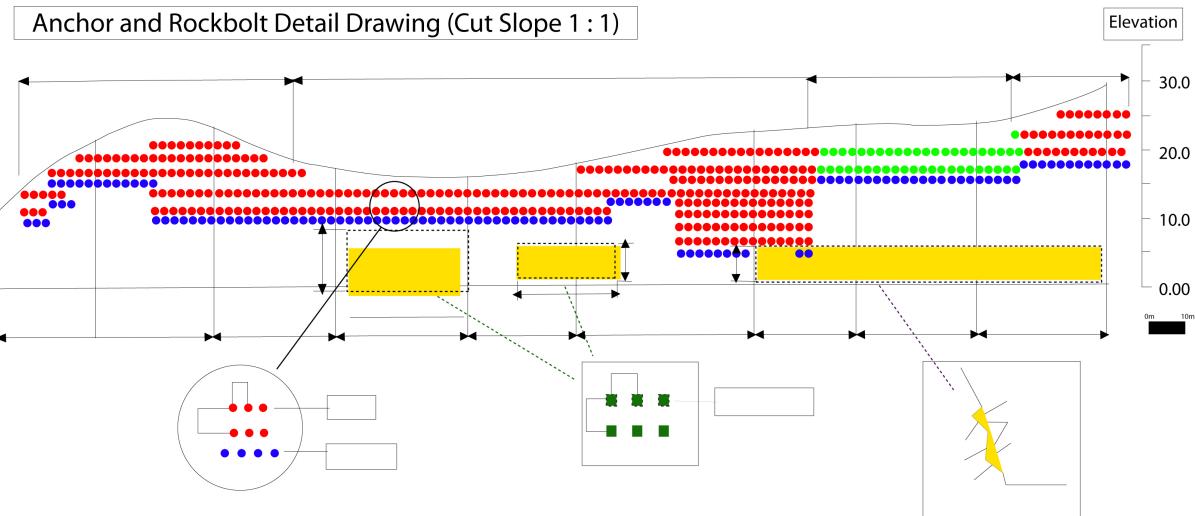
Figure 23: Anchor and rock bolt detail drawing with reduced gradient (1:1) (Lee 2000)
