SETTLEMENT AND LIQUEFACTION DUE TO THE MARCH 13, 1992
ERZINCAN EARTHQUAKE

Altay ACAR and Steve R. HENCHER

Dept. of Earth Sciences, The Univ. of Leeds, Leeds-UNITED KINGDOM

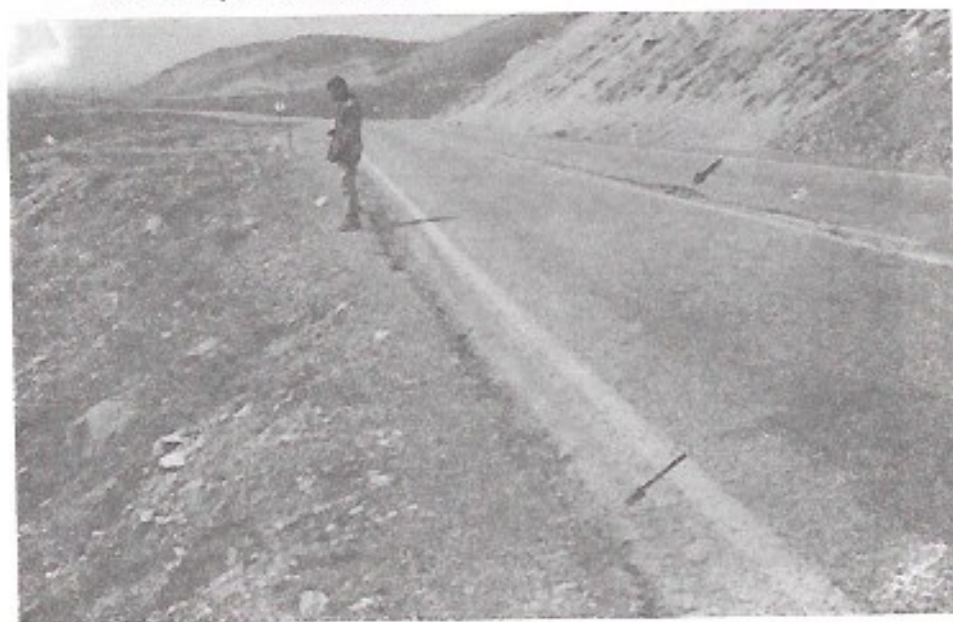
During a reconnaissance survey just after the Erzincan earthquake, several fractures were observed cutting the highway where constructed on alluvial deposits between Erzincan and Erzurum, approximately 35 km southeast of Erzincan. The highway embankment had slumped severely with associated longitudinal cracking (Fig.2) and this is attributed to liquefaction of the weak foundation alluvial deposits. On the south side of the highway, a number of cracks, 5 to 10 cm wide, more than 10 m in length, and trending $N45^\circ W$, were observed. Similar cracks were also found locally within an area of 2 km^2 .

Figure 2. Slumping of highway embankment.

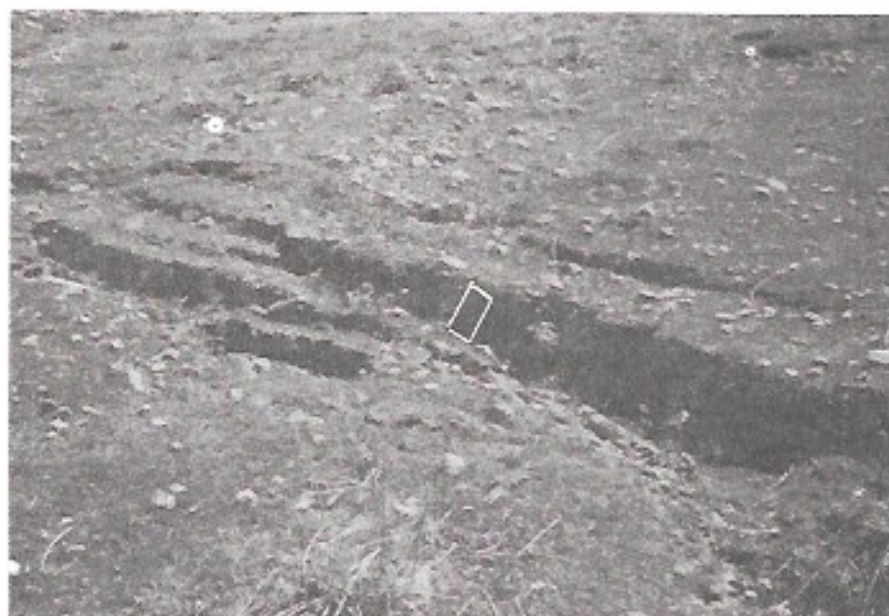
The most remarkable fractures observed occurred between the railway and the highway. One discrete perfectly elliptical slump approximately 11 m in length and 7 m wide was found in ground inclined at only 6 degrees. The ground had simply rotated on an axis sinking 30 cm at the rear tension scarp and rising 30 cm at the toe (Fig.3). Many of the fractures showed evidence of the upwelling of sand as illustrated in Fig.4. Rings of sand 5-20 cm in diameter and 10-20 cm thick formed as a result of upward flowing water were found adjacent to the the railway track (Fig.5). Following settlement of the ground

Figure 3. Discrete slump due to liquefaction. (A) Ground sinking 30cm at rear tension scarp. (B) Ground rising 30 cm at toe.

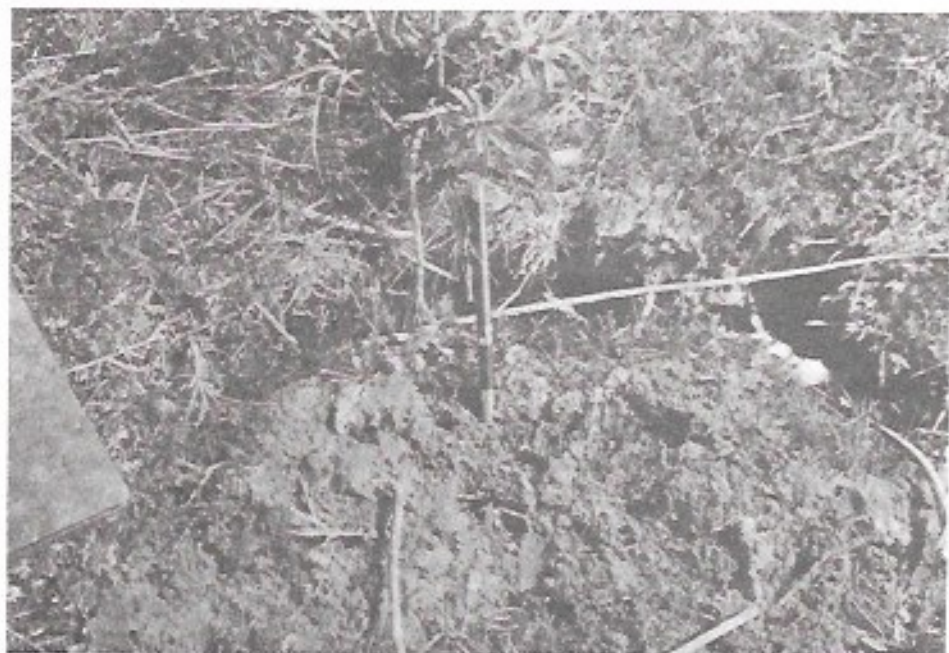
Figure 4. Evidence of out-flow sand and water.

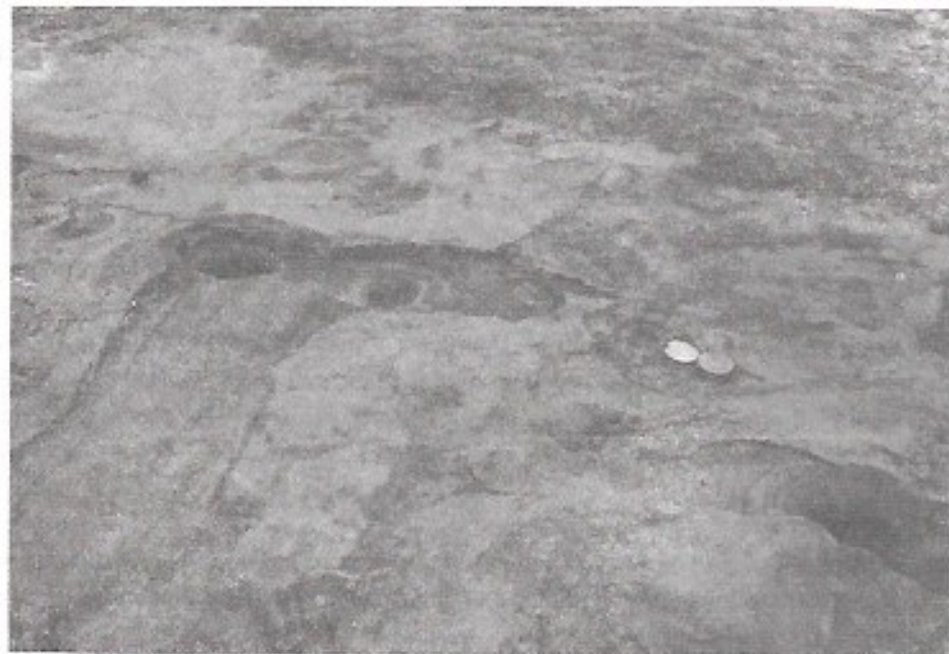
Figure 5. Sand vents surrounded by sand rings.

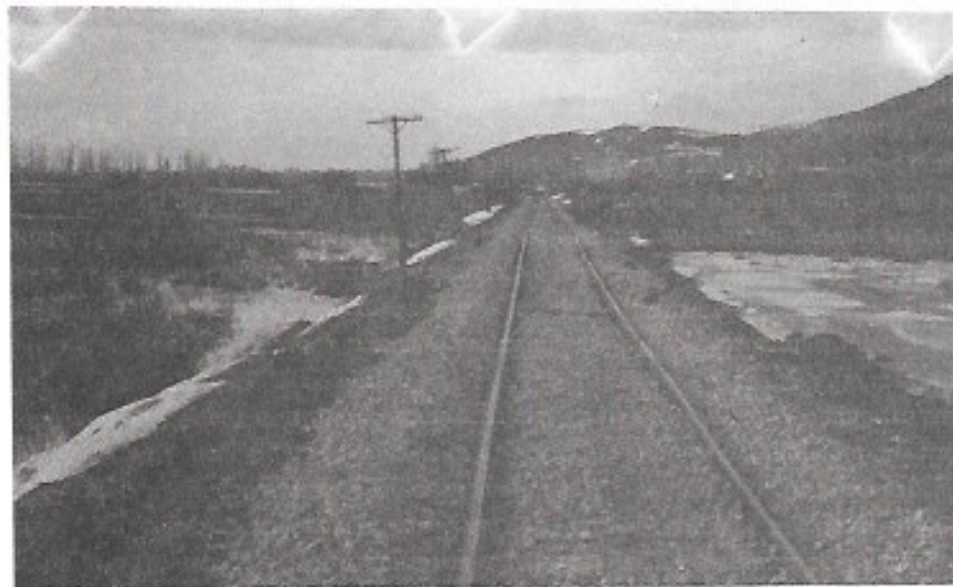
a considerable depth of water accumulated at the site. It is reported that the railway embankment had to be raised by 0.5 m locally and evidence was noted at structural damage to a tunnel through the embankment (Fig. 6).

Figure 6. Railway bending due to settlement of railway embankment.

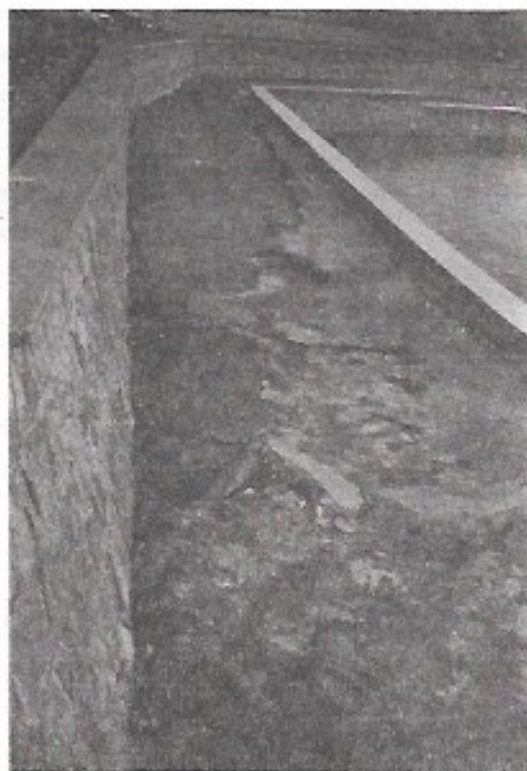
At Ekşisu, 6 km northeast of the epicentre, natural springs are bottled by the local mineral water company for marketing. Ground water levels are close to the surface. Several retaining walls in the vicinity and the car park suffered major damage during the earthquake due to liquefaction of backfill exerting higher lateral pressure on the walls. Tilting and lateral displacements of walls was associated with severe ground cracking.

Movement of retaining structures occurred over a length of 50 m. Retaining walls which are typically of a 1.5 m high gravity boulderwork structure had their lower sections locally tilted outward (Fig.7). Elsewhere lateral translation caused fracturing of the retaining wall with associated tension cracks in the backfill (Fig. 8).

Figure 7. Tilting of retaining wall.

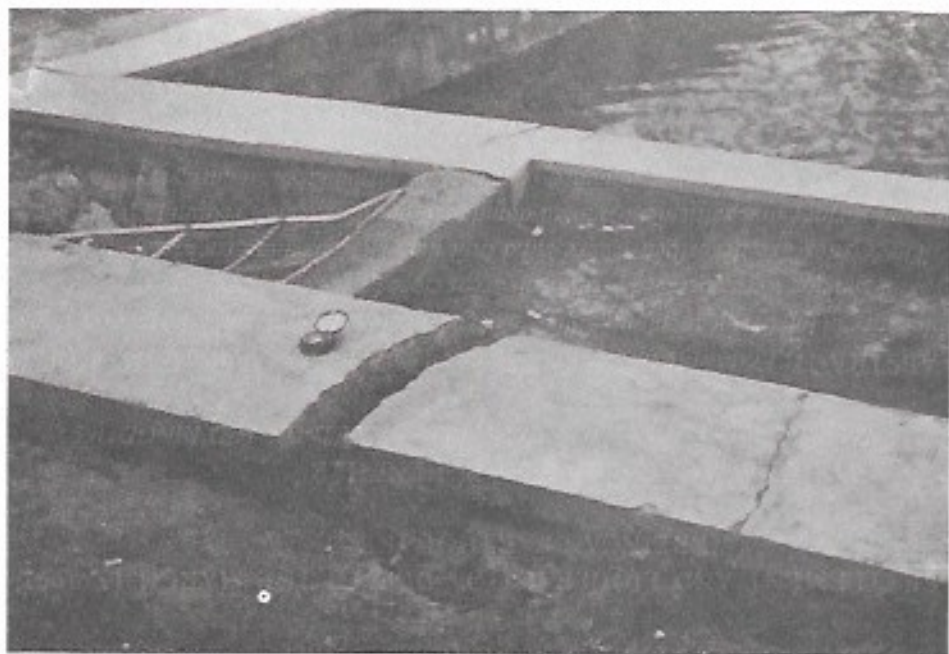
Figure 8. Lateral translation caused fracturing of retaining wall with associated tension crack in backfill.

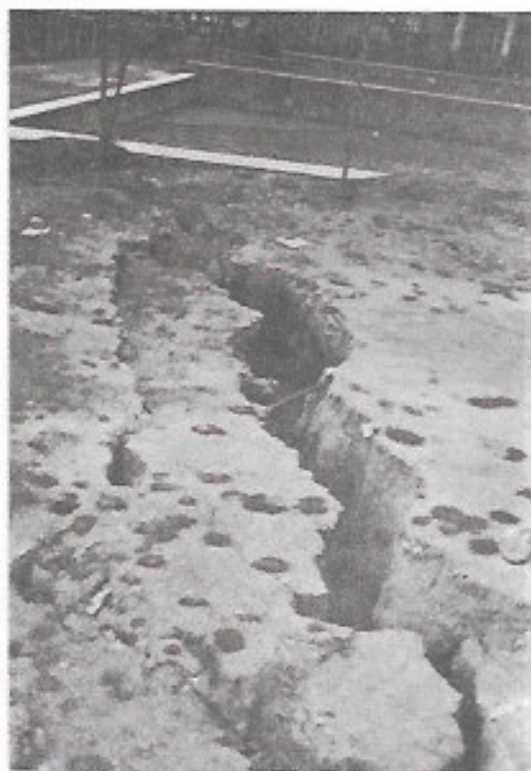
The major cracks across the car park trended N50°W although this direction probably related local failure mechanisms and topography rather than any association with the North Anatolian Fault which runs close by and with a similar strikes (Figs. 9 and 10).

Figure 9. Large cracks extending across car park.

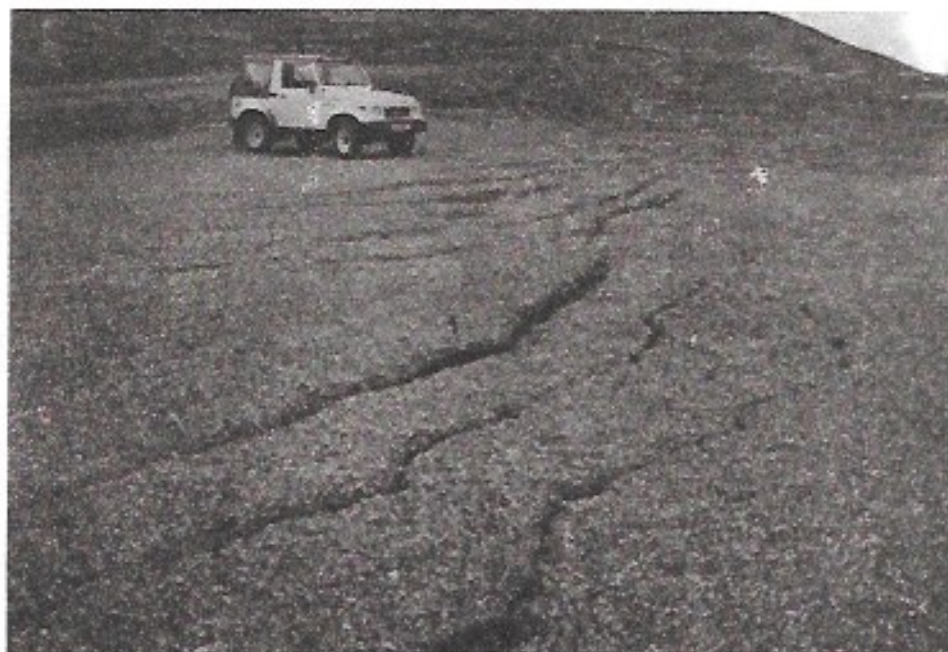
Figure 10. Subsidiary cracks extending across car park on backfill.

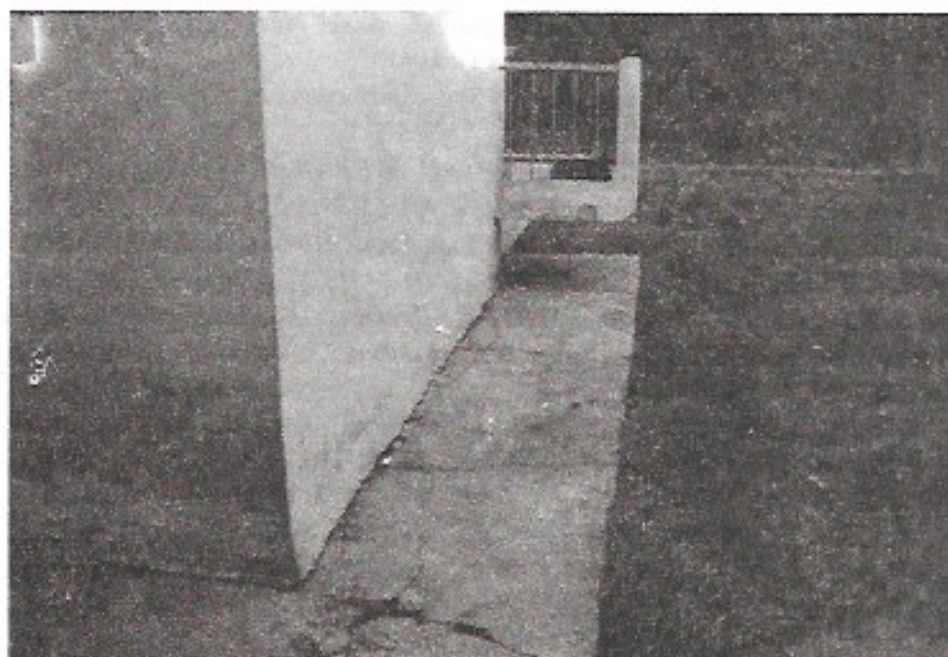
The third site is located 45 km southeast of Erzincan, next to the highway between Erzincan and Erzurum, at Tanyeri Railway Station. At this location, compaction of alluvial material used as backfill to the basement of a three storey building occurred causing concern to residents. The ground settled by approximately 10 cm around the building which otherwise showed no significant damage (Fig. 11). According to the residents the 2 m basement is dry and no signs of water outflow were observed. It can be concluded that the settlement was simply the result of ground shaking causing densification of loose backfill.

Figure 11. Settlement of fill material.
