The Glendoe Tunnel Collapse in Scotland

S. R. Hencher¹

Abstract

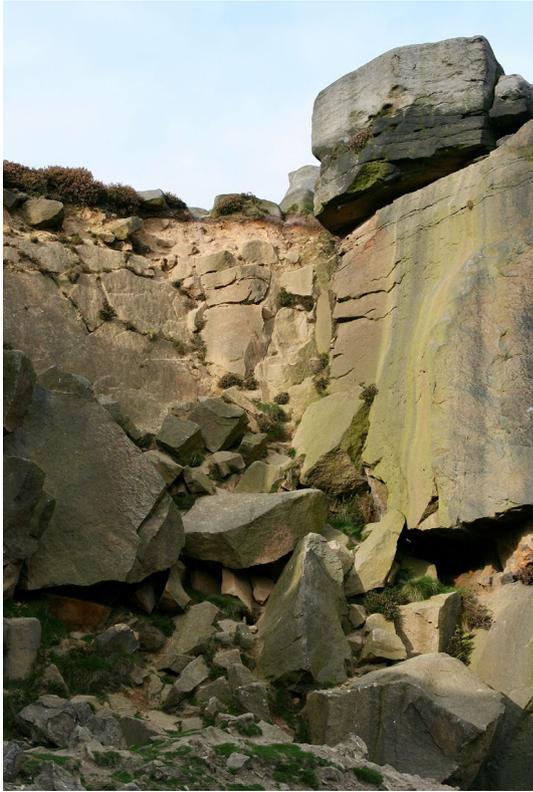
Fig. 3 Unexpected failure in the corner of the Cow and Calf Quarry

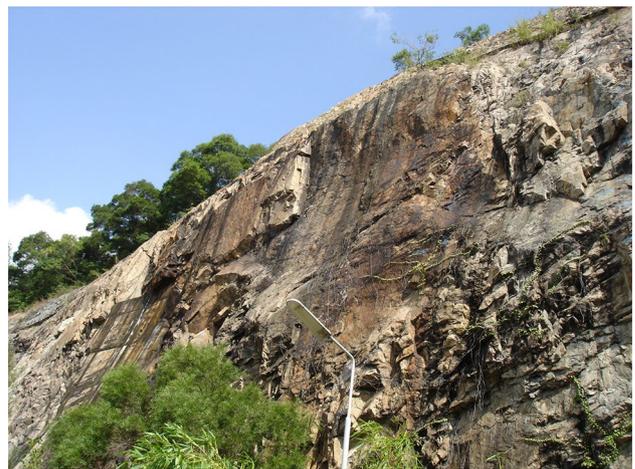
Fig. 5 Undercut blocks sitting on steeply dipping planes

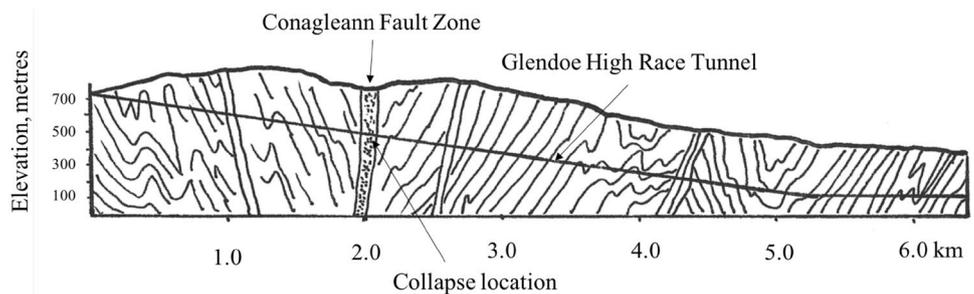
Fig. 6 Section along the headrace tunnel, showing location of Conagleann Fault Zone where the collapse occurred. (traced from Dr. Smith’s presentation to court, slides 5 and 7, Woolman 2016)

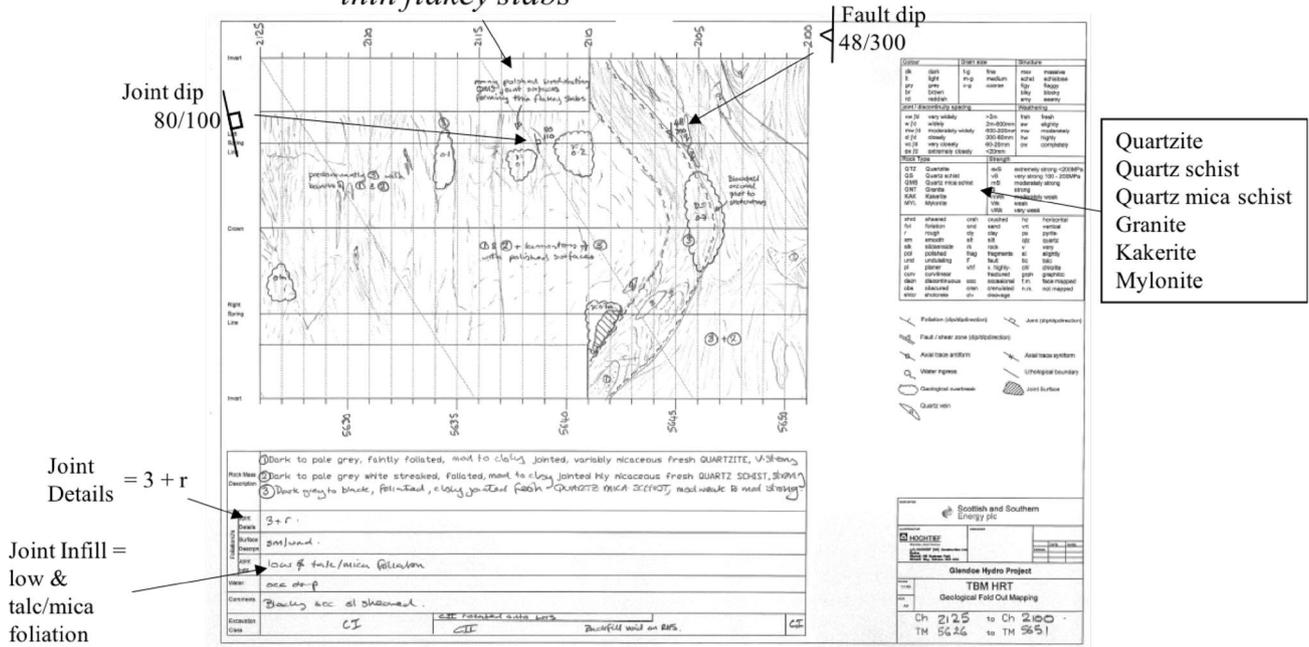
“many polished undulating QMS joint surfaces forming thin flakey slabs”

Fig. 8 Part of section where collapse occurred, from the Geological Fold Out Mapping Sheet for chainages 2025–2100, reproduced in Lord Carloway’s Opinion at page 138. Note that the first two rock names are typed (presumably typical), with just the strengths added in writing (very strong and strong). Rock type 3 is added, in writing, as “closely jointed fresh QUARTZ MICA SCHIST, moderately weak to moderately strong”. Note also the comment at the top of the page

“many polished undulating QMS joint surfaces forming thin flakey slabs”. This is the likely material that collapsed to form the fine pile of debris seen in Fig. 10. The two discontinuity directions 48/300 in the fault zone and 80/110 in the general rock, form an adverse wedge with a third joint dipping, say, at 70/200. Note that “Joint Details” are defined as “3 + r”, meaning three joint sets plus random joints, for the Q-system

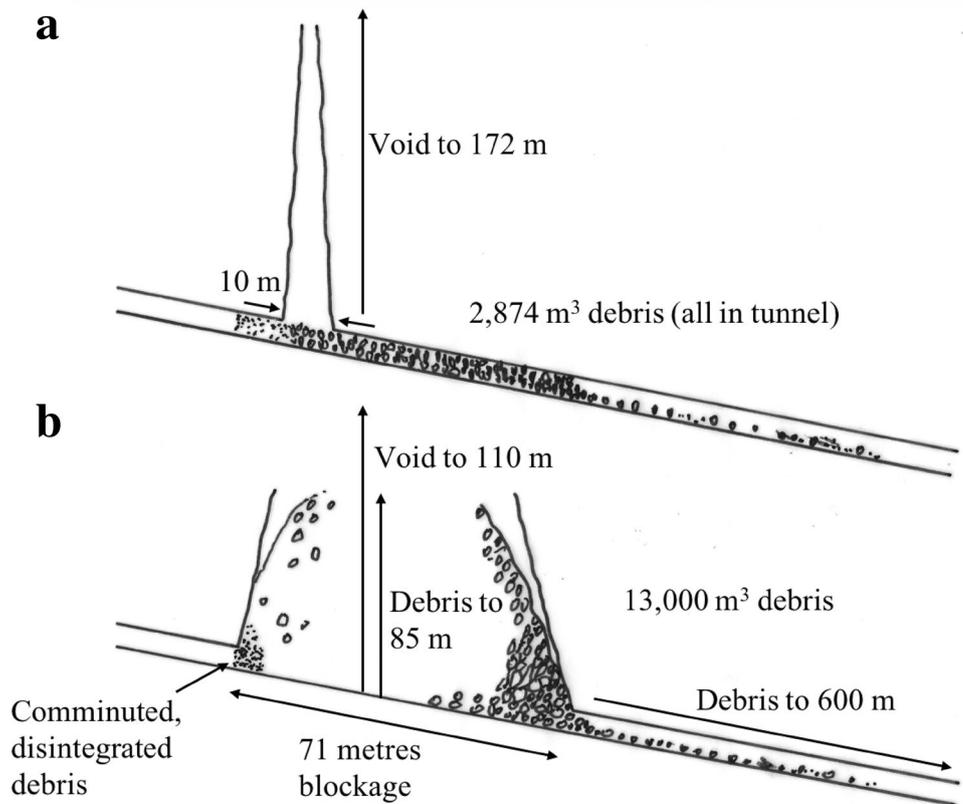
Fig. 9 Interpretations of debris volumes and dimensions at Glendoe tunnel collapse. **a** Shows an interpretation of a rock fall of 2874 m³, blocking off 71 m of tunnel, with the rest of the debris stretching out 600 m towards the turbines. It is assumed that this is for a block fall from the roof, of dimensions 10 m × 5 m. The rock would have fallen from a void extending 172 m above the tunnel invert. **b** Shows an interpretation of an alternative model with collapse throughout the 71 m and debris up to 13,000 m³. For this scenario, there would remain debris to a depth of about 85 m above the tunnel invert and voided ground up to 110 m. For both models, there is comminuted, disintegrated debris blocking the upper part of the headrace tunnel (see Fig. 10 plus Sect. 4)

(for a fault zone rock that is moderately weak to moderately strong, meaning 5–50 MPa) and of 80/100 taken in the area of sheared QMS require just one more discontinuity dipping at, say (precision not required), 70/200 to form an unstable wedge as shown in Fig. 11. It is noted that Taylor classified the jointing as “3 + r”, which translates to three sets plus random joints in the Q classification (Barton et al. 1974). Two ‘sets’ (measurements) are recorded, but where is the third? There are possible traces in Fig. 8 with the correct orientation but the traces die out, presumably as incipient discontinuities. Secondly, there is a photograph of large blocks of rock from the downstream end of the debris, reproduced here as Fig. 12. It is probable that the failure was the result of the falling of large wedges of rock, released by discontinuities, over a period of 6–8 months, leading to the collapse of rock up to 110–172 m above the tunnel as depicted in Fig. 9.

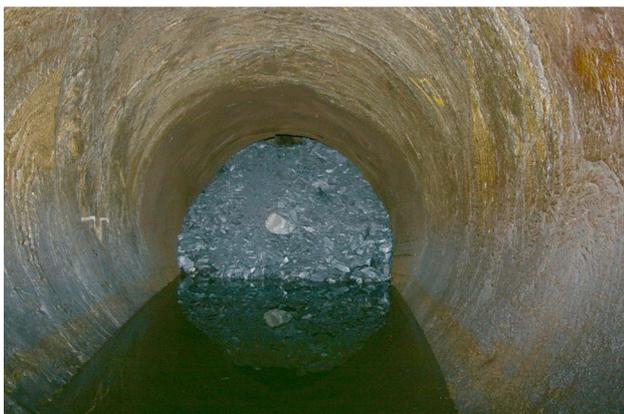
Fig. 10 Collapsed ground (upstream end)—taken from Woolman (2016). Note folded and faulted rock in the walls of the tunnel. This must be close to the fault zone. Note that the rock mass is broken down to very fine material, which is remarkable, given the decision not to line this section, and that no one could see the fault. The interpretation is that the material in situ was disintegrated, probably by tectonic action, rather like the ‘Rashings’ material in the South Wales Coalfield which looks intact but on extraction breaks down to sigmoidal fragments

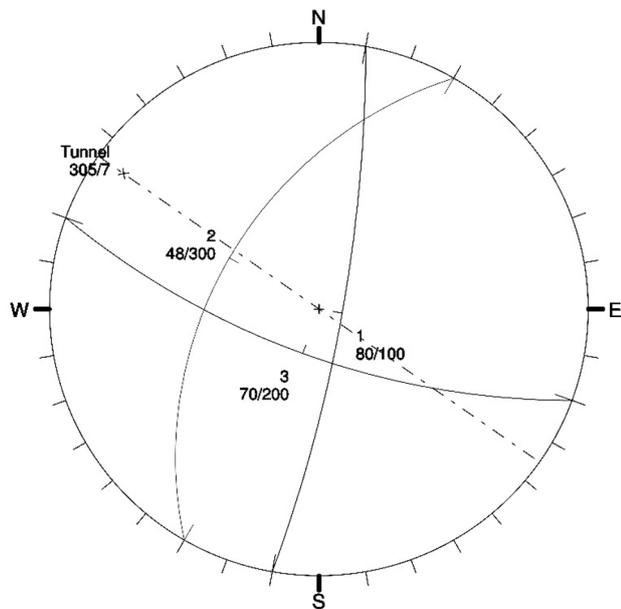
In my opinion, there is far more evidence of the collapse being dominated by large-scale wedge failure and rock collapse on incipient discontinuities than by erosion. In Table 4, I list some of the factors. Firstly, there are the discontinuity measurements in Fig. 8. The two measurements of 48/300¹

Fig. 11 Stereogram of tunnel in 305 direction, plunging at about 7° with two discontinuities 48/300 and 80/100 (as measured in the Geological Mapping Sheet, in Fig. 8) and a hypothetical third joint (70/200). The three discontinuities produce an unstable wedge in the crown of the tunnel. Note that Taylor classified the rock as “3+r” meaning three sets plus random. Stereogram produced by software UNWEDGE by Rocscience, Canada

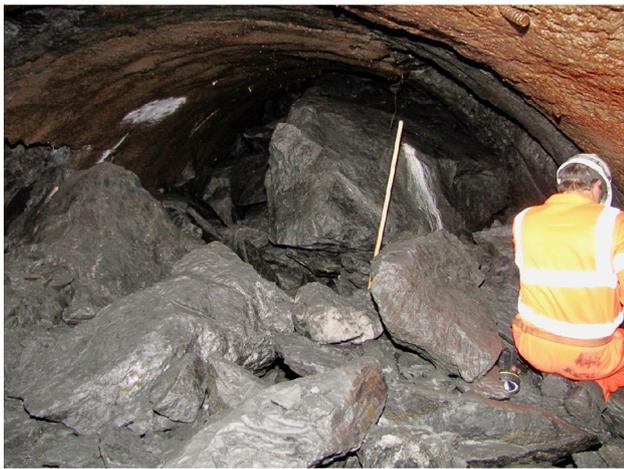
Fig. 12 Collapsed ground (downstream end). Note that the ground is largely made up of large fallen blocks (according to this photo). Photograph from Woolman (2016)

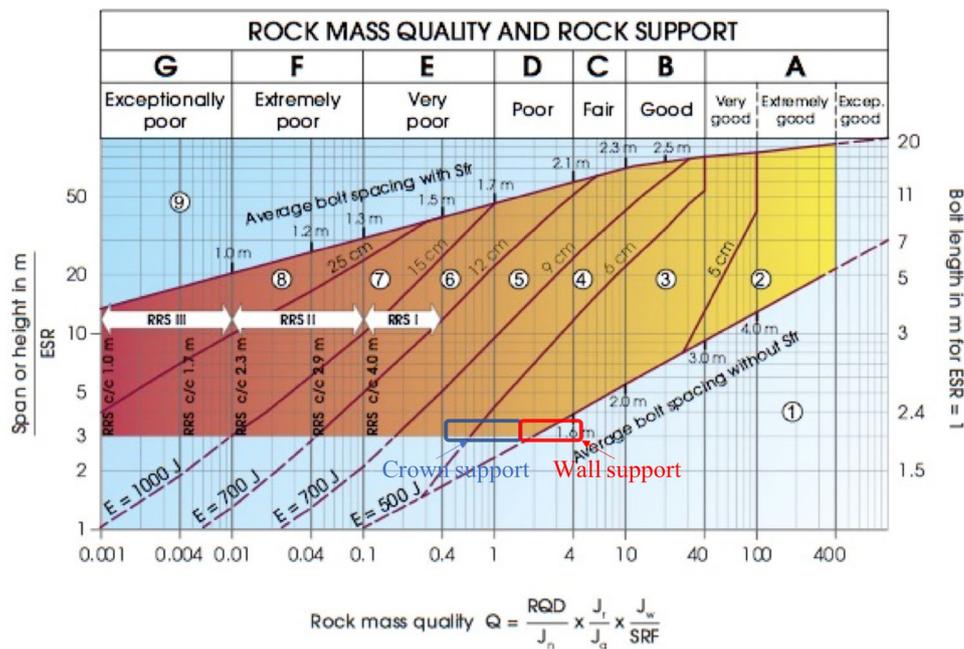
To use these values, it is necessary to examine the support class graph, reproduced here at Fig. 13. There would be some support required in the crown, less so in the walls of the tunnel and certainly no need for a fully lined option of 100% shotcrete (100 mm) and bolts. This

Fig. 13 Q support chart from (Norwegian Geotechnical Institute (NGI) 2015)

complies with what was done (Class 2 plus backfilling of voids with shotcrete).

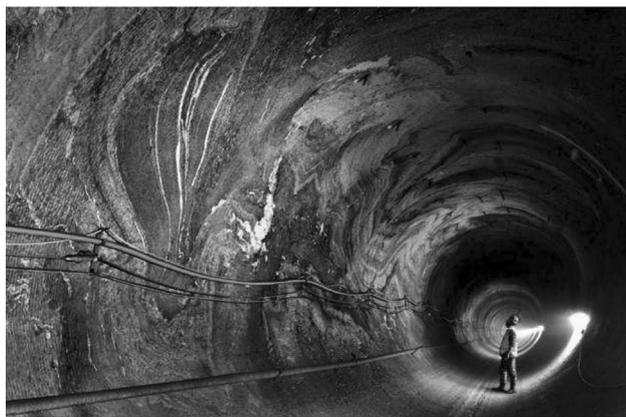
There is one additional, publicly available, photograph showing conditions in the HRT. This is reproduced in Fig. 14 and is apparently a British Geological Survey photograph, taken well away from the CFZ. Note that the rock in the tunnel walls is intensely folded and faulted and that the tunnel is not shotcreted. This is, no doubt, an example of Class 1 rock but the chance of predicting failure in this convoluted rock mass is slight. There are no numerical modelling methods of which I am aware that can deal with such ductile, undulating

Fig. 14 Folded and faulted (ductile) ground in the Glendoe high race tunnel—well away from the Conagleann Fault Zone (BGS photo)

bands and slithers of rock. If the judgement by the tunnel engineers or geologists, utilising the Q-system, was that no support was required, so be it. There does, however, remain an unquantifiable risk that collapse might occur, which could only be dealt with by lining the tunnel.
