DESIGN AND CONSTRUCTION ISSUES FOR EXCAVATION AND TUNNELLING IN SOME TROPICALLY WEATHERED ROCKS AND SOILS

J. Nicholas Shirlaw¹, Stephen R. Hencher² and Jian Zhao³

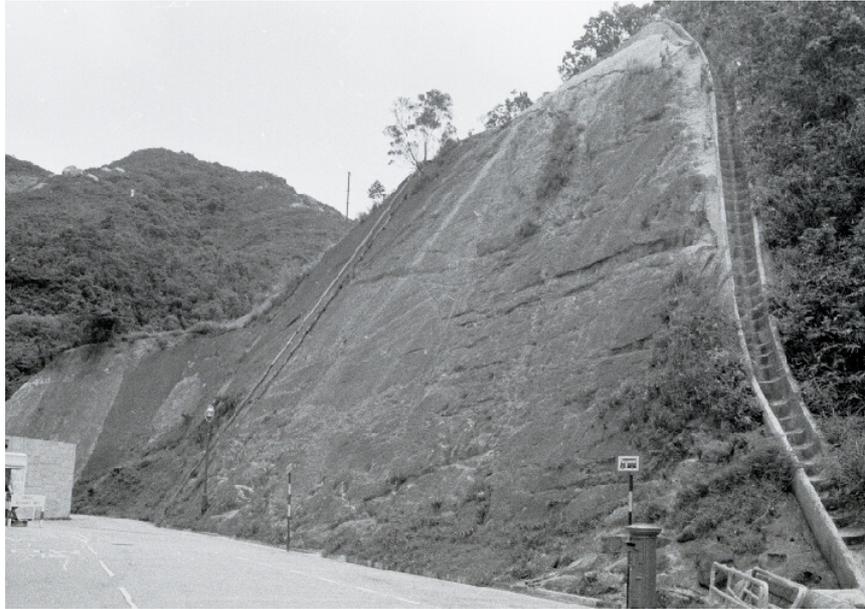
Figure 2 : Cut slope in fairly uniform Grade IV Granite (Zone 6)

In tropical areas, the rock is often altered so severely that it is disintegrated or chemically altered to the state of a soil so that it can be broken and crumbled by hand, sometimes to depths of tens or, rarely, hundreds of metres. The weathered rock mass will retain relic structure from its geological past, which will often control its engineering behaviour. This is a major distinction from a sedimented soil such as a sand or clay. Relict discontinuities, in particular, will define the pattern of weathering throughout the mass, lead to anisotropic strength and control the through-flow of water. Examples of weak, weathered profiles are given in Figures 2 and 3.

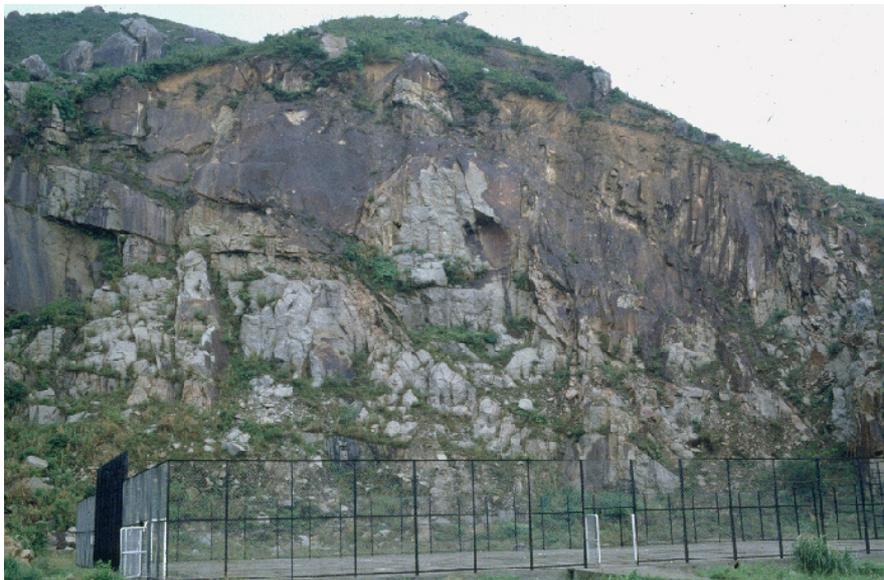
Figure 3 : Irregular weathered profile in granite, Lamma Island, Hong Kong. Note paler Grade II granite in centre, flanked by weaker Grade II to IV

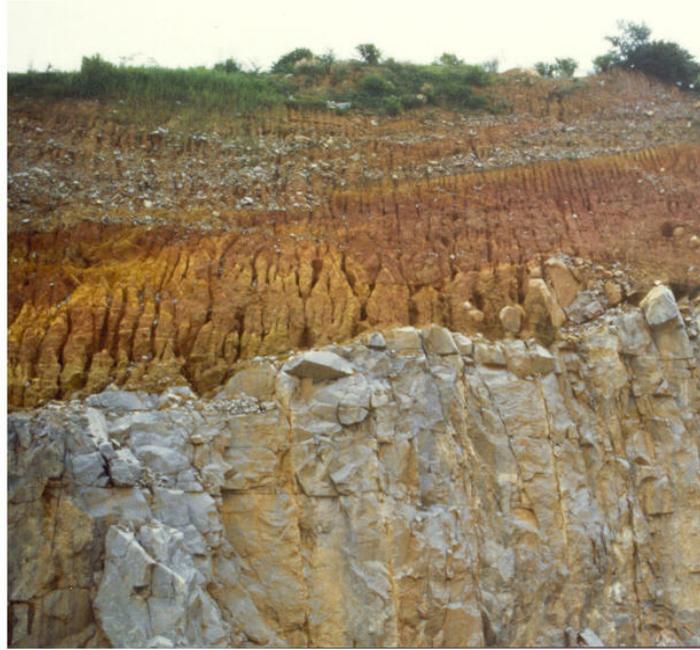
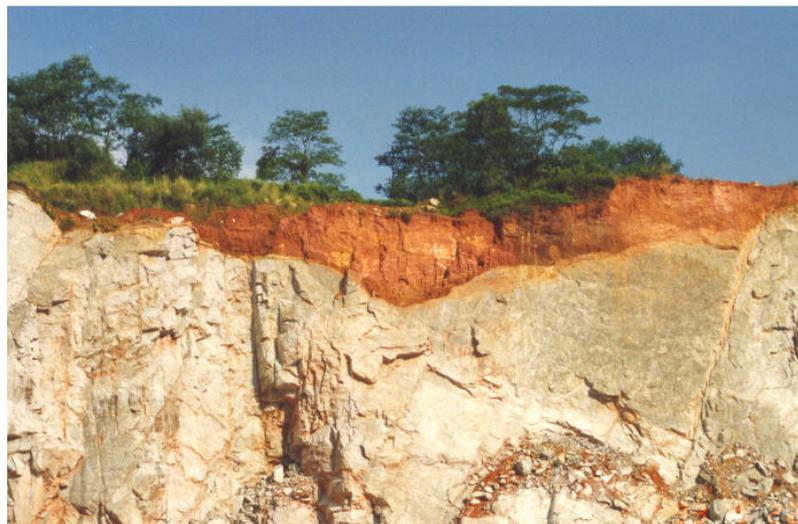
Figure 9 : Weathering profiles in the Bukit Timah Granite observed at a quarry in the Mandai area of Singapore

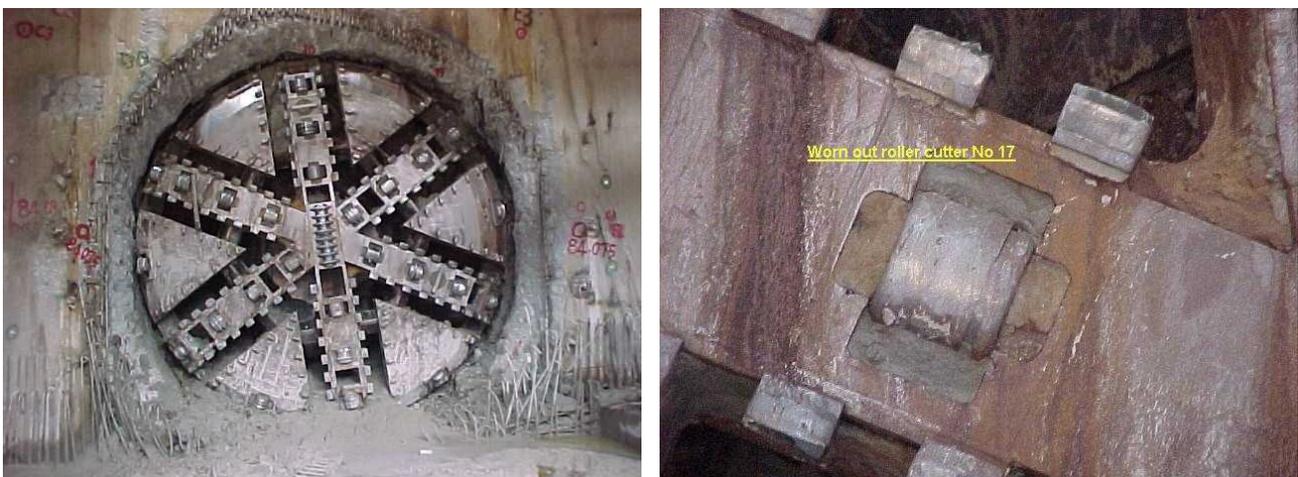
Figure 26 : Abrasion of cutting tools after first drive under the Singapore River

The high abrasion and temperature recorded in the South Bound drive were in large part due to the nature of the ground and the need to maintain a high face pressure because of the weathered sandstone/soft clay interface. However, there was another factor: the contractor's choice of conditioning agent for the spoil in the Plenum Chamber. For the South Bound drive and most of the North Bound, either water or

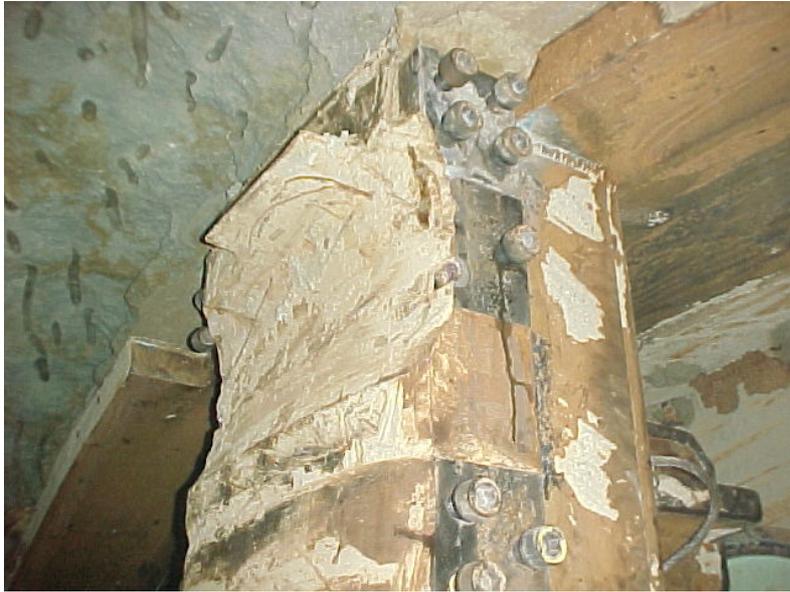
Figure 27 : Abrasion of spoke after passing under Kallang River

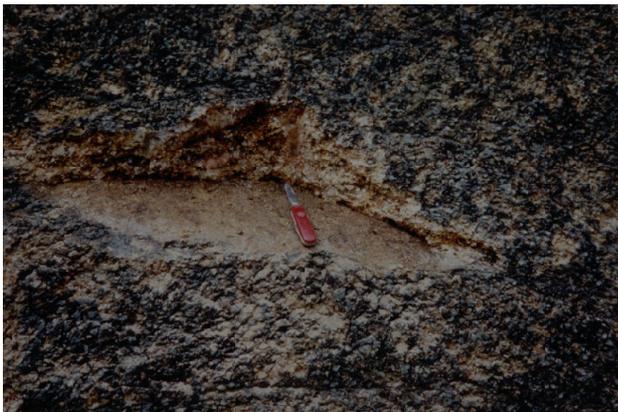
Figure 38 : Relic joint in completely weathered granite (Grade V)

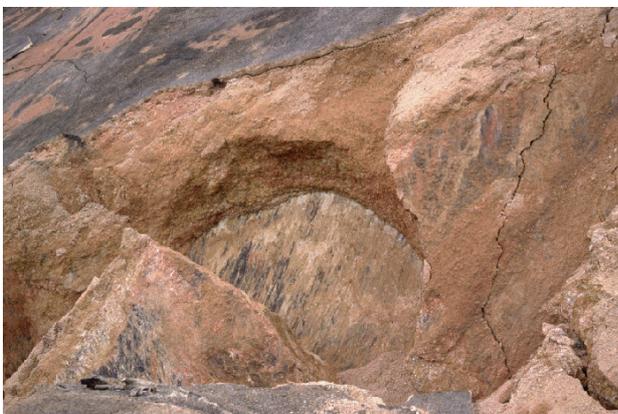
Figure 39 : Relic Release Joints in the Rear of a Landslide through Grade IV Granite

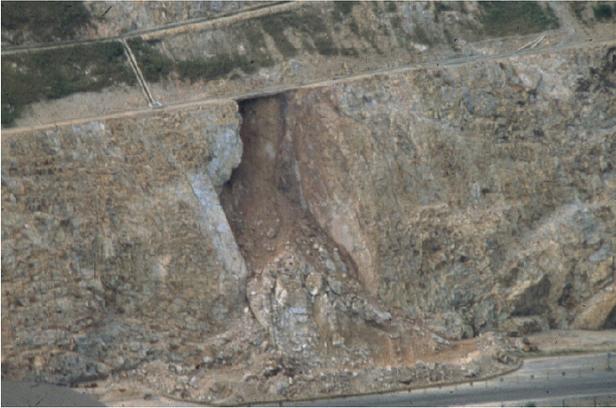
Figure 40 : Aerial view of landslide through fractured, weak granite
