Geomorphological landslide models for hazard assessment: a case study at Cloudy Hill, Hong Kong

Quarterly Journal of Engineering Geology and Hydrogeology 2009, v.42; p473-486.
doi: 10.1144/1470-9236/08-001

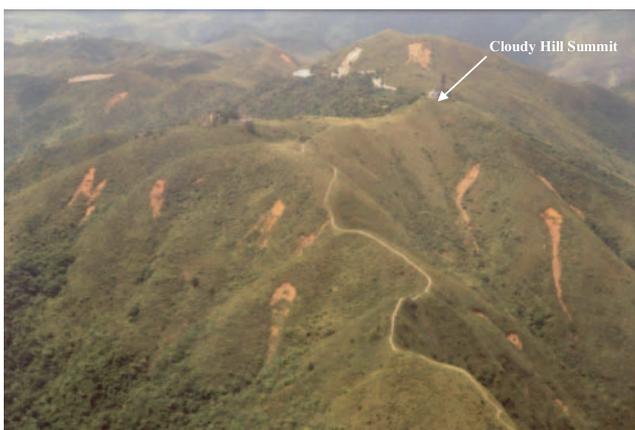
Fig. 2. Oblique aerial view of the 2000 and 2001 landslides on Cloudy Hill (looking north).

As a result of intense rainstorms in April 2000 and June 2001 more than 45 landslides occurred in natural terrain in the vicinity of Cloudy Hill, Tai Po in the NE New Territories, Hong Kong (Figs 1 and 2). As part of a continuing landslide investigation programme of the Government of the Hong Kong Special Administrative Region, a detailed study was undertaken for the Geotechnical Engineering Office (GEO) (Halcrow China Limited 2003). The study included systematic investigation of the characteristics and mechanisms of the failures so as to assess the geomorphological and geological factors influencing susceptibility. Landslide settings and triggering factors were studied for comparison with failures elsewhere in Hong Kong. The study involved detailed aerial photograph interpretation (API) of the 2000 and 2001 landslides as well as historical landslides as shown in Figure 3. The distinction in Figure 3 between pre- and post-1963 landslides is a pragmatic one in that the 1963 set of air photographs was of particularly high quality and resolution, and allows a high level of confidence in the interpretation of landslides as distinct from gradual, erosional features (Styles & Hansen 1989). Engineering geological mapping was carried out for the majority of landslides.

Tai Po (Fig. 1). The study area is about 4 km² with the elevation ranging from about 40 m above Hong Kong Principal Datum (PD) to 440 mPD (PD is about 1.23 m below mean sea level). Much of the higher side slopes (above 200 mPD) is grass covered. The lower slopes are generally covered by a mixture of low shrub and woodland, becoming dense woodland along drainage lines (Fig. 2).

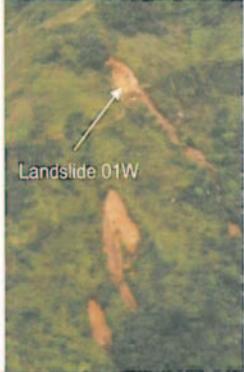
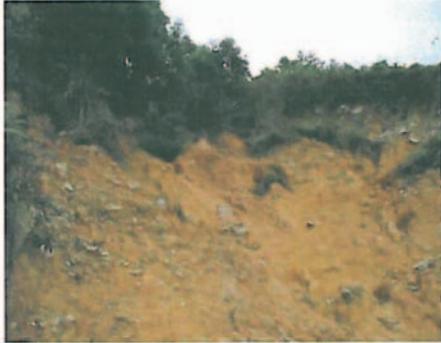
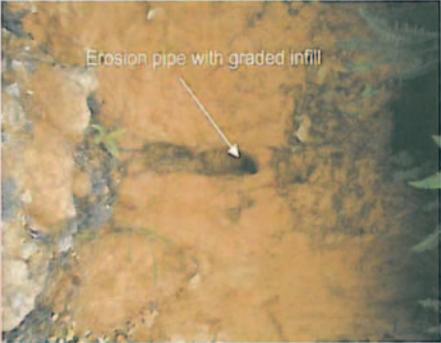
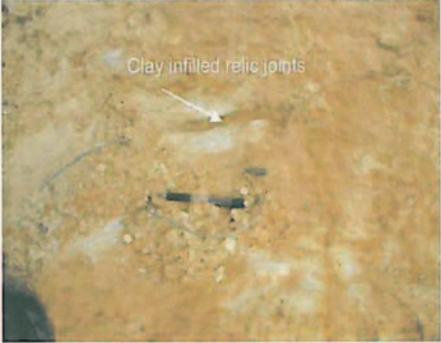
Photo. No.CH01WXCC Date 22/08/01 (Looking SE)		Photo. No.P8220077 Date 22/08/01 (Looking E)

Photo. No.P8220076 Date 22/08/01 (Looking E)		Photo. No.P8220078 Date 22/08/01 (Looking E)

Fig. 7. Example reconnaissance fieldsheet.

using a Garmin handheld global positioning system (GPS). Preliminary measurements and general observations were made and recorded using standard field sheets as presented in Figure 7. A summary of the key data is presented in Table 1, with the location of the inspected landslides shown in Figure 8. Following an initial review, eight landslides were selected for more detailed study. Selection for detailed study included criteria such as failure volume (over 100 m^3), evidence of reactivation, possible structural control, presence of tension cracks and other evidence of pre-detachment deformation such as deformation of quartz veins during weathering or sediment infilling to joints.

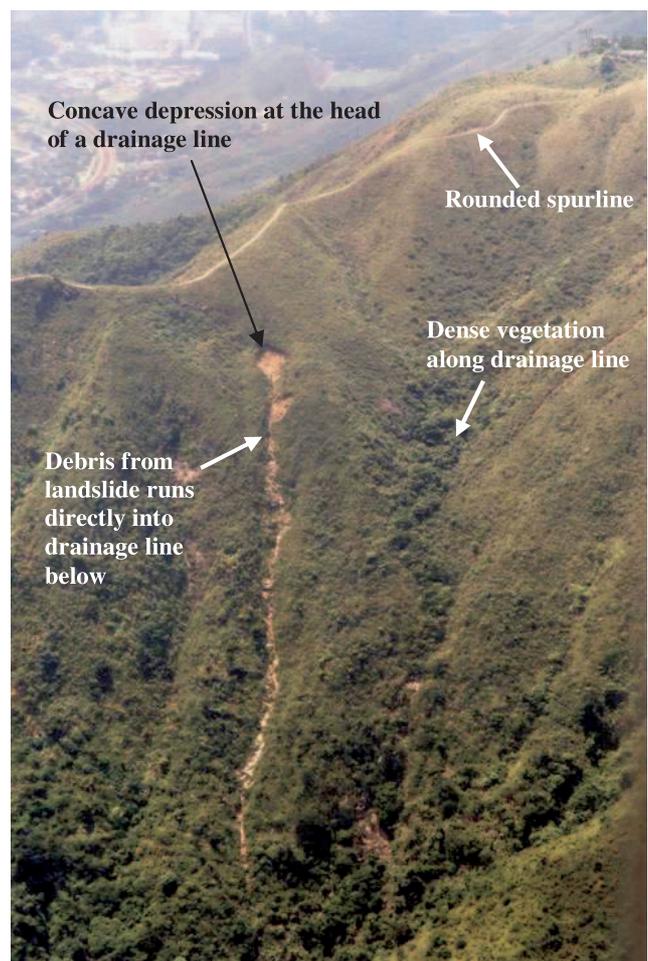
Fig. 12. Setting of a Type II landslide.

Type II landslides are illustrated in Figures 11 and 12. They occur in concave depressions that are typically situated directly at the head of a drainage line (Fig. 12). Type II landslides occur following long-term accumulation of colluvial debris in a depression and may be
