Application of Back Analysis to Hong Kong Landslides

S.R. Hencher, J.B. Massey, E.W. Brand
Geotechnical Control Office
Hong Kong

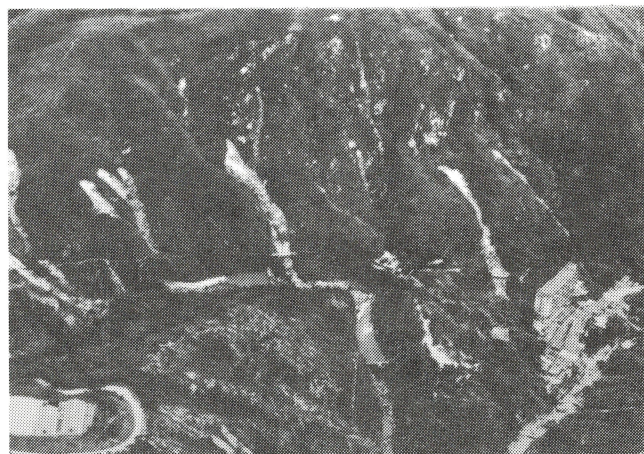
Fig. 1 Clustered Landslides on Natural Hillside

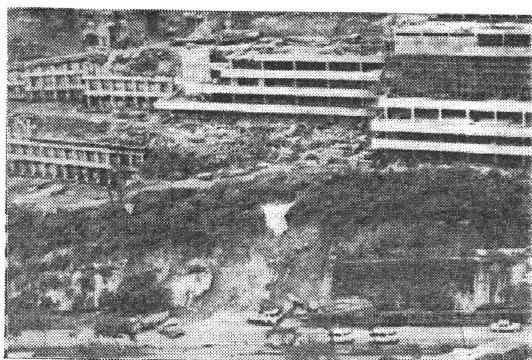
The landslide shown in Figures 2 & 3 occurred during intense rainfall in the early morning of 29th May 1982. A 15 m high portion of the 50° slope collapsed suddenly, resulting in approximately 1 000 m³ of debris. The case was selected for study largely because the unfailed slope had been previously investigated and

Fig. 2 General View of Chai Wan Landslide

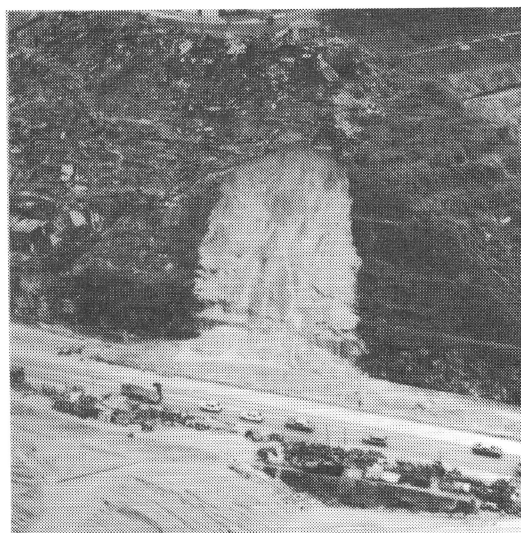
Fig. 5 Junk Bay Landslide

The major failure at Junk Bay occurred in a 20 m high portion of a slope cut at approximately 50° and resulted in about 1 300 m³ of debris. As in the Chai Wan case, the slope had previously been investigated and instrumented, which made it a potentially rewarding case for study. A fire had occurred at the crest in November 1981, leaving ideal conditions for rapid infiltration and ponding of water. A view of the failure is shown in Figure 5, and a cross-section is given in Figure 6 which shows the major features.

The geometry was easily defined in the same way as for the Chai Wan study, and close inspection of the failure surface quickly revealed a likely mechanism of failure. Joints infilled with thick kaolin daylighted about half-way down the face and covered much of the lower failure surface. Furthermore, distinct seepage flows were observed from above the kaolin. The upper part of the failure passed through decomposed granite of grade VI (residual soil) to grade IV (highly

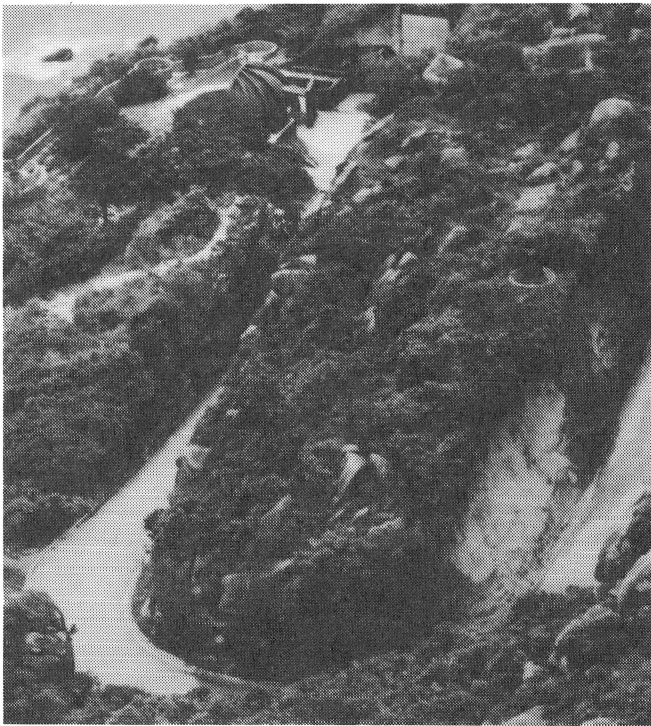
The minor landslide shown in Figure 7 was chosen for the study on account of its apparent simplicity. The geometry was uncomplicated, and the

Fig. 7 Aerial View of Chung Hom Kok Landslide

failure plane passed through seemingly homogeneous decomposed granite. Field observations and the geomorphology of the slope indicated that it might be reasonable to disregard groundwater pressure, and the failure therefore seemed eminently suitable for back analysis to provide shear strength parameters for the decomposed granite of the region.

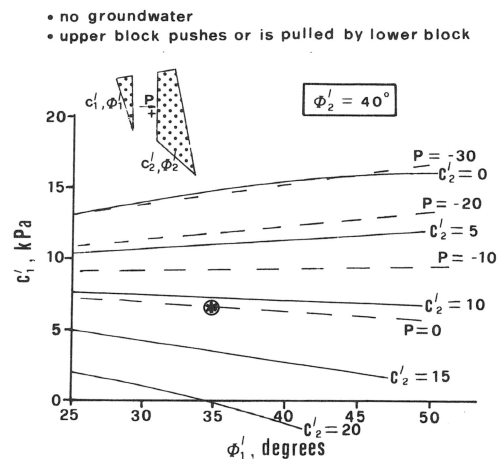
Fig. 9 Limit Equilibrium Solutions for Two-Block Model, with $\phi_2' = 40$ degrees

The results obtained for an assumed friction angle (ϕ_1') of 40 degrees for the lower layer are given in Figure 9. It can be seen that there are many possible sets of strength parameters for the decomposed granite. For example, for a zero interslice force ($P = 0$), the cohesion of the lower layer would be about 11 kPa, and possible parameters for the upper layer might be $c_1' = 7$ kPa and $\phi_1' = 35$ degrees.
