The Glendoe Tunnel Collapse in Scotland

S. R. Hencher¹

Abstract

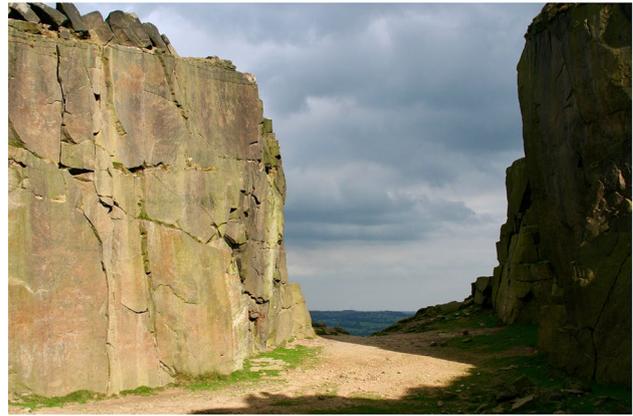
Fig. 2 The Cow and Calf Quarry, Ilkley, West Yorkshire, UK

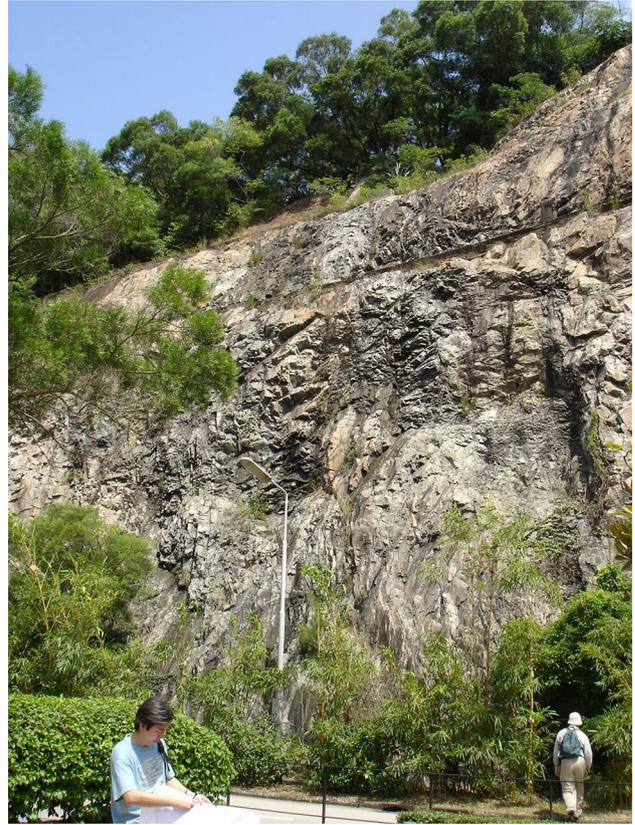
Fig. 4 The Chinese University rock cut slopes, Hong Kong

considered by one of the Client's advisors that the measures proposed by Halcrow were excessive. A visit was made to the site by a Halcrow director with other geotechnical engineers to examine the rock in detail. It was observed that there were slabs of steeply dipping rock, many of which were undercut and some showing some degree of opening. That condition, combined with the knowledge of a history of rock falls at the site, led to the conclusion that the proposed measures by the engineers were essentially correct and appropriate (Figs. 4, 5). The Client disagreed on the basis of advice from a separate consultant, and proceeded to terminate the Halcrow contract, opting for some reduced measures; it is unknown what works were actually carried out to the slopes. This simply illustrates that geotechnical opinions may differ about situations, and that the Client can adopt a riskier path, if he so chooses, and is so advised.
