WEATHERING AND EROSION PROCESSES IN ROCKS – IMPLICATIONS FOR GEOTECHNICAL ENGINEERING

Steve Hencher
Halcrow China Ltd

***Abstract:** This paper provides an introduction into active processes of weathering and how these affect the engineering properties of rocks. Five particular aspects are dealt with in some detail. The first concerns the shear strength of intact materials with particular consideration of the transition from rock-like to soil-like behaviour. The second topic is permeability of weathered rock profiles and in particular the often channelised flow of groundwater. Topic three concerns material disintegration and the growth of joints in the weathered rock mass; a classification of joints based on their “life-cycle” from oriented micro fractures to fully developed planes of weakness is introduced. The fourth topic concerns weathering along joints and the consequences for shear strength of such discontinuities. Finally deterioration of the overall rock mass is considered in a geomorphologic development sense, where such deterioration occurs and how such deterioration may be taken as indicative that failure is developing.*

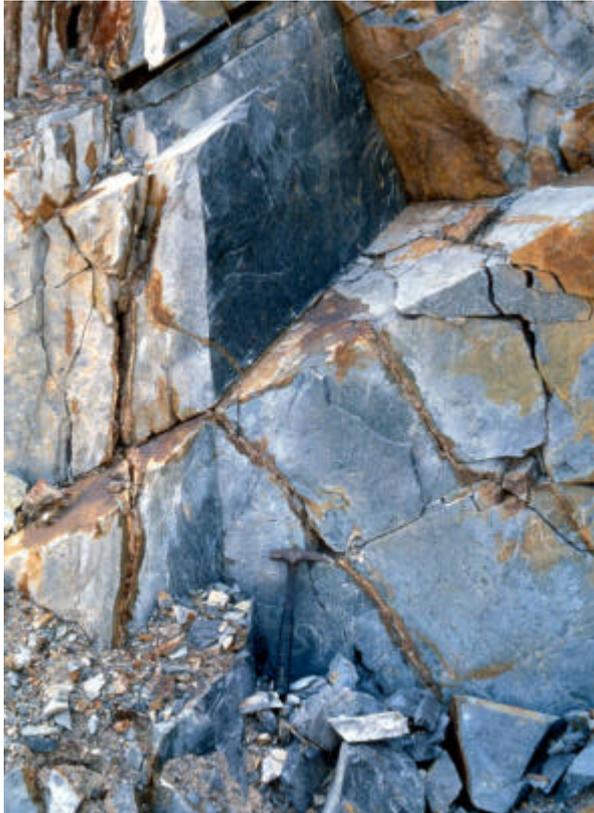
Figure 1 Iron and manganese oxide staining on joints

Figure 1 shows discoloration due to mineral decomposition and deposition associated with localised flow along rock joints. It should be recognized when trying to understand weathering development or to generalise about hydraulic conductivity that water paths through the rock mass and even along a single joint are usually tortuous (Kikuchi and Mito, 1993). This makes interpretation of water conductivity tests open to various interpretations (Black, 1990). Channel flow governs the movement of groundwater in fractured rock and fracture networks develop with time, as discussed later in this paper.

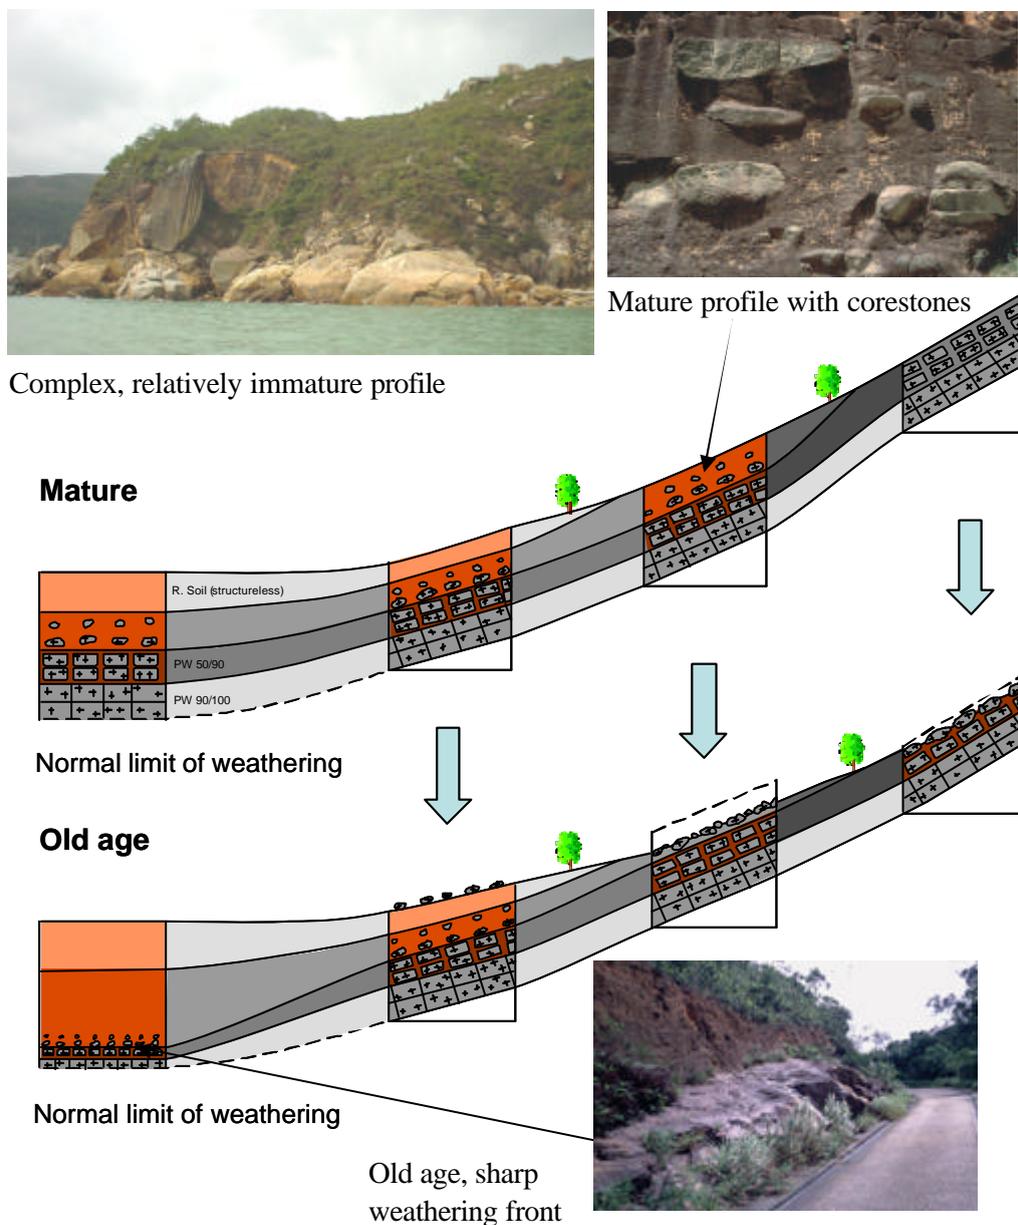
Figure 2 Examples of weathered terrain profiles (compiled from schematic diagrams presented by Ruxton and Berry, 1957)

The examples of weathering profile presented by Ruxton and Berry (1957) and illustrated in Figure 2 are not exclusive. Other examples of profiles that might be encountered are illustrated in Figure 3.

Generally it is to be expected that the quality of the weathered rock mass will improve with depth although there may be exceptions with more weathered zones occurring beneath less weathered rock, as discussed earlier and illustrated in Figures 2 and 3.

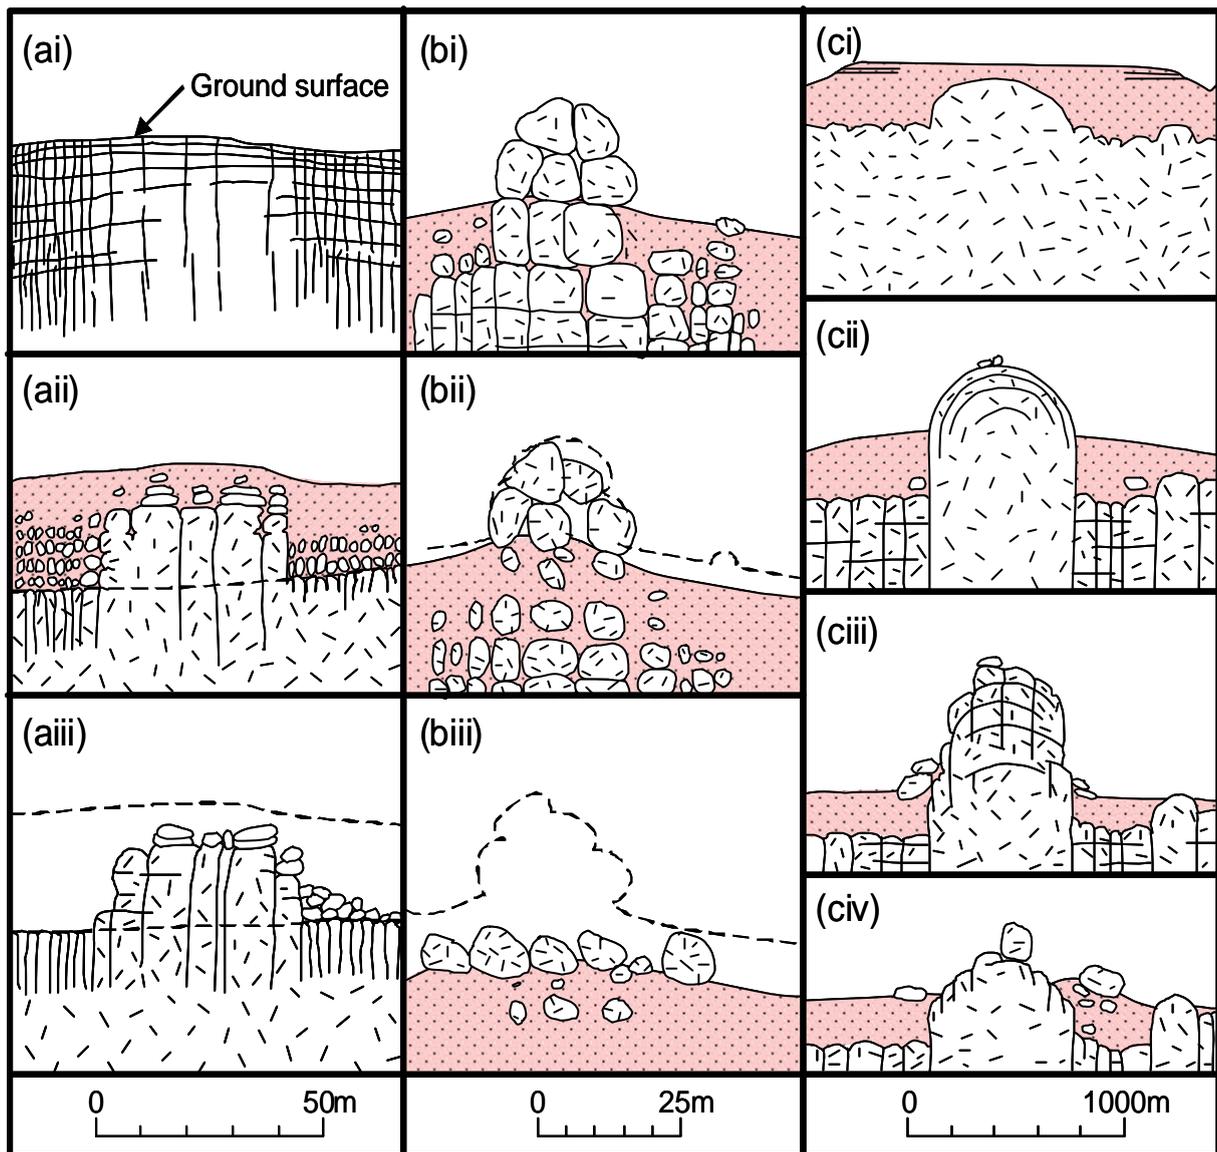
Figure 3 Other examples of weathering profiles. Redrawn from Selby (1993)
 ((a) after Linton, 1955; (b) & (c) after Thomas, 1965)

In practice it can be extremely difficult to interpret the nature of the underlying profile simply from observations at the ground surface, either from air photograph interpretation or surface mapping. A large rock, partially exposed in a hillside, might be the upper surface of a tor as in (civ) in Figure 3; alternatively it could be part of an *in situ* boulder left behind as the weathering front proceeded at a more rapid rate beneath it as per (biii) above and as shown in the Ruxton and Berry example for shallowly dipping slopes at old age in Figure 2. Another possibility is that the rock is a displaced and partially buried boulder that has migrated from further uphill.

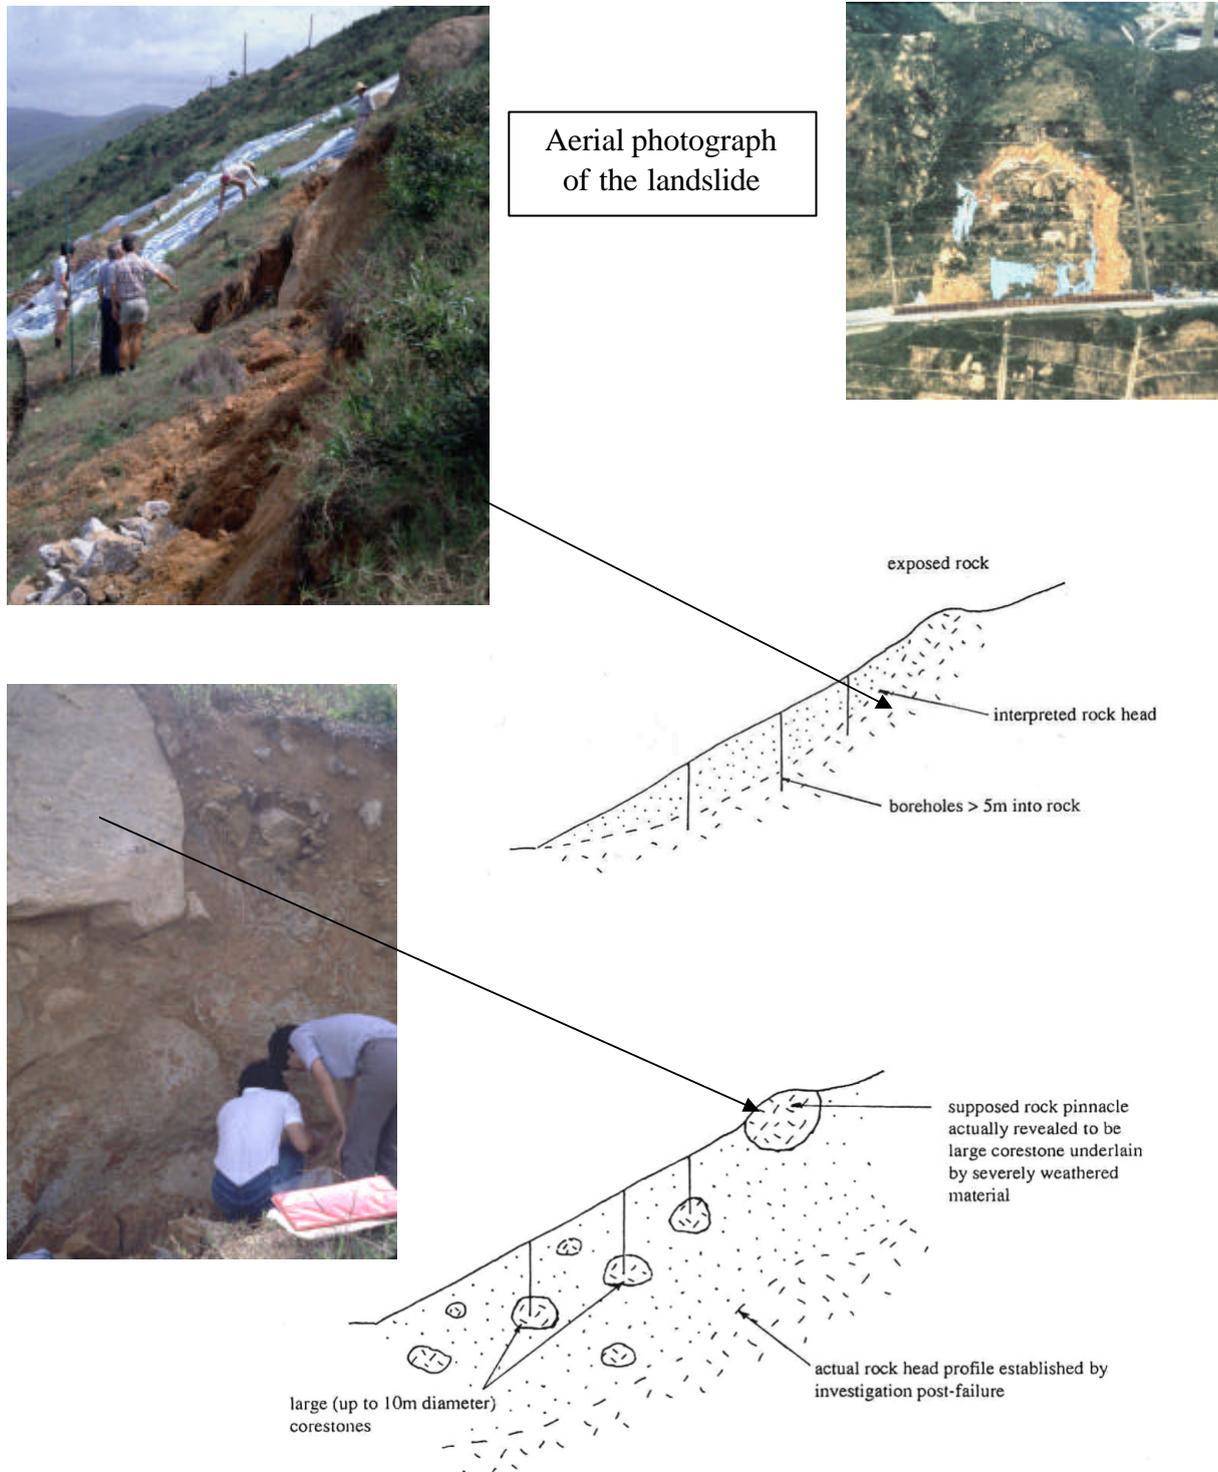
Figure 4 Expected and actual weathering profile – Tsing Yi landslide, 1982 (sections from Hencher and McNicholl, 1995)

adopted for design with possibly dire engineering consequences, as illustrated by Hencher and McNicholl (1995) with respect to a landslide in a cut slope on Tsing Yi Island (Choot, 1983a). Boreholes put down for the design of the slope had been stopped having proved 5m of rock (upper part of Figure 4). Additional boreholes put down after the failure indicated that the original boreholes had terminated in large corestones and not below rockhead as had been assumed for the design. The eventual slip surface passed beneath the corestones through what had wrongly been assumed to be rock.

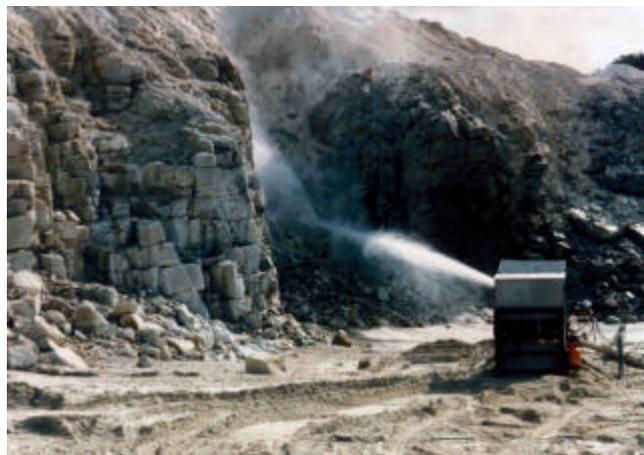
Figure 5 China clay pit, Cornwall, UK

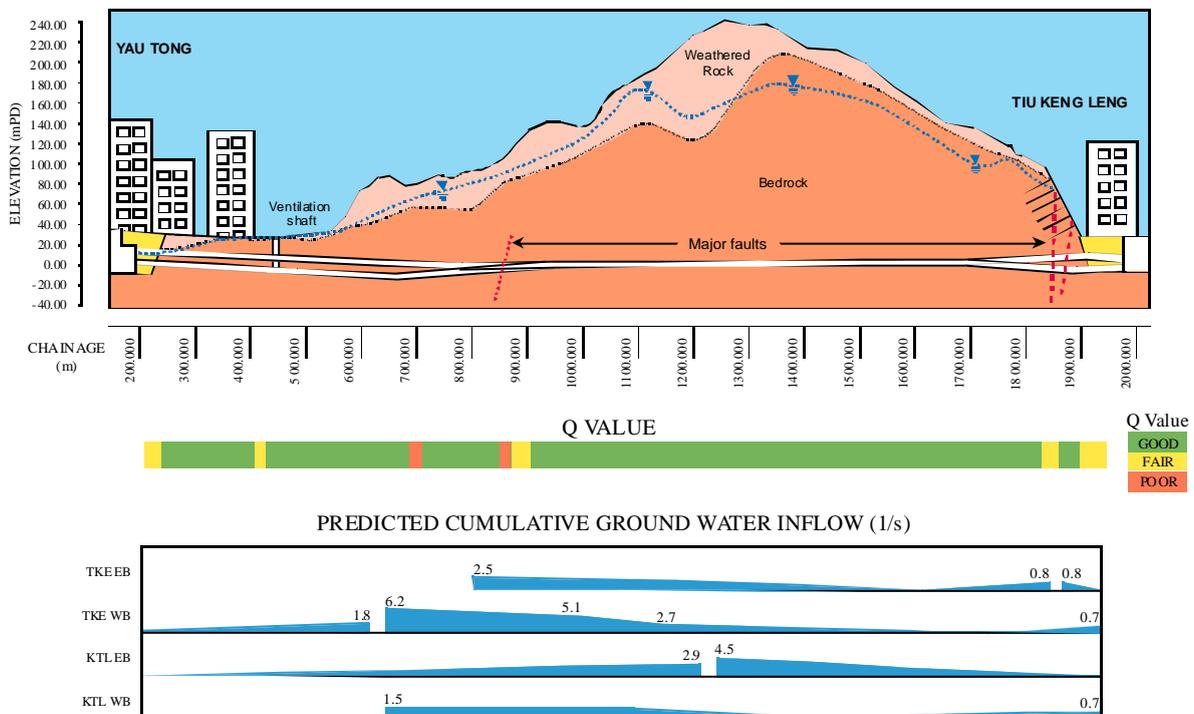
Figure 6 Black Hills tunnels, anticipated conditions

In Hong Kong hydrothermally altered rocks are occasionally encountered, often associated with concentrations of kaolin and other minerals such as epidote and tourmaline. Such occurrences are even less predictable than the nature of weathered rock profiles. Figure 6 shows the anticipated ground conditions for the Black Hills tunnels (Mass Transit Railway, Tseun Kwan O extension). During tunnelling the majority of rock proved to be generally as anticipated; typical rock conditions are shown in Figure 7.

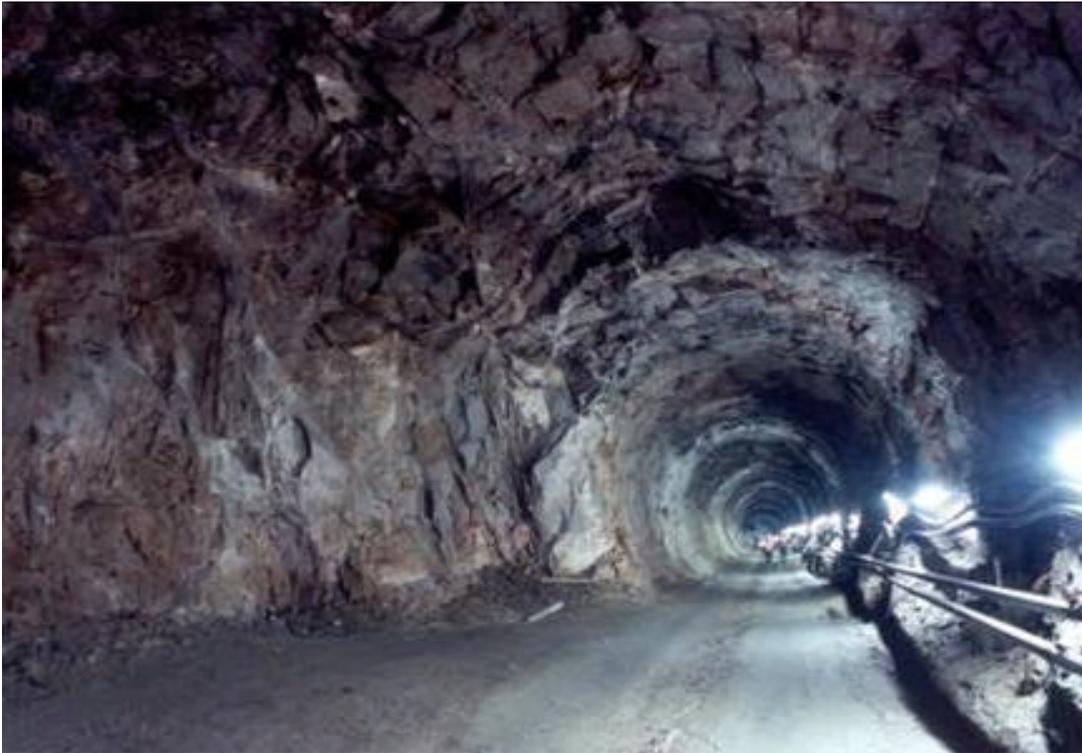
Figure 7 “Normal” rock conditions encountered in the Black Hills tunnels

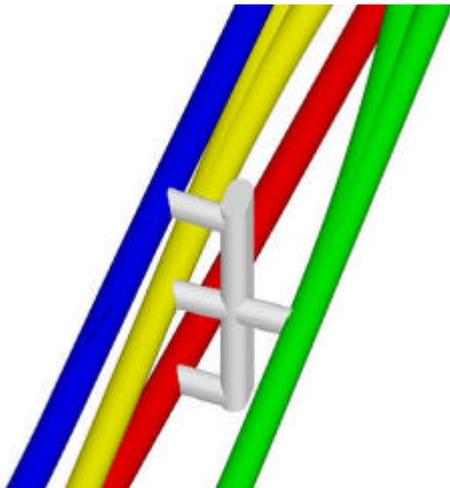
Figure 8 Crossover tunnels in the Black Hills project

In the event, with tunnel cover of perhaps 200m, hydrothermally altered granite was encountered unexpectedly in the main drive and could be traced as a zone across several of the roughly parallel tunnels (Figure 8). It caused a collapse and some delay. Figure 9 shows one of the tunnels with hydrothermally altered material exposed in the invert. The hydrothermal origin of the weak zone was indicated by its location at depth, with stronger rock overlying, and by its association with relatively rare assemblages of minerals.

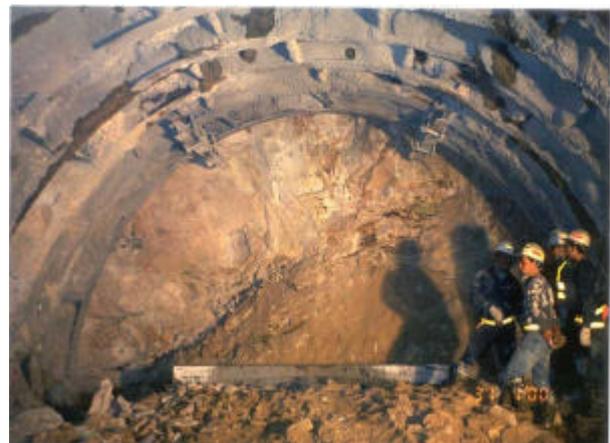
Figure 9 Hydrothermally altered rock in the tunnel invert, Black Hills tunnel

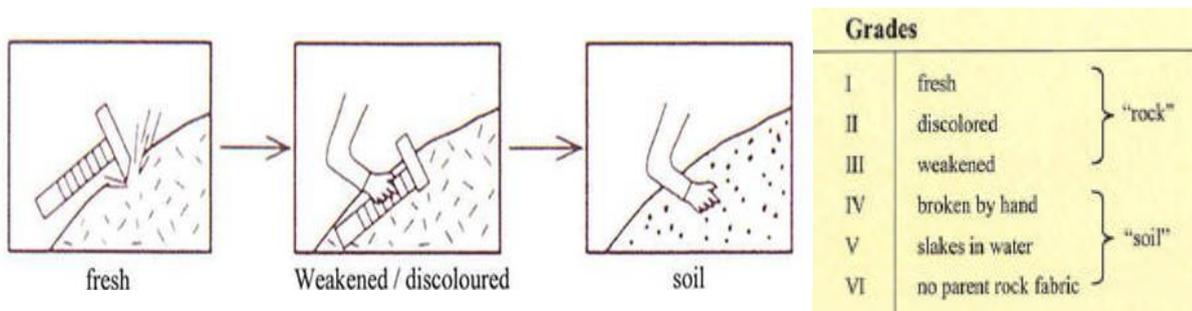
Figure 10 Grade classification for weathered intact rocks

One thing needs to be made clear; weathering grades are not absolute but are a matter of definition. Grades are only useful for description if engineers and geologists use them as defined and do not reinvent them because of personal "experience" and preference. The six stages, which are based on the original work of Moyer (1955), are illustrated in Figure 10. Simple index tests are recommended for separating the different grades to encourage consistent recognition and description. This is a very important objective because otherwise people get the wrong impression of what the rock is really like and incorrect information is communicated. The use of index tests is discussed in detail by Martin (1986). Figure 11 shows examples of grades of weathered rock in Hong Kong.

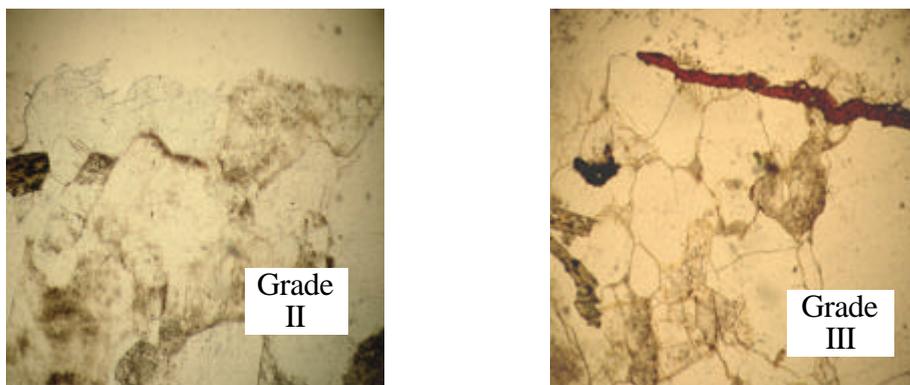
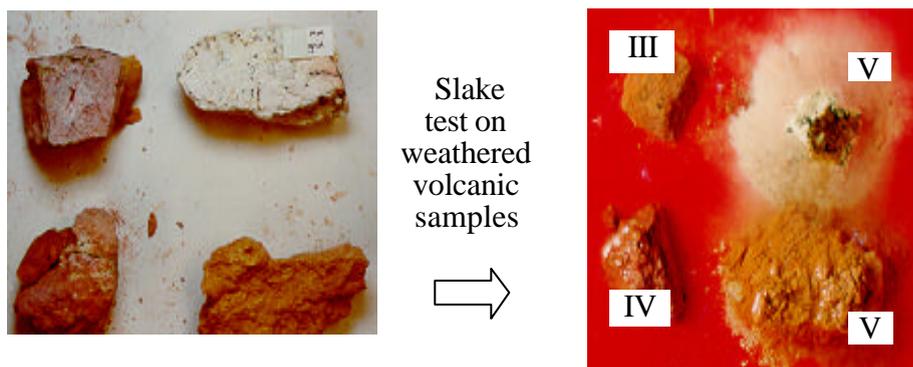
Thin sections through grades II and III granite; normal light; grains about 2mm

Figure 11 Examples of weathered grades

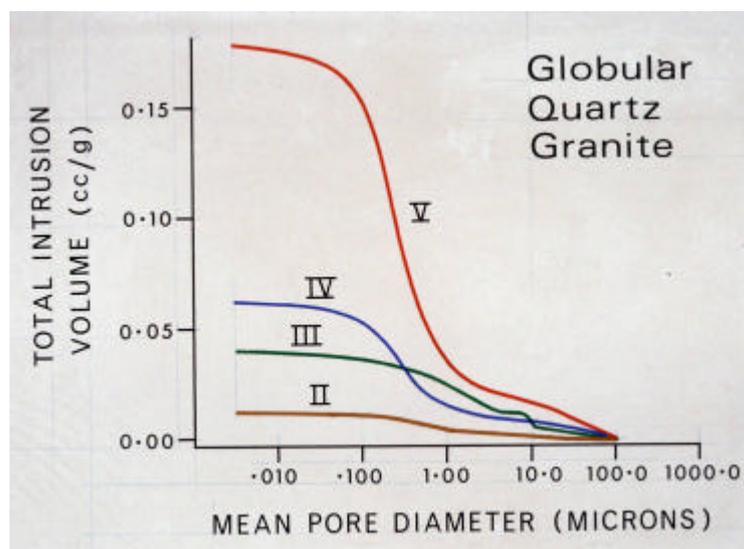
Figure 12 Growth of voids in granite (after Ebuk, 1991)

In other words approximately 50% of the mass was internally eroded from the surrounding saprolite and transported into the tomb over a period of about 2000 years. This massive migration would obviously leave the remaining *in situ* material highly porous with a precarious structure with the potential to collapse. Figure 12 shows changes in granite porosity accompanying weathering measured by Ebuk (1991). Note the marked increase in porosity (intrusion volume of mercury) from Grade IV to Grade V. Such a reduction in mass and growth of voids is associated with loss of strength and increased compressibility.

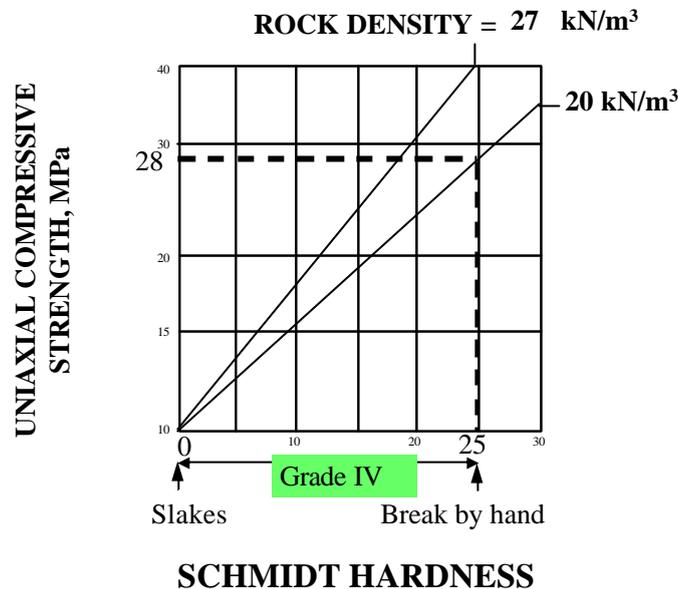
Figure 13 Compressive strength vs Schmidt hammer rebound number (Brown, 1981)

Figure 13 is part of a rock strength chart for the Schmidt rebound hammer given in the ISRM Recommended Method (Brown, 1981). The range for grade IV material, 0 to 25, is given on the horizontal axis.

According to the ISRM chart, a rock with a rebound value of 25 and a density of 27 kN/m^3 would have a uniaxial compressive strength (s_c) of about 40 MPa. Rock at the grade IV / grade III boundary would however, be less dense so, if we assume a density of 20 kN/m^3 , s_c of 28 MPa is derived for the top of grade IV from the ISRM chart. Figure 14 shows the Mohr circle for $s_c = 28 \text{ MPa}$ with a tangential strength envelope assuming $\phi = 38^\circ$ which is about right. For this case cohesion of 7 MPa would be anticipated which is much higher than normally measured for strong grade IV material, as discussed later.

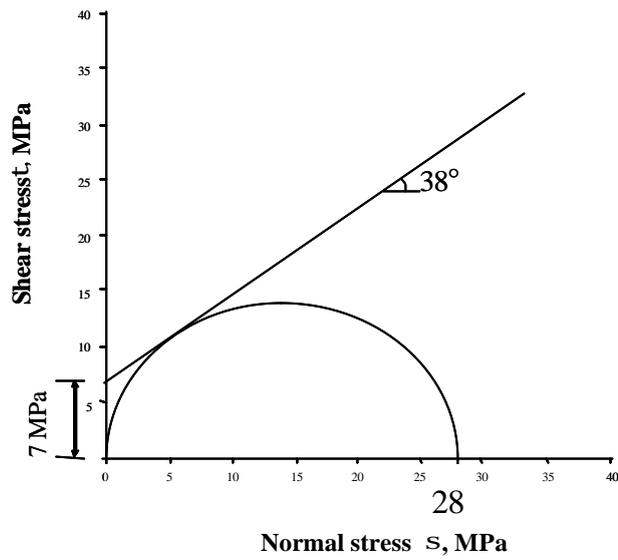
Figure 14 Anticipated shear strength at grade IV – III boundary on basis of Schmidt rebound value

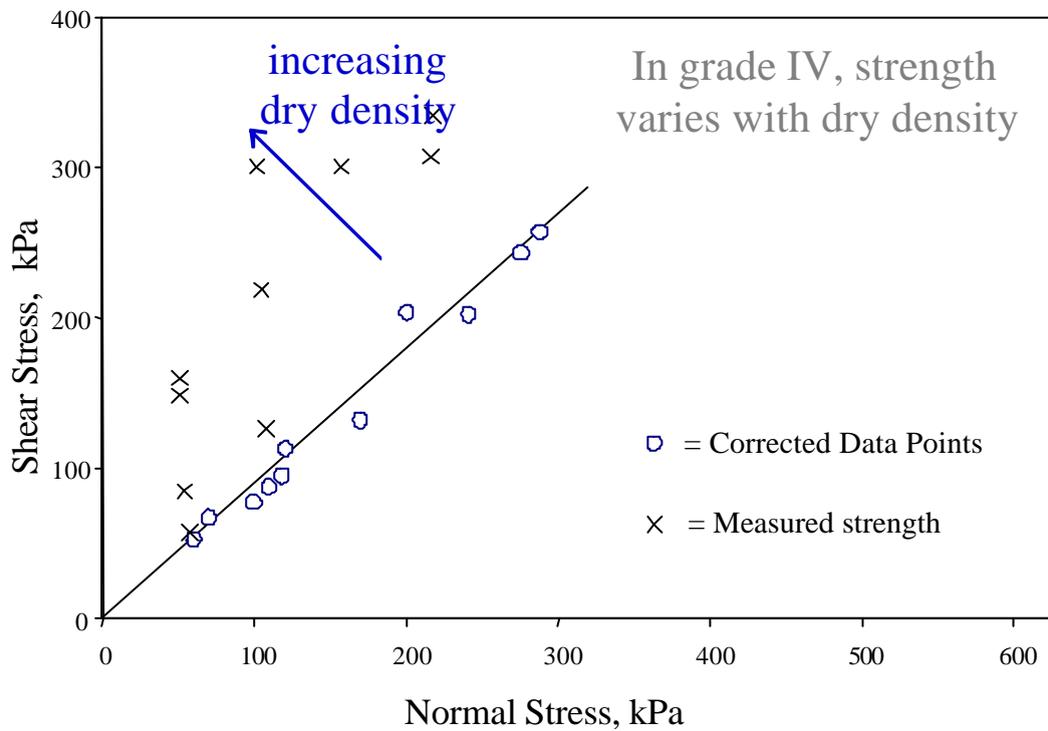
Figure 15 Direct shear test data from Tuen Mun Highway (after Hencher and Martin, 1984)

Occasionally higher values are reported for samples with reliable weathering grade description. Figure 15 shows results from direct shear tests on samples of grade IV weathered granite taken from a trial pit within a failure scar on Tuen Mun Highway (Hencher, 1983b; Hencher and Martin, 1984). Whilst all the samples were classified as grade IV, the samples varied in strength and dry density. The crosses in Figure 15 represent measured peak strengths and show considerable scatter. Dilation was measured throughout tests and when “corrected” for that work the “non-dilational” basic friction angle (essentially the same as critical state) was well defined for all samples as about 38 degrees – the same as for many rock joints (Hencher and Richards, 1982, 1988). The angle of dilation and uncorrected peak strength increased with increasing dry density (and decreasing degree of weathering). One of the interesting things about these data is that *all* the variable strength is accounted for by dilational work as if the materials were sands of different densities. True cohesion was expressed as dilational work in testing and approached 300 kPa for the denser samples.

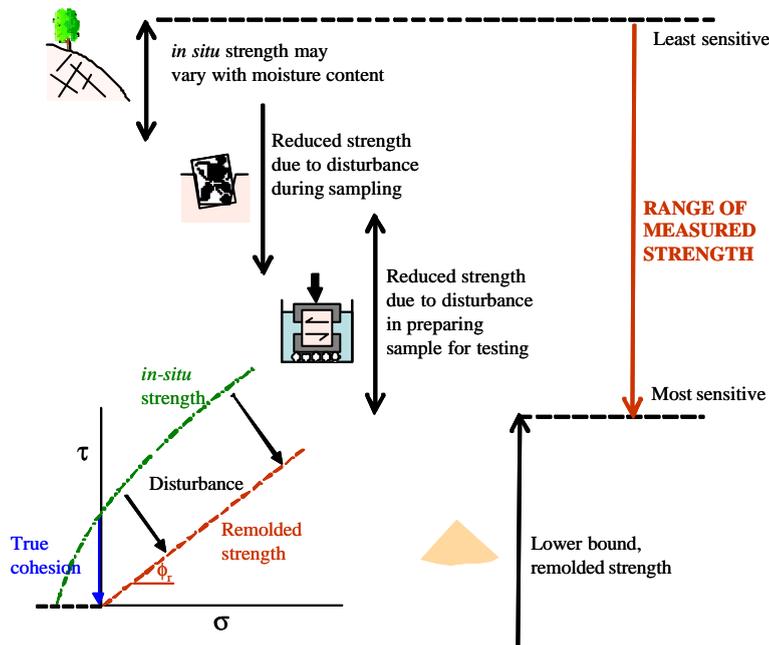
Figure 16 Sources of disturbance leading to reductions in measured strength

Without doubt, one of the prime reasons for measured strengths in weathered rocks (grades IV and weaker) being lower than anticipated theoretically is disturbance during the sampling and testing process. Figure 16 is an attempt to illustrate this schematically.

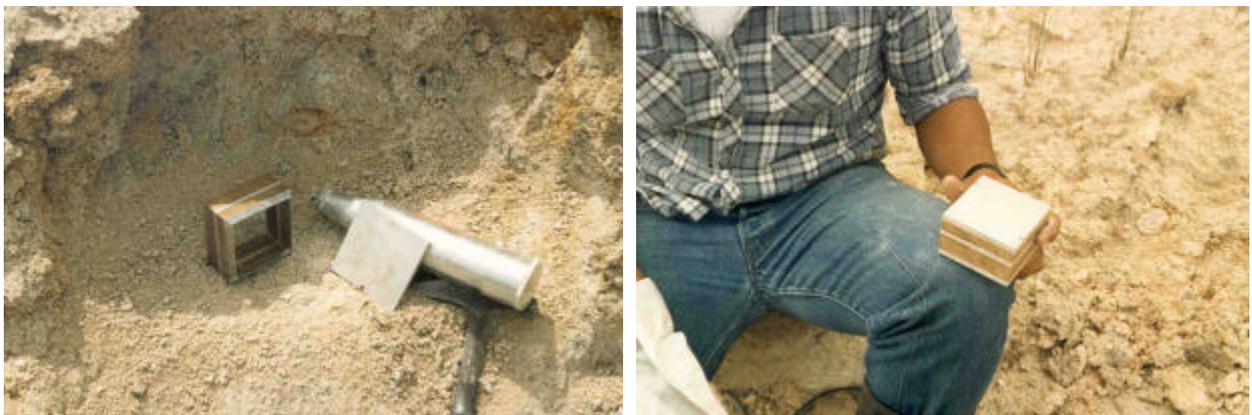
Figure 17 Leeds sampling box (a) for trimming in the field; (b) with top and bottom caps attached and ready to be transported to the laboratory. Central aluminium spacers split into two halves and can be removed prior to shearing, minimising further disturbance to the sample.

Ebuk (1991) carried out research on the shear strength characteristics of grades IV, V and VI weathered granite samples from Nigeria, UK and Hong Kong. For his research he employed several newly developed pieces of equipment including a sampling device that could be used directly in a direct shear box. This box, known as the “Leeds shear box” (Ebuk et al. 1993) was devised to reduce one of the sources of disturbance, namely trimming of field samples to fit into a laboratory device. The sample can be cut into the box and sealed, in the field, as illustrated in Figure 17.

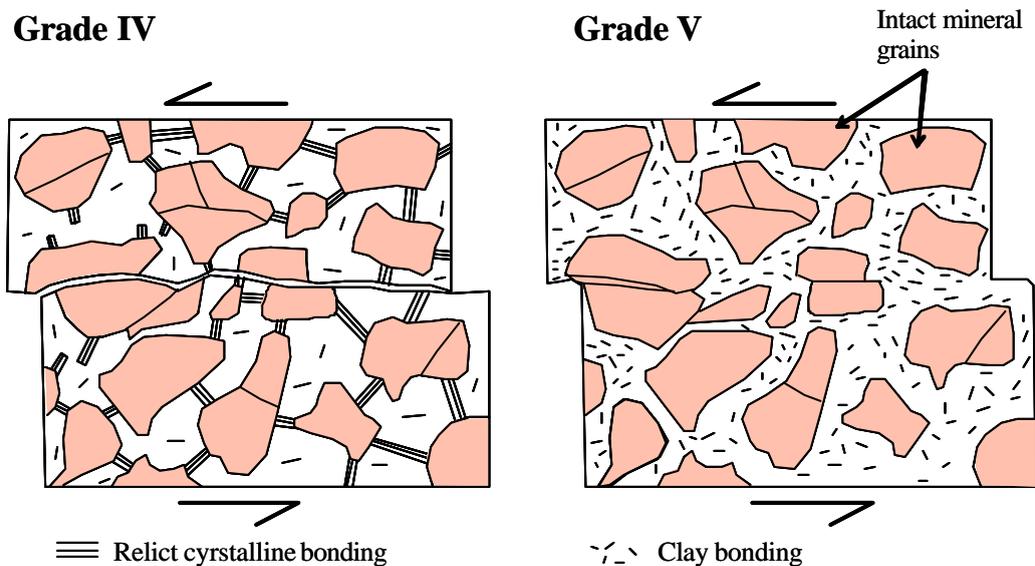
Figure 18 Idealised shear behaviour (after Ebuk, 1991)

One of his major observations was to confirm the decreasing role of relict bonding from grade IV to grade V as illustrated schematically in Figure 18. Differences in shear behaviour reflected these changes in state. For example, in Figure 19 it can be seen (topmost diagrams) that relatively strong grade IV exhibited brittle failure with a sharp and sudden drop in strength from peak. Moisture conditions had little influence on measured strength. Weaker material close to the grade IV/V boundary showed more plastic behaviour and reduced strength when saturated. Ebuk attributed this change in behaviour to softening of the clay matrix. Ebuk measured a range of strengths with cohesion up to 300 kPa for some grade IV samples (Figure 20) but this is still well below the anticipated 3 MPa or more for material of uniaxial compressive strength of 12.5 MPa as discussed earlier and so may still be far below the strength actually available *in situ* for such intact materials.

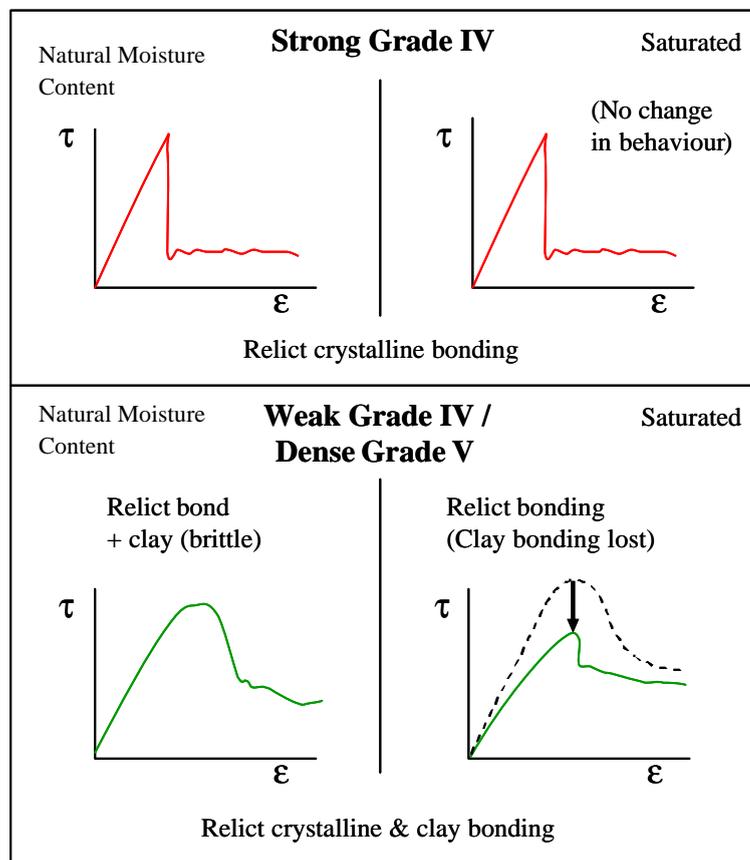
Figure 19 Influence of bonding type on shear behaviour (after Ebuk, 1991)

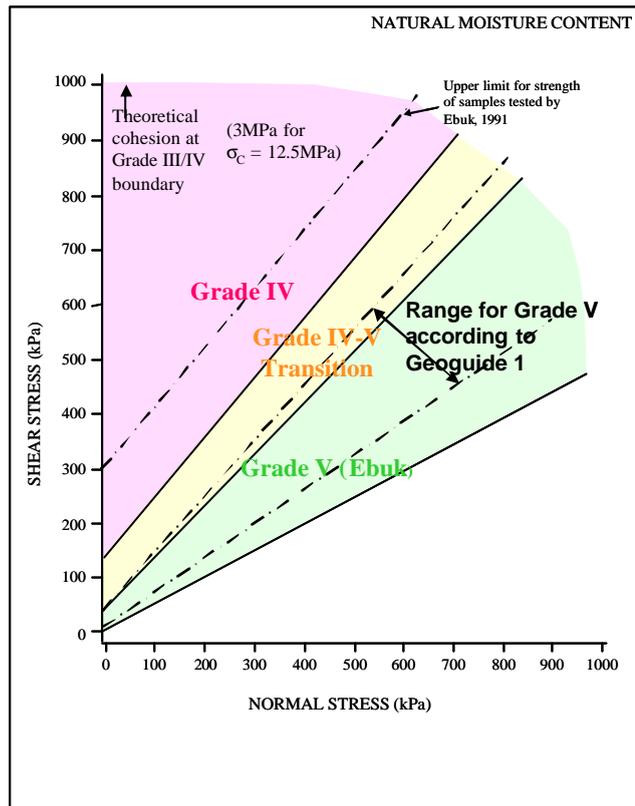
Figure 20 Influence of bonding type on shear behaviour (after Ebuk, 1991)

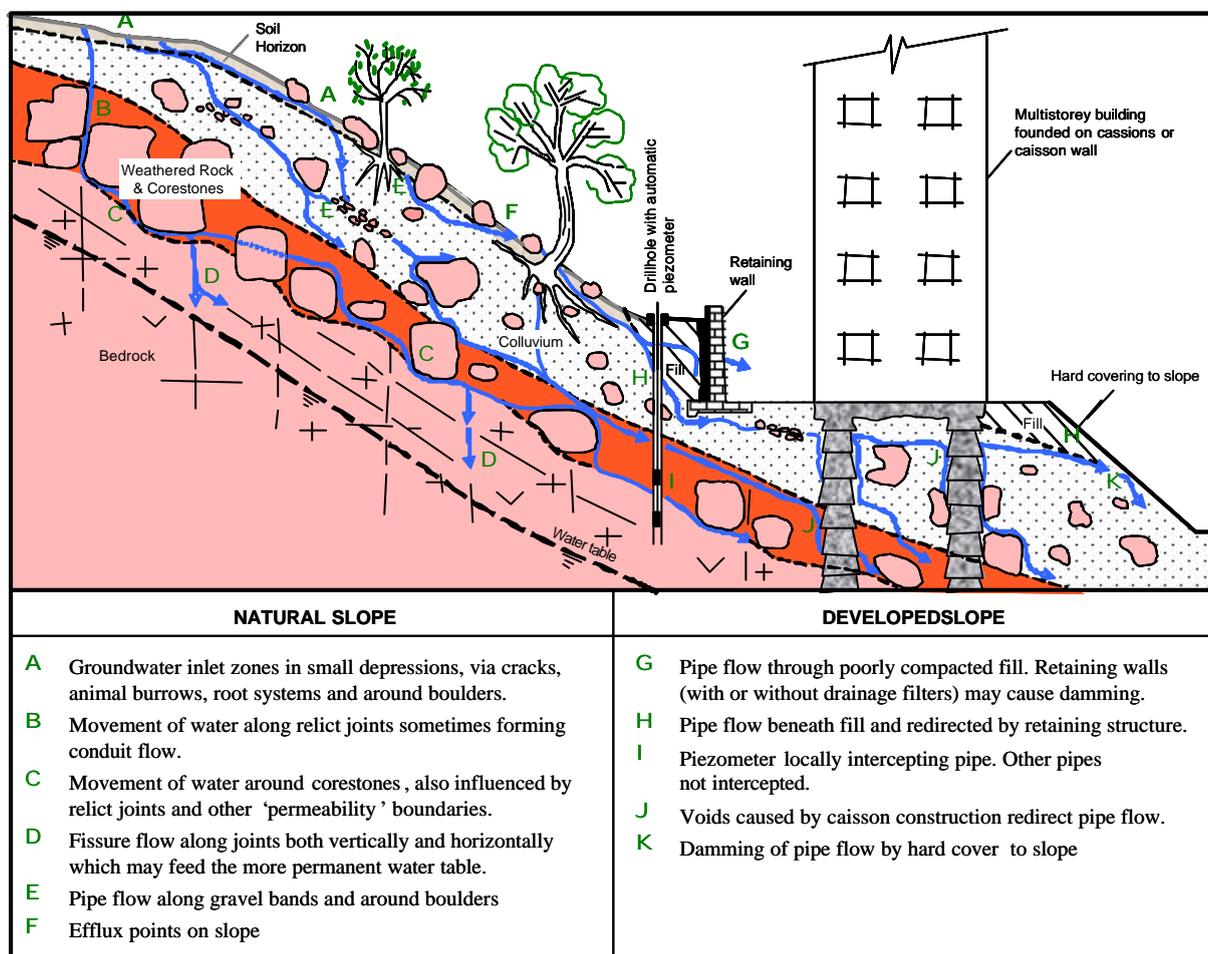
Figure 21 Schematic representation of piping in natural ground and close to developments (after Nash and Dale, 1984)

The development of pipes and their significance was recognised in the early 1980s in Hong Kong and a very useful summary paper was published by Nash and Dale (1984). One of their key figures, reproduced here as Figure 21, clearly indicates some of the potential problems that geotechnical engineers need to consider. Examples of failures associated with pipe flow are presented in Figures 22 and 23 from Hencher (1983b) and Choot (1983b) respectively. In fact, from the author's experience, a very high proportion of large landslides in Hong Kong are associated with pipe flow. Such pipes are often open (if active) but evidence of older pipe systems can be found in core samples where they are clogged with sediments ranging from well-sorted sands to graded bedding, indicative of underground stream systems depositing sediments into underground lakes, to gap-graded deposits.

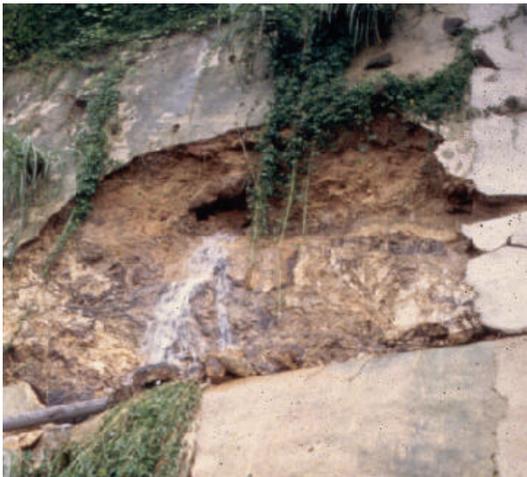
Figure 22 Pipe in a landslide at Chai Wan Road, 1982

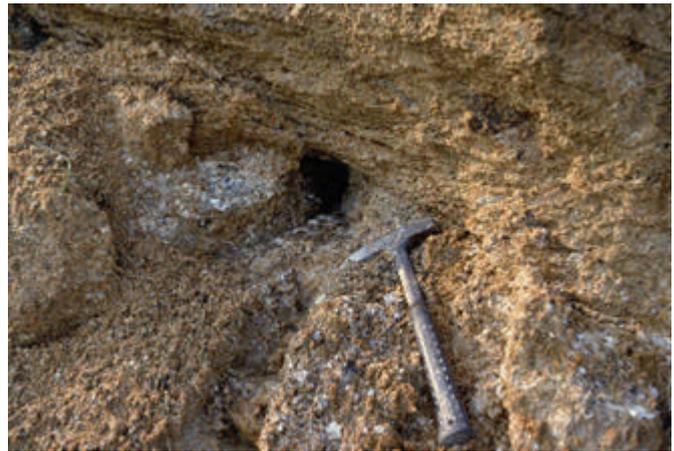
Figure 23 Pipe in Tsing Yi Pepco slope

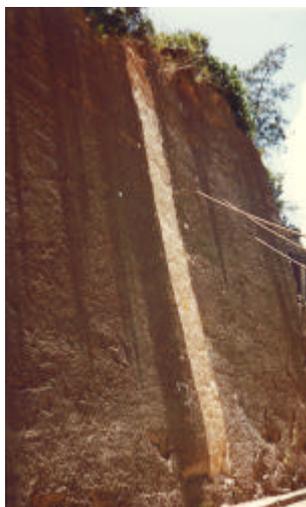
Figure 24 Pipes are seldom seen in undisturbed saprolite exposures

That said, not all saprolites are characterised by the presence of pipe systems and, examples, in cut slope exposures are relatively few from the author's experience (see Figure 24). This observation which contrasts with the common occurrence of pipes in landslides, implies that the development of pipes might be linked to early stages of failure with the rock mass dilating and ground water flow exploiting the openings to erode out underground stream courses.

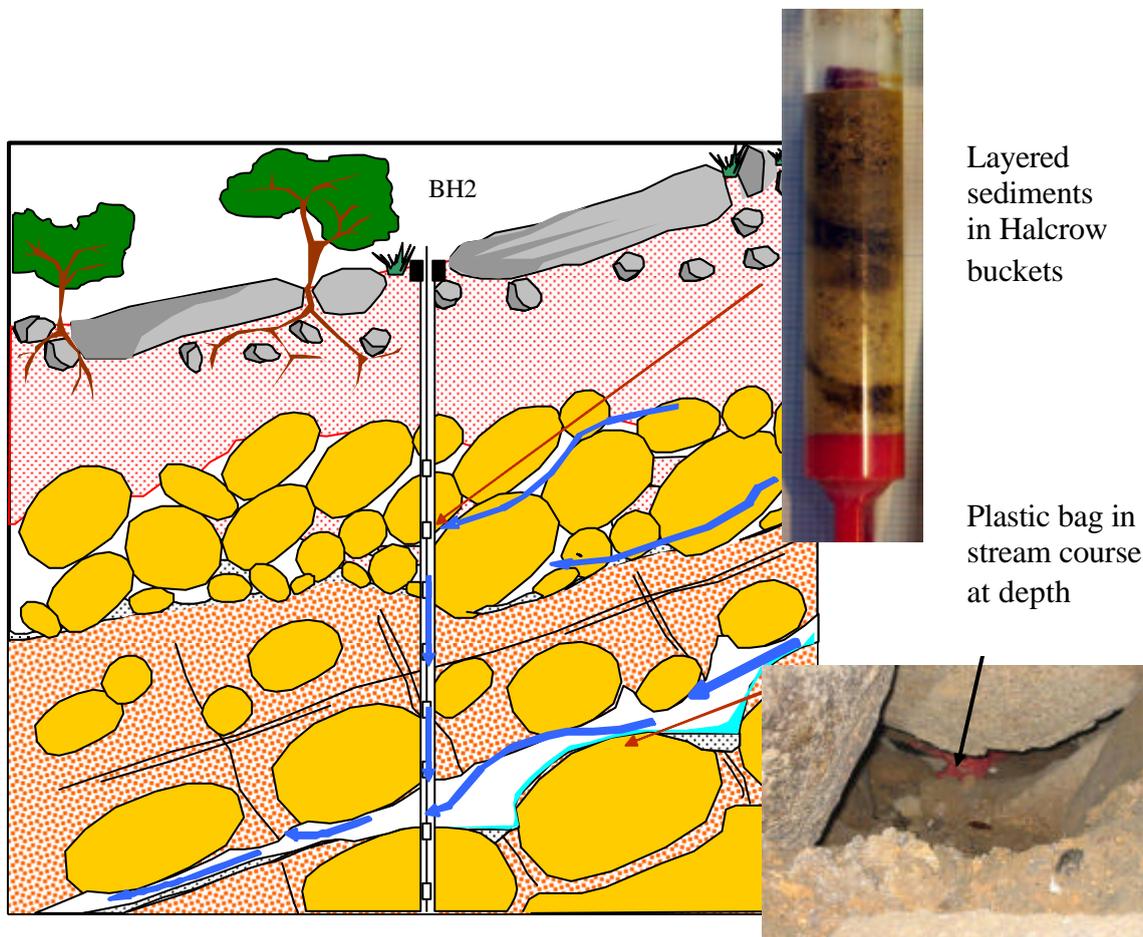
Figure 25 Evidence of underground streams close to the Yee King Road cavity

In 2003, evidence was discovered of a very large and unusual pipe system within weathered granite. A cavity, essentially a swallow hole, developed in a hillside above Yee King Road. Subsequent investigation showed that the cavity had chimneyed up from a large underground stream. Subsurface investigations and geophysical testing established the presence of several major, roughly parallel underground streams (Halcrow China Ltd, 2003). There was evidence that the underground streams were carrying sediment loads. Figure 25 shows layered deposits, including graded bedding, in a series of Halcrow buckets that had been installed down a borehole close to the cavity a few years prior to the incident. Evidently sediment-rich water had flowed down the borehole, past the buckets and escaped from the bottom into other, deeper stream courses (otherwise the borehole would have been choked with sediment, which it was not). The implied model is essentially that of transient turbidity currents flowing through a complex stream system following periods of high rainfall.

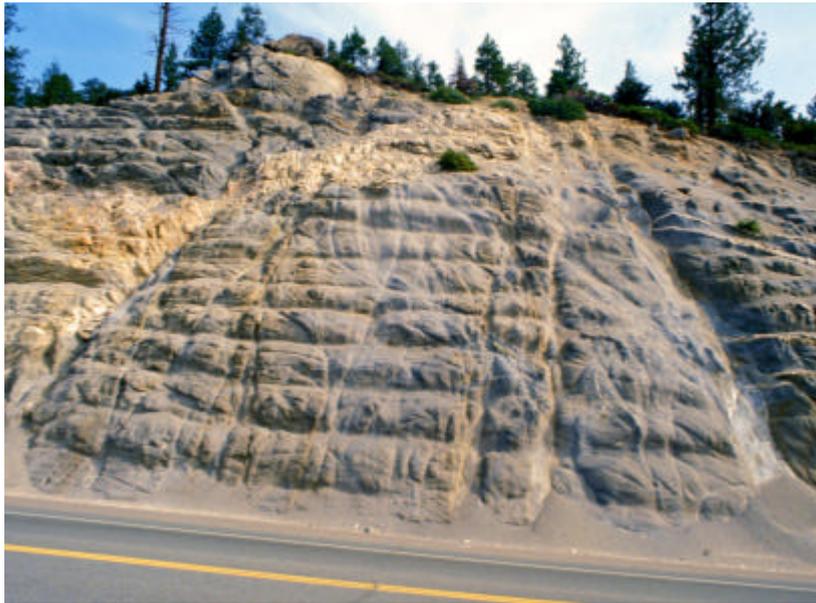
Figure 26 Disintegrated granite – Nevada, USA

In Hong Kong the term completely decomposed granite is taken to be synonymous with completely weathered granite because that is the dominant nature of the weathering process which is in accord with the recommendations of Anon (1995). However a second common process during weathering is the growth of fractures at small and large scales, as emphasized by Selby (1993). In Hong Kong this is rarely acknowledged in description but it is an important process. Elsewhere in the world, especially in colder climates, the results of disintegration dominate the weathering product. Saprolite develops as a sandy soil of interlocking particles that are barely changed chemically. Such profiles are common in Korea (Lee and de Freitas, 1989) and other examples are shown from the USA in Figures 26 to 28.

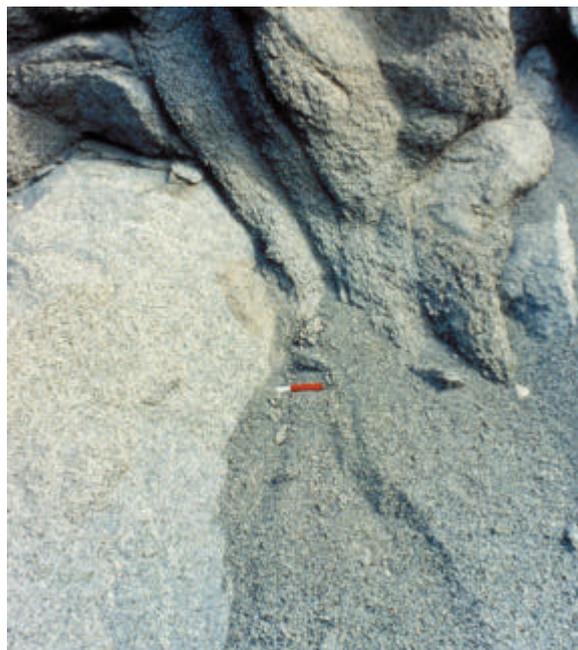
Figure 27 Detail of disintegrated granite detail from Nevada

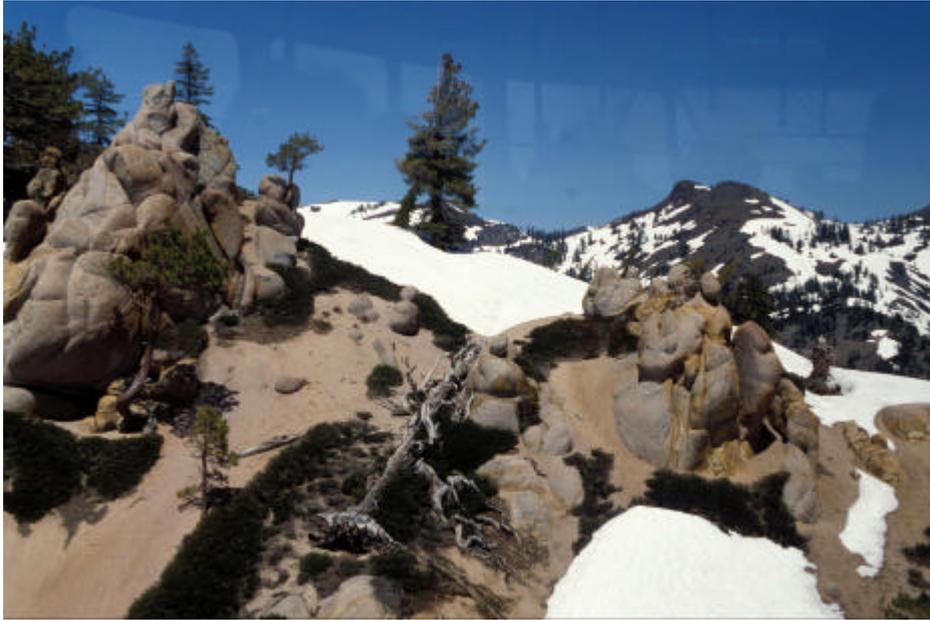
Figure 28 Frost-shattering disintegration with core stone development – above Lake Tahoe, USA

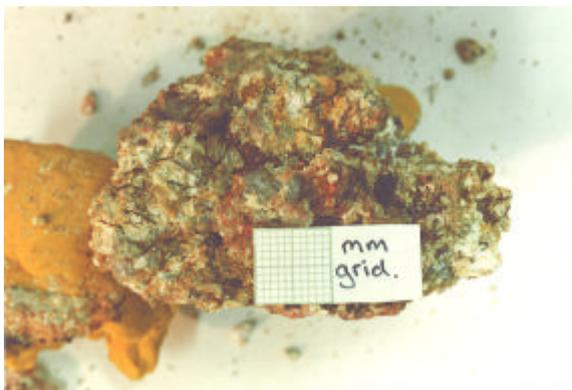
Figure 29 General disintegration accompanying decomposition in Hong Kong

Disintegration is also an important process in the development of weathered profiles in Hong Kong. During the CHASE study (GCO, 1981) discussed earlier it was found that disintegration sometimes made it difficult to assign weathering (decomposition) grades and required separate description. A three-class description method was adopted for degree of microfracturing – none, minor and extensive – with a special note where they were parallel (often parallel to the hillside and clearly relief features similar to sheeting joints). Examples are given in Figures 29 to 31.

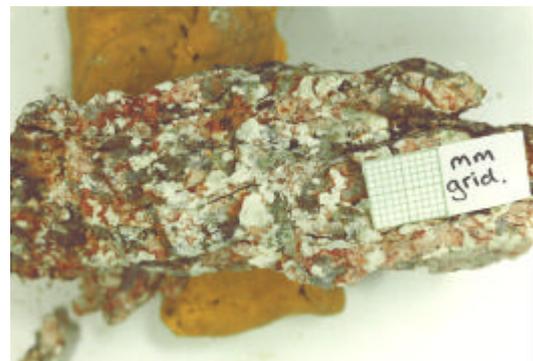
Figure 30 Parallel microfractures

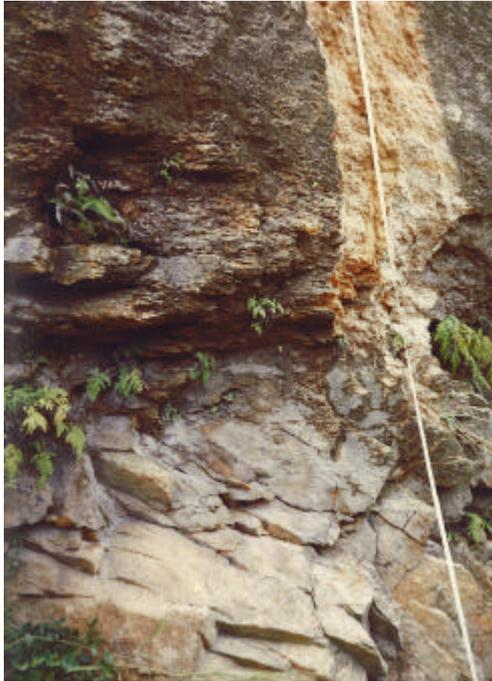
Figure 31 Extensive parallel microfractures in field
