WEATHERING AND EROSION PROCESSES IN ROCKS – IMPLICATIONS FOR GEOTECHNICAL ENGINEERING

Steve Hencher
Halcrow China Ltd

***Abstract:** This paper provides an introduction into active processes of weathering and how these affect the engineering properties of rocks. Five particular aspects are dealt with in some detail. The first concerns the shear strength of intact materials with particular consideration of the transition from rock-like to soil-like behaviour. The second topic is permeability of weathered rock profiles and in particular the often channelised flow of groundwater. Topic three concerns material disintegration and the growth of joints in the weathered rock mass; a classification of joints based on their “life-cycle” from oriented micro fractures to fully developed planes of weakness is introduced. The fourth topic concerns weathering along joints and the consequences for shear strength of such discontinuities. Finally deterioration of the overall rock mass is considered in a geomorphologic development sense, where such deterioration occurs and how such deterioration may be taken as indicative that failure is developing.*

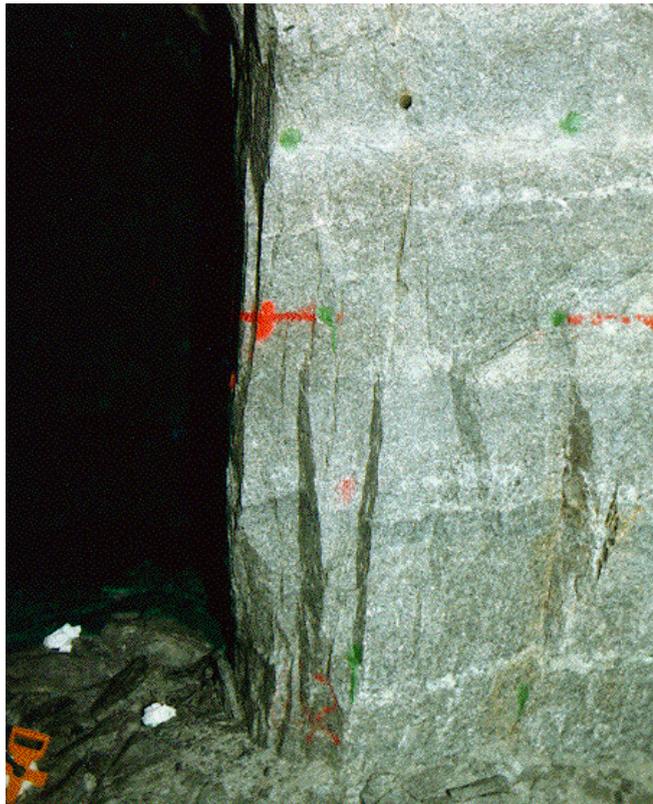
Figure 33 Stress relief in otherwise unjointed granite at great depth (Underground Research Laboratory level) (courtesy of Professor Derek Martin)

Evidence of active joint development is not well documented but there are some key examples. Martin (1994) reports site conditions at the Underground Research Laboratory (URL) in Canada. At the depth of the URL there are **no** joints in the granite but at shallower levels there are. Figure 33 shows stress relief fractures in the otherwise unjointed rock at several hundred metres depth within the granite pluton. Figure 34 shows stress relief fractures in core retrieved from depth. Interestingly the fractures in the rock close to the Earth's surface (where unloaded and more weathered) in some cases follow the same directions as appear as stress relief fractures in the otherwise unjointed granite (Martin, personal communication). Further details on this interesting and well researched site are presented in Everitt and Latjai (2004).

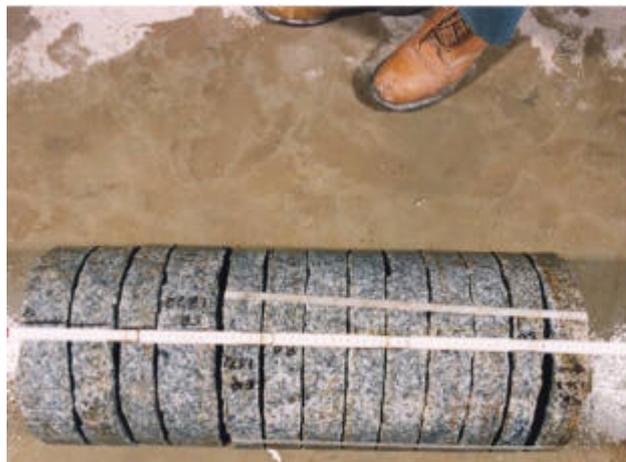
Figure 34 Discing on removal of core - URL Manitoba (courtesy of Professor Derek Martin)

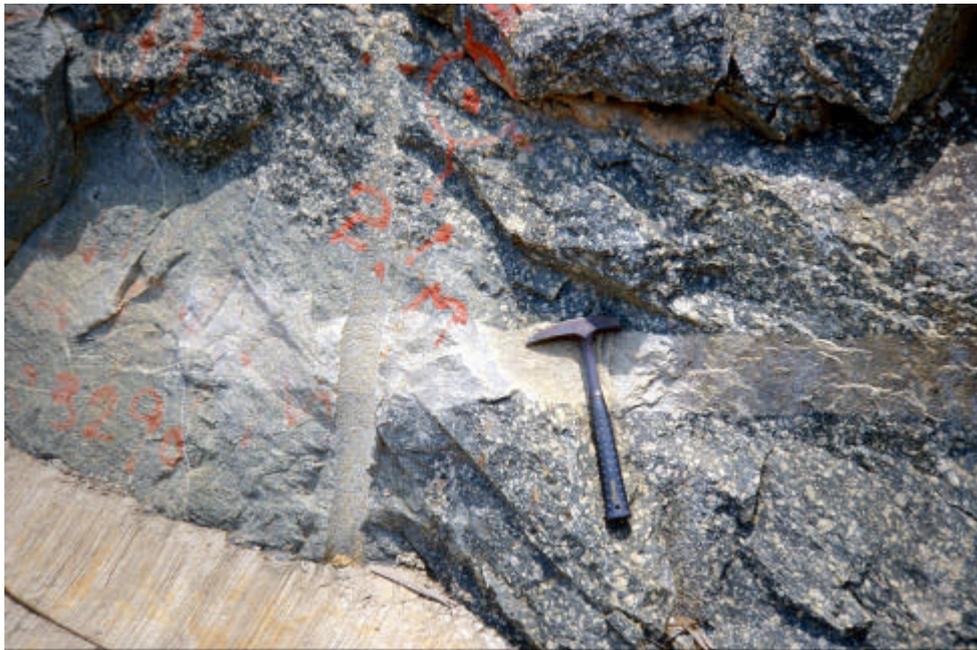
Figure 35 Three rock types on Tsing Yi Island: note fused nature of interfaces

Figure 35 shows three igneous contacts, at the ground surface, on Tsing Yi Island and illustrates that dyke contacts are not necessarily particularly weak planes even though they are clearly recognisable discontinuities (Class 2 in Figure 32). The author has heard it argued many times that dyke boundaries are weaknesses and expected locations for water flow but clearly that is an overgeneralization. Many other examples of strong, incipient discontinuities – faults, dyke boundaries and bedding planes - are illustrated by Fletcher (2004). Figure 36 shows a progressively developing fracture in a coastal granite exposure near Stanley.

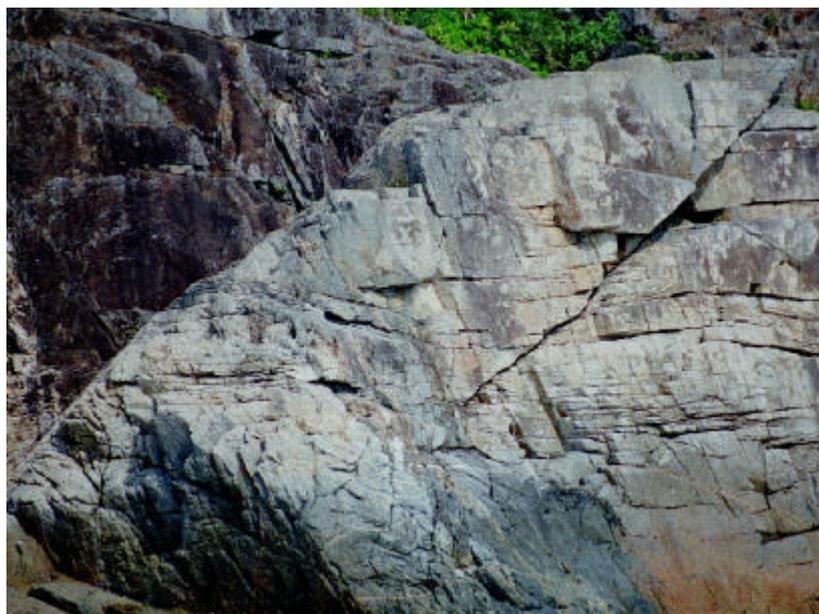
Figure 36 Fracture network under development at Stanley—come back in another 2000 years and what would you see?

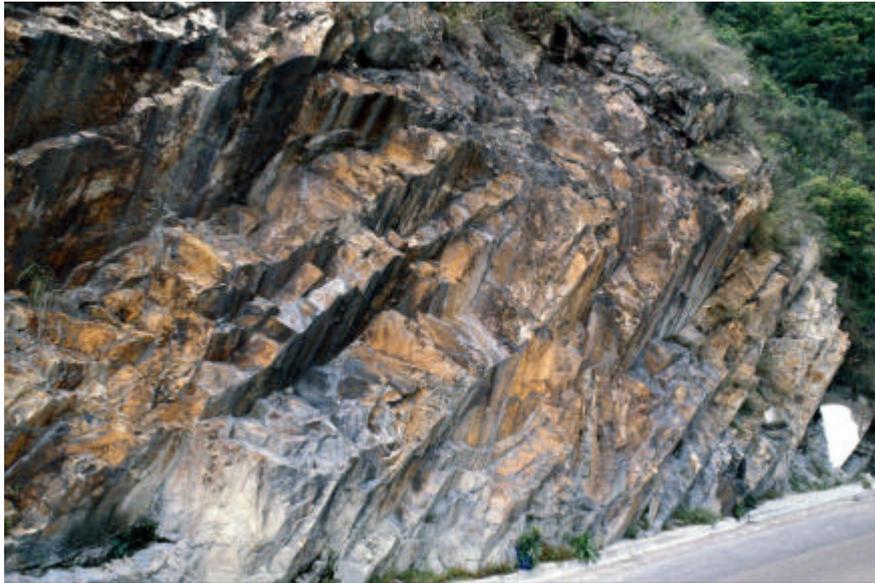
Figure 37 Island Road: a parallel set of “tectonic” joints on examination

The first occasion that the author realized that many fractures, including what, on first examination, appeared to be a parallel “tectonic” set of joints, only fully developed through weathering processes was when considering the stability of rock cuttings along Island Road, Hong Kong, when the road was to be widened in the early 1980s. Figure 37 shows what appears to be a set of tectonic joints through the volcanic rocks in a cutting. At one location it was noted that there was what seemed to be a sheeting joint passing through the supposed set of tectonic joints.

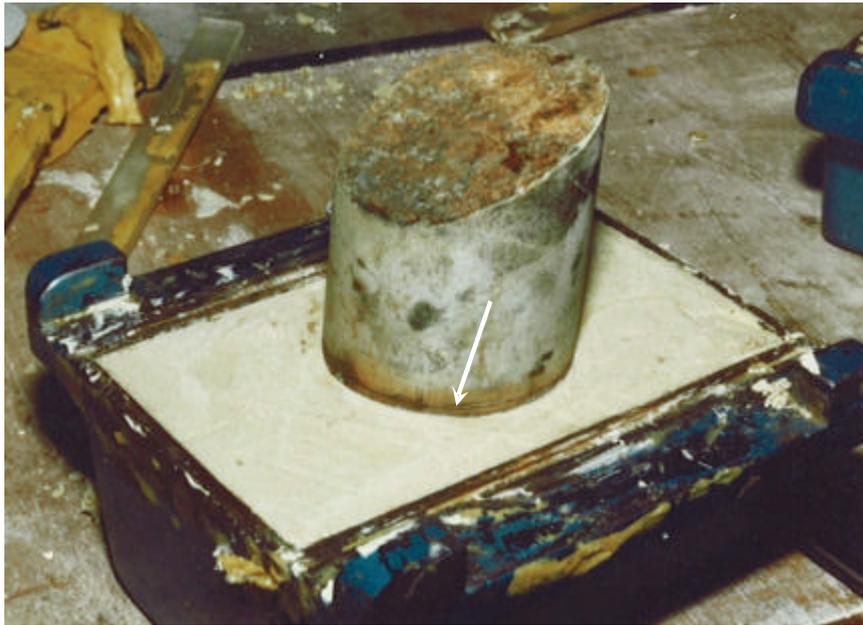
Figure 38 Island Road: incipient (Class 2) "tectonic" joint

Further evidence that many joints are only fully developed through weathering was provided by examination of core from the same site. Figure 38 shows an intact piece of core being set up for a direct shear test in a Golder Associates type shear box (Hencher, 1983). The surface to be sheared followed an incipient trace of one of the parallel joints (Class 2). Figure 39 show photographs and descriptions of the joint surface post shearing. Figures 40 and 41 show close-up views of the rock bridge that had kept the core intact. The coloured alteration bands surrounding the rock bridge are evidence of active weathering processes gradually eating away the bridge. Eventually that joint would have fully developed as a Class 4 joint with no tensile strength.

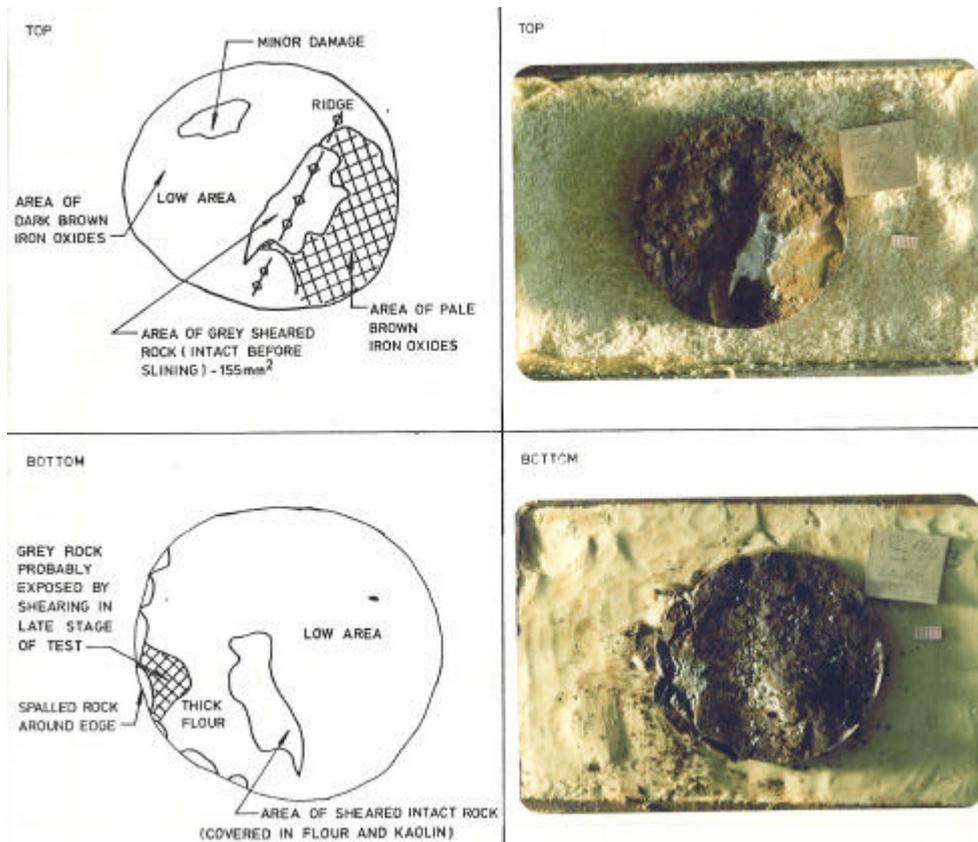
Figure 39 Rock bridge post-shear

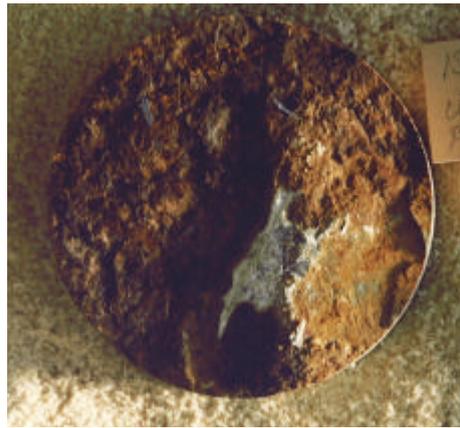
Figure 40 Closer view of rock bridge

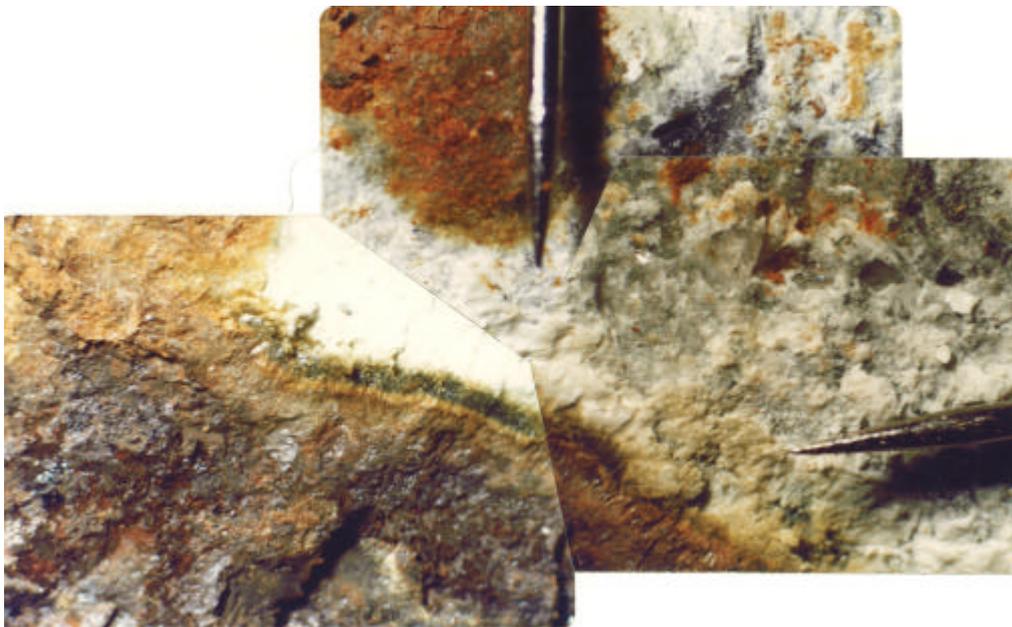
Figure 41 Island Road: rock bridge being slowly eaten away

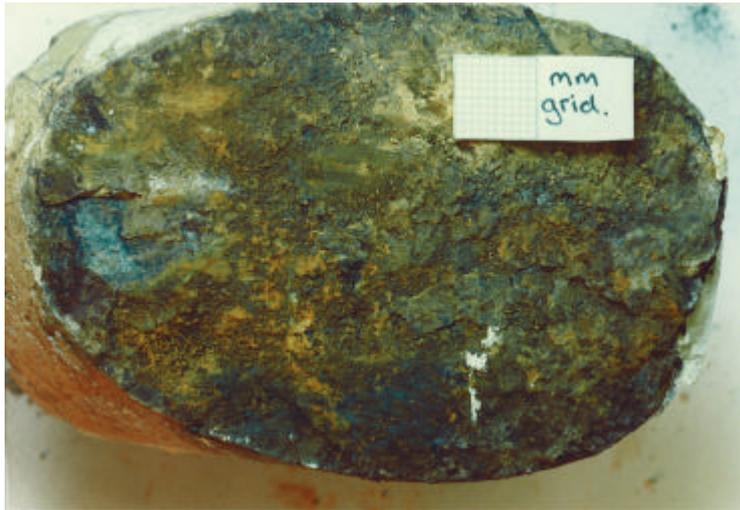
Figure 42 Iron oxide coated joint

As noted earlier, the initial stages of weathering generally takes place along open discontinuities where water can permeate. The water and associated ions attack the exposed minerals and transport weathering products to new locations. Joint surfaces are therefore the loci for weak, weathered bands, erosion and smoothing of surface texture and the deposition of secondary minerals. All these processes can have marked consequences for shear strength. Examples of weathered products deposited along joints as coatings or infillings are given in Figures 42 to 44.

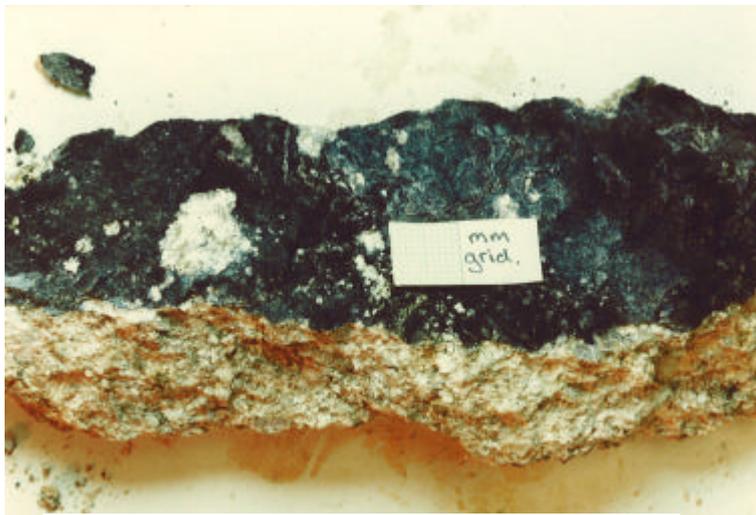
Figure 43 Manganese dioxide coated joint

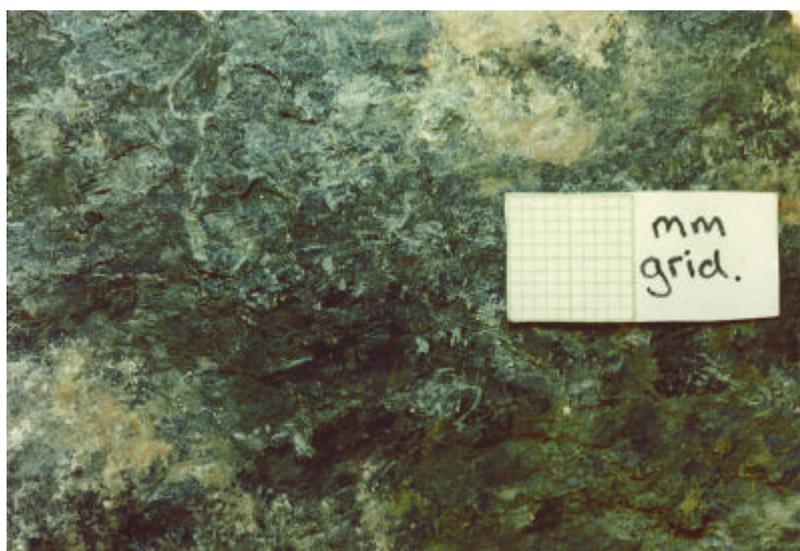
Figure 44 Chlorite coated joint

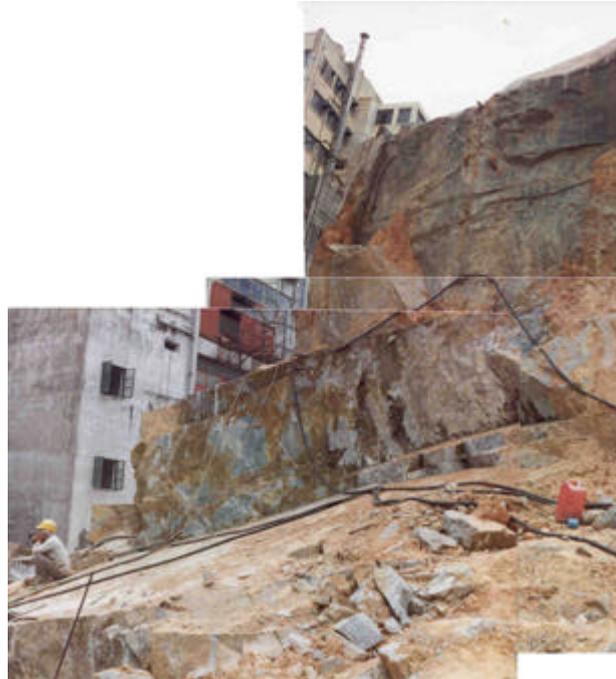
Figure 44 Yip Kan Street rock slide

The Yip Kan Street failure of July 1981 (Hencher, 1981) illustrates the importance of weathering on the shear strength of rock joints. The failure took place on a dry day on daylighting joints that were in some areas only dipping at about 20 degrees (Figure 44). The parent rock is a coarse-grained quartz syenite.

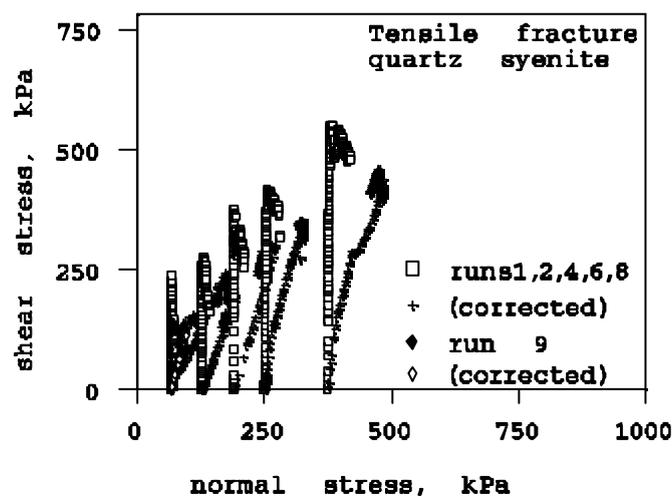
Figure 45 shows the results from a multistage shear test on an artificially formed tensile fracture through the slightly decomposed parent rock. This gives the upper bound for shear strength of an open, matched, class 4 discontinuity with no infill or coating.

Figure 45 Artificial tensile fracture in grade II quartz-syenite (Yip Kan Street)

The test was conducted under an initial normal stress (run 1) of 50 kPa, then, after cleaning off any debris, the joint was reset in its original position and sheared again under a higher normal stress (100 kPa - run 2). After run 2 and further cleaning off, the joint was reset and retested at 50 kPa. The processes was then repeated (i.e. at 150, 50, 200, 50, 250, 50, 350, 50 kPa). The 50 kPa runs following each of the increasing normal stress stages gave a measure of progressive damage to the joint. Essentially the test was simulating the decrease in surface roughness that might occur either through wear or weathering. Figure 45 shows selected test results both as measured and corrected for dilation (Hencher and Richards, 1988; Hencher, 1995). It can be seen that the corrected data define a basic non-dilational friction envelope (peak) quite well.

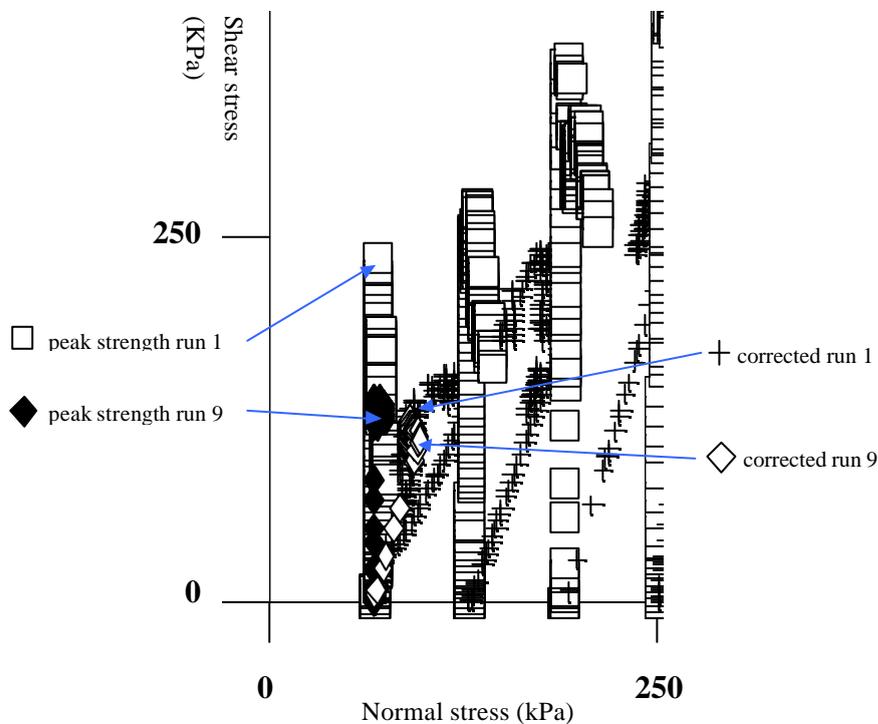
Figure 46 Details of tests on grade II quartz syenite

Figure 46 shows some of the data in more detail. It can be seen that the uncorrected data from runs 1 (a fresh, matching tensile fracture) and 9 (after repeated shearing), at the same normal stress, are very different because of the loss of roughness and surface texture by run 9. It is also noted however that the *non-dilational*, corrected data for peak strength from runs 1 and 9 is almost the same. This illustrates that loss of roughness will reduce peak strength considerably because of reduced dilation but the underlying non-dilational friction for natural joints is essentially a constant. Generally that friction angle is about 40 degrees for most silicate rocks (Papaliangas et al 1995). Clearly the rock slide at Yip Kan Street could not have occurred on unweathered joint surfaces.

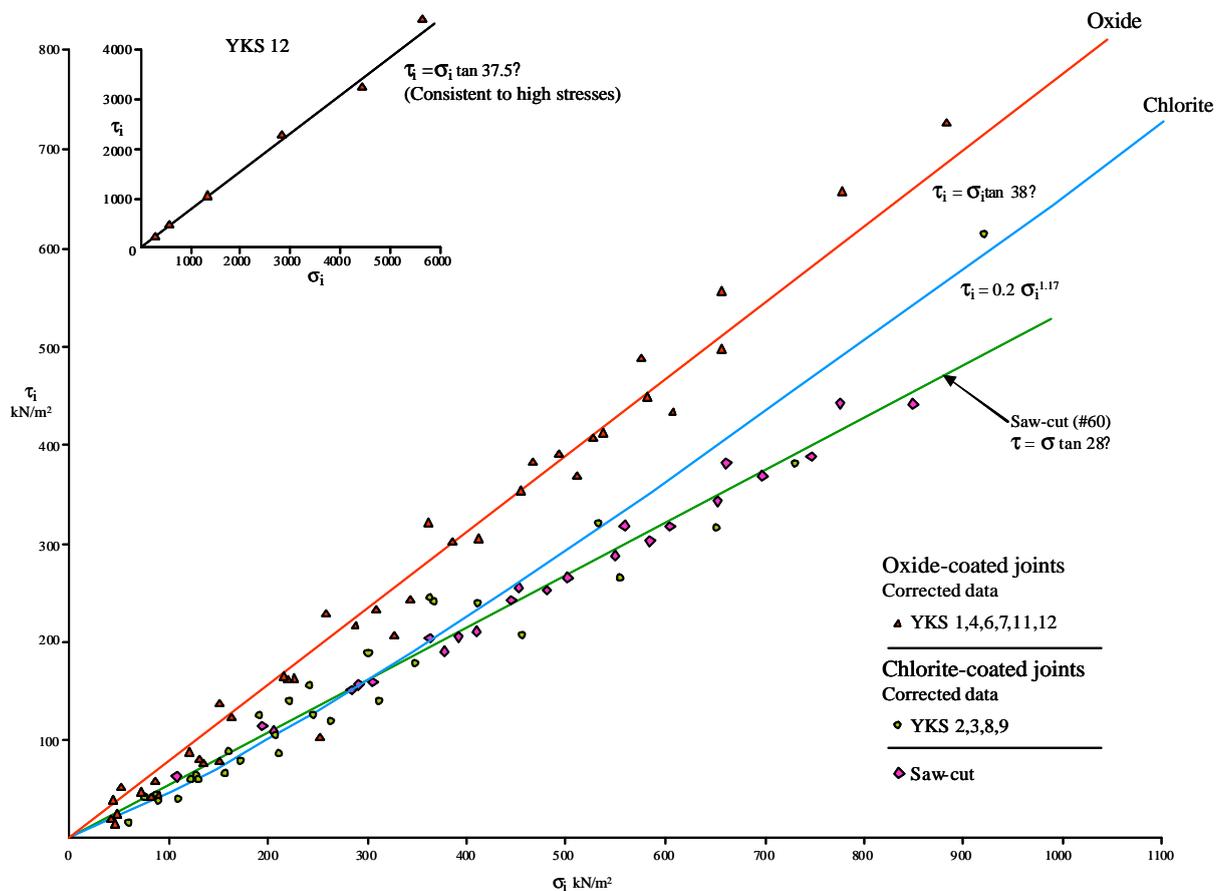
Figure 47 Direct shear test data (corrected for dilation) at Yip Kan Street

In fact the failure occurred along persistent joints coated with weathering products. There were two main coatings observed – iron oxide and chlorite. Direct shear tests were conducted on samples of both types of joint. The data are presented in Figure 47. It can be seen that the iron oxide coated joints exhibited non-dilational friction of about 38 degrees (up to normal stresses of 6MPa) which is consistent with values measured on similar coated joints in granite (Hencher and Richards, 1982). The shear strengths measured for the chlorite-coated joints however were much lower at the low stresses relevant to the failure and indeed were lower than for saw cut surfaces. The failure was thereby explained as due to sliding on chlorite-coated joints and highlights the importance of weathering processes on shear strength.

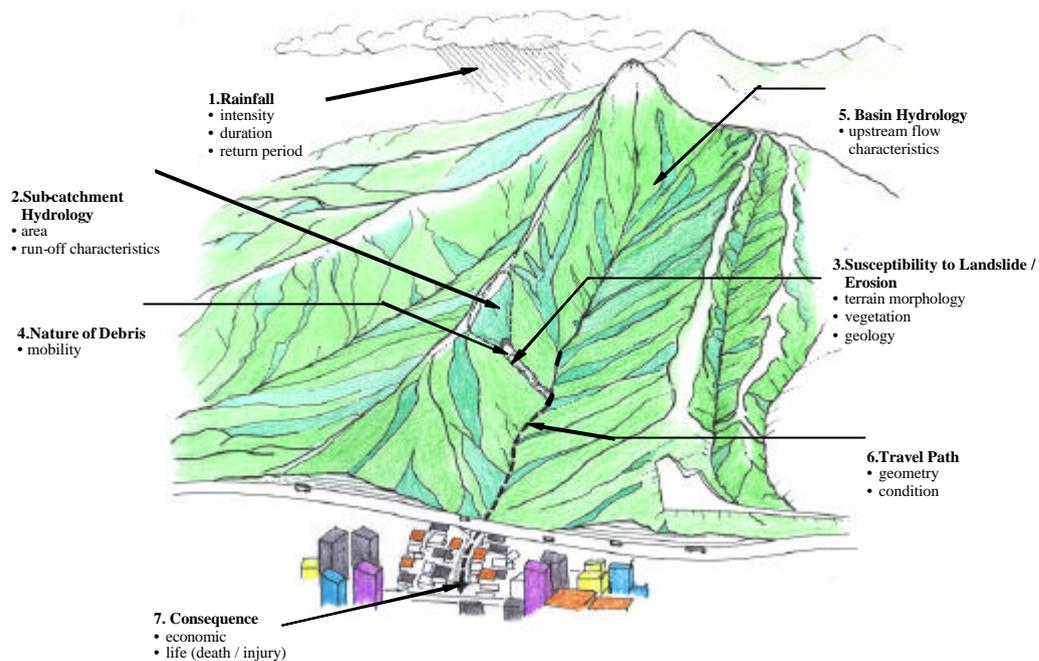
Figure 48 Factors contributing to risk from natural terrain landslides

It is obvious that slopes progressively deteriorate with time until eventually they fail. Ho (2004) reports that natural terrain landslides occur in HK at an average rate of 1 per 2 km² per year. Some of the factors influencing natural terrain failures (and their consequences) are illustrated in Figure 48.

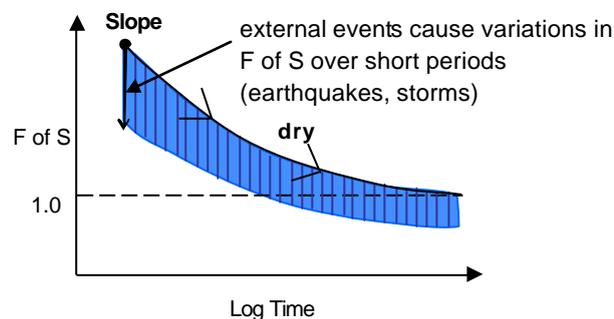
Figure 49 Reduction of Factor of Safety with time (long term and short term)

The concept of deterioration as it relates to general geomorphological development is illustrated schematically in Figure 49. The gradual deterioration can be represented by a curve in which the Factor of Safety reduces over a period of time which may comprise tens or hundreds of years. The vertical lines represent temporary reductions in Factor of Safety caused by relatively short-term, transient events (days). In the course of time, the slope will deteriorate to the point where it is vulnerable to a transient event – causing a reduction in the Factor of Safety below 1.0. Whether that event results in catastrophic failure or only minor movement and internal distress depends on many factors including the severity of the triggering event and how long it lasts.

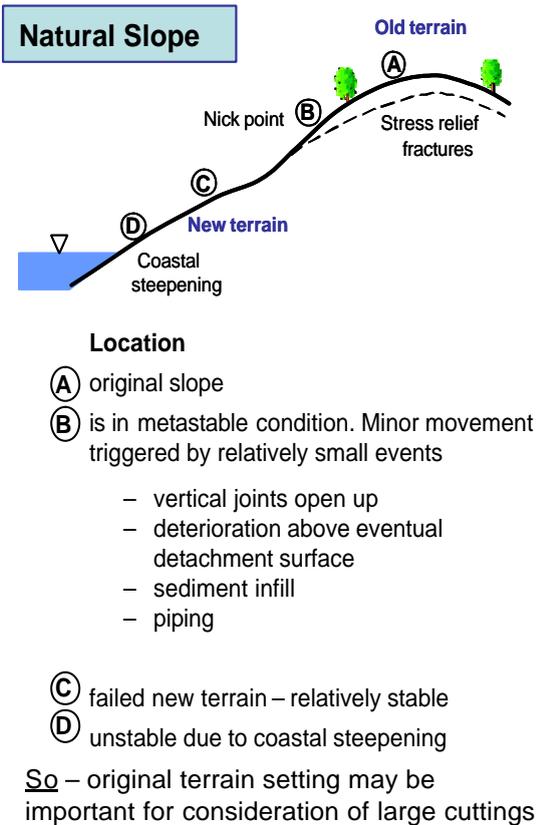
Figure 50 Schematic cross section through hillside

In general it can be surmised that for any given hillside, at any particular time, different locations will have different Factors of Safety. One might consider the hillside to comprise an inventory of different slopes of different susceptibilities. The susceptibility at each location will be a function of the weakness of the rock/soil at that location but also many other factors such as local slope angle (and therefore shear stress), catchment leading to that location (which will influence water pressures and erosion potential), local topography leading to concentrations of surface flow, erosion and undermining and vegetation cover (e.g. deep-rooted trees will help hold the soil together). In general however particular zones of the hillside will have different susceptibilities. In Figure 50 the concept of “old” and “new” terrains (Hansen, 1984) is illustrated schematically in terms of slope development. Location A is within the old terrain at the top of a hill, which is being progressively eroded at an active “landslide front” at Location B. Location C is in shallower terrain where the landslide front has already passed through. At Location D coastal erosion is active. The differences in susceptibility at each of these locations are represented in Figure 51. Away from the coast, location B has the highest susceptibility and rapid deterioration and even detachment failure can be expected in high rainfall events or earthquakes.

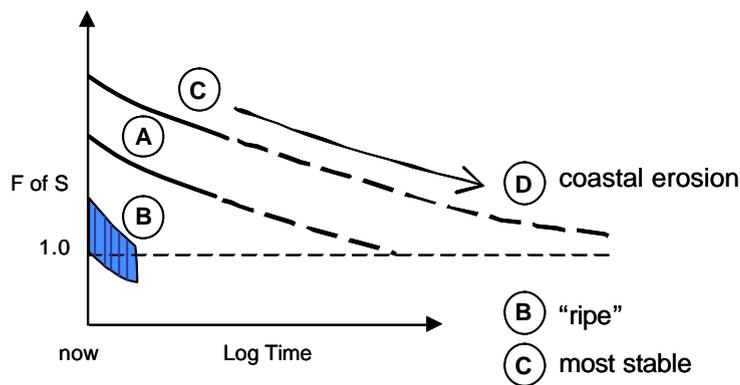
Figure 51 Susceptibilities at different locations on hillside

At B a minor rainstorm (say a one in 1 year storm) will probably not result in any discrete landslides although it will contribute to the general deterioration of the hillside which might be measurable given sophisticated instruments.

A more severe event (say a one in 10 year storm) may cause a few failures in areas where the ripened factor of safety is approaching 1.0 (say 1.0 to 1.1).

A much more severe event (say one in 100 year storm) may cause all slopes to fail within a much wider range (say 1.0 to 1.3). Not only will the intensity of such a storm initiate discrete failures but the duration of the heavy rain will make the debris more mobile so that it can flow a long way and impact on more structures than would otherwise be the case.

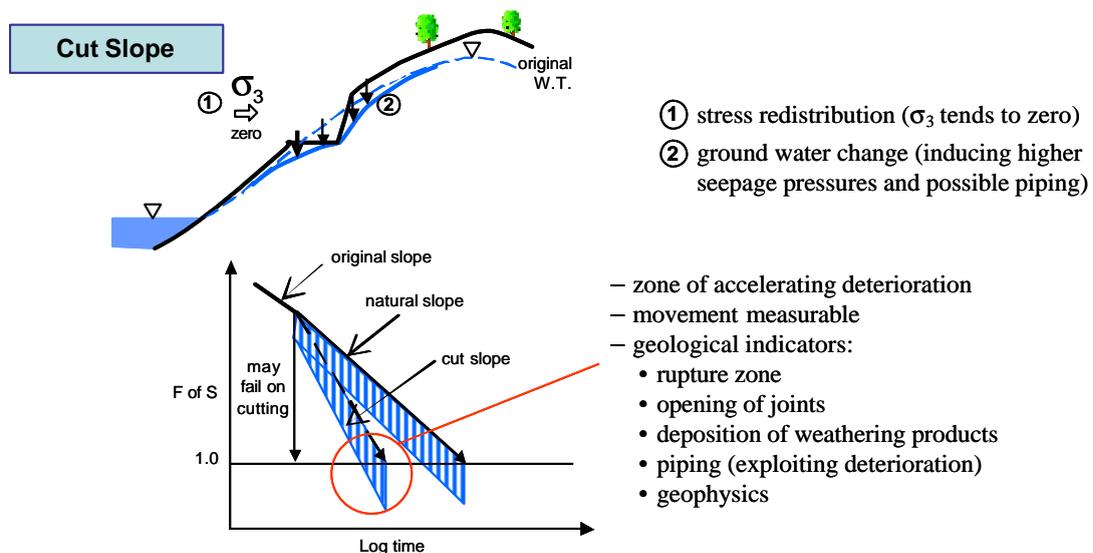
Figure 52 General concept of stability for cut slopes : geomorphological setting and deterioration

Cutting slopes will make them more susceptible to triggering events as illustrated in Figure 52. At the location where the cutting is made, the natural slope would have gradually deteriorated in geological time perhaps over hundreds of years. However the process of cutting the slope leads to a reduction in the Factor of Safety because of increased shear stress (over-steepening), reduction in confining stress and possibly more aggressive groundwater conditions.

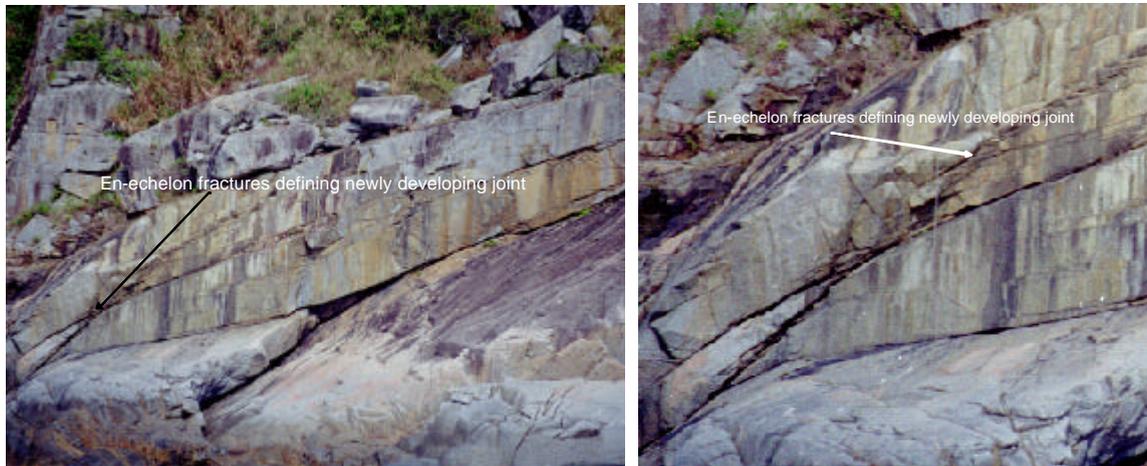
Signs of gradual deterioration or, more likely, the cumulative effect of intermittent triggering events can be seen in many exposures. Figure 53 shows a joint that is apparently developing with the formation of en-echelon fractures. Eventually it will fully develop as a through going fracture such that the overlying block will detach. Note the evident dilation (opening up) in the lower part of the joint.

Figure 53 Fracture development in granite, Hong Kong

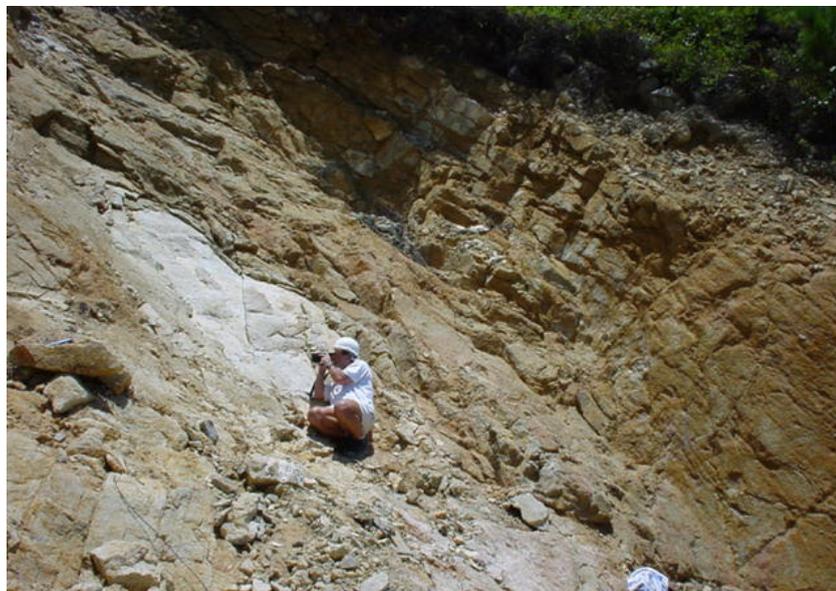
Figure 54 Source area for the Leung King natural slope landslide, 2000

Figure 54 shows the source area for a landslide in natural terrain that showed clear evidence for progressive deterioration prior to final failure (Halcrow China Ltd, 2001).

The failure was essentially a translational rock slide on an undulating sheeting joint. In Figure 54 a central exposed area can be seen that is pale grey, almost unjointed granite. That part of the hillside (and below) has not moved. In contrast, the rock above is brown stained and contains many joints. That is because it has moved, resulting in joint development and extension because of stress concentration, and stained because of weathering processes.

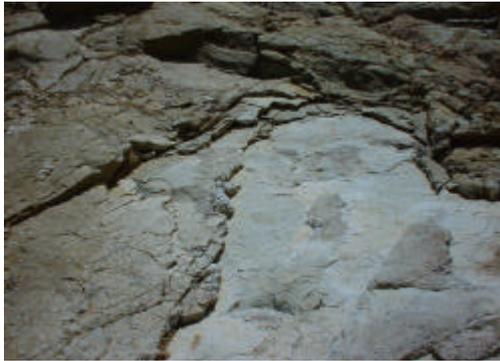
Figure 55 Fractured rock (partially displaced) above unfractured basal release surface (sheeting joint)

Figure 55 shows the contact between the upper, brown and fractured, displaced rock and the underlying grey, unfractured granite.

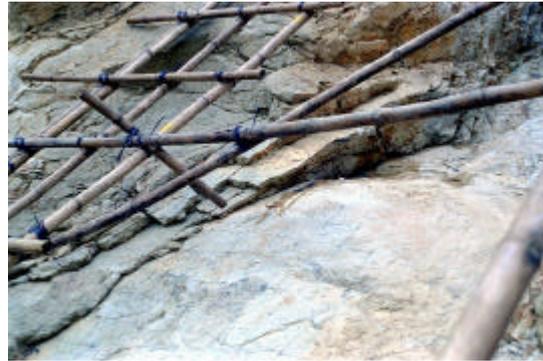
Figure 56 Wavy sheeting joint surface with measuring grid. The overlying rock slab has been displaced slightly downhill

Figures 56 to 58 show one of the waves in the sheeting joint with evidence of previous movement followed by infilling of the opened fractures with sediment. The landslide zone probably underwent repeated events during which the FoS was reduced temporarily below 1.0 with a cycle of displacement and weakening on each occasion. The process is illustrated schematically in Figure 59.

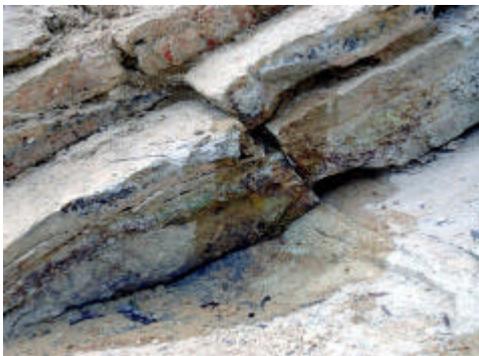
Figure 57 Close up of part of Figure 56

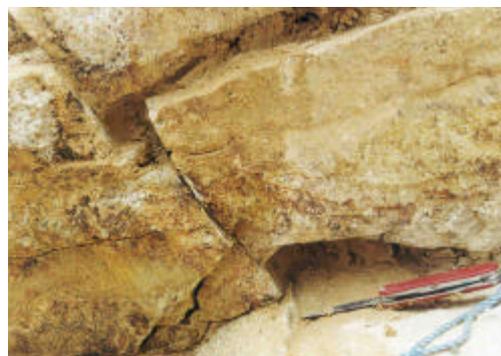
Figure 58 Even closer view showing displaced granite blocks and clay infill

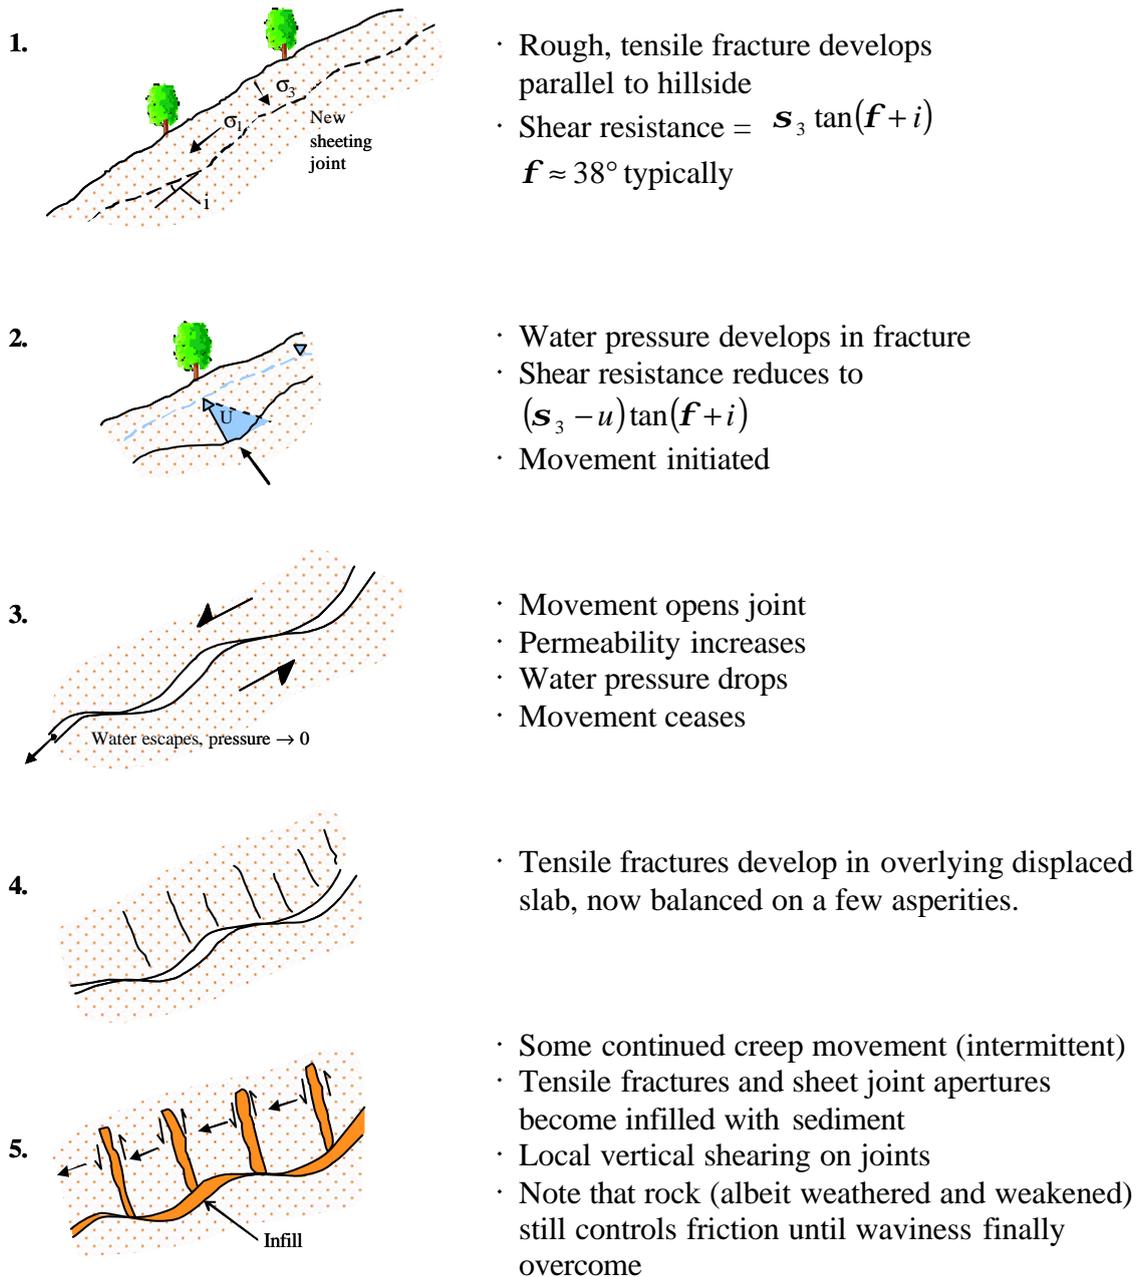
Figure 59 Deterioration of slope with intermittent movements on sheeting joint

Another case is illustrated from a failure on Tsing Yi Island (Choot, 1983b) where there was evidence of previous movement (clay-infilled joints). Indeed the eventual “failure” involved the same mechanism as that illustrated in Figure 59 with limited movement involving dilation and the release of pore pressures allowing a temporary restoration of a FoS greater than 1.0. Figure 62 shows the slope with considerable signs of distress but not full detachment. Figure 63 shows an exposed joint in the rear of the failure, infilled with kaolin and slickensided with manganese dioxide. Almost certainly this slickensiding largely pre-dated the movement shown in Figure 62. Figure 64 shows a sample taken from the joint with thick kaolin infill, merging with the decomposed granite fabric and almost certainly having accumulated in an intermittently opening joint over a long period. Similar, more recent examples are discussed by Kirk et al. (1997) and illustrated in Fyfe et al. (2000). In particular the presence of clay-infilled vertical fractures as seen in the rear of the fatal Shum Wan Road (see Fyfe et al. op cit) and Fei Tsui Road landslides (personal observation) are possibly indicators of precursory movements in the author’s opinion.

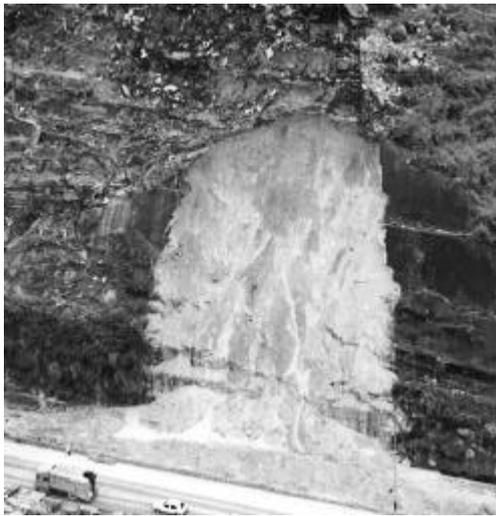
Figure 60 Junk Bay Road landslide

There are many case examples of dilation and fracturing of the rock mass, often associated with deposition of sedimentary clay, mainly kaolin, prior to final detachment. One example is the landslide at Junk Bay Road (Hencher, 1983c). The failure took place on a sheeting joint, patchily infilled with thick kaolin (Figures 60 and 61). Almost certainly, prior movement had taken place with dilation and deposition of kaolin in the hollows on the sheeting joint surface. An important corollary of this concept is that the joint would maintain rock-rock contact on waves prior to final detachment. In other words the clay infill, though important as an indicator of distress and probably affecting permeability, would not affect the frictional shear strength of the joint up to the final stage of detachment.

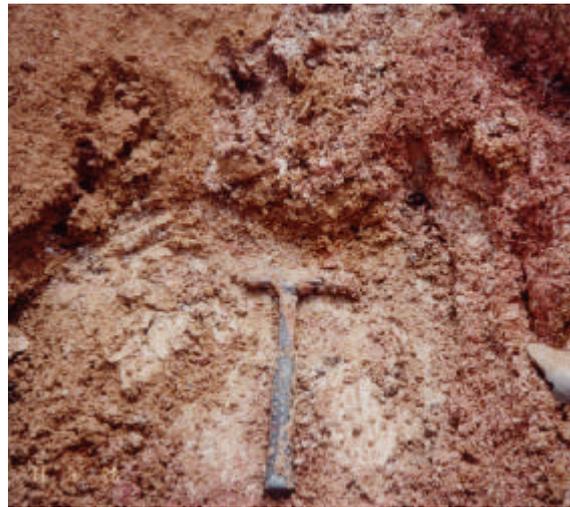
Figure 61 Kaolin-infilled sheeting joint at Junk Bay Road landslide

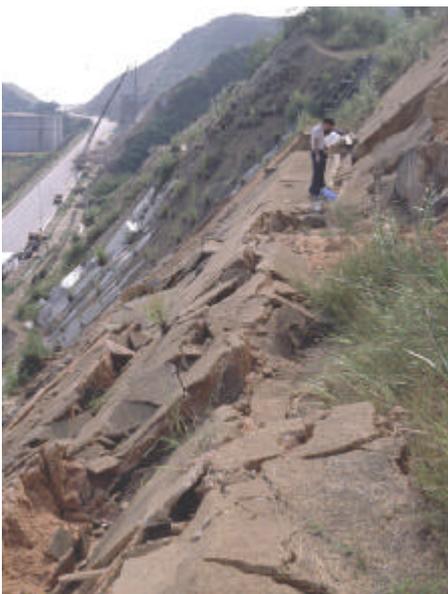
Figure 62 Tsing Yi, distressed slope, 1982

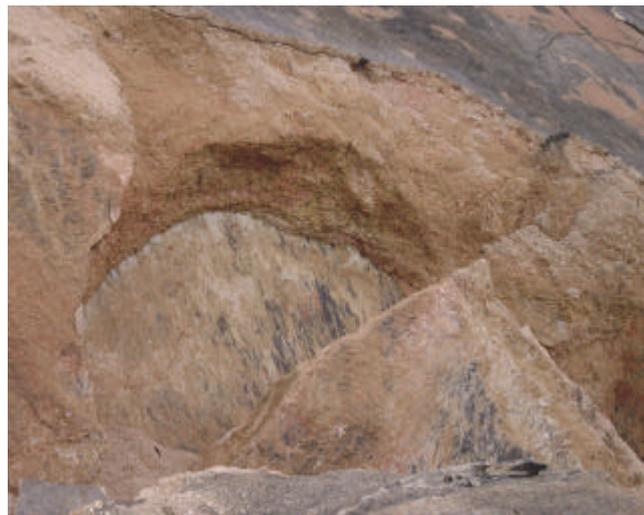
Figure 63 Tsing Yi : slickensided joint in back scarp

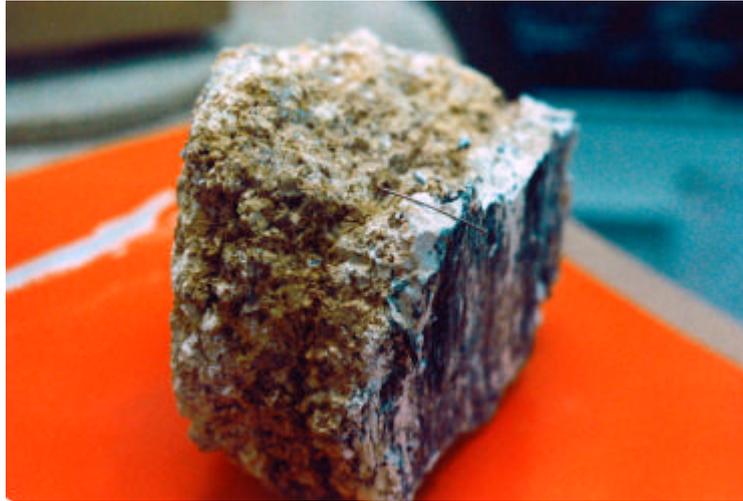
Figure 64 Sample from kaolin infilled and slickensided joint

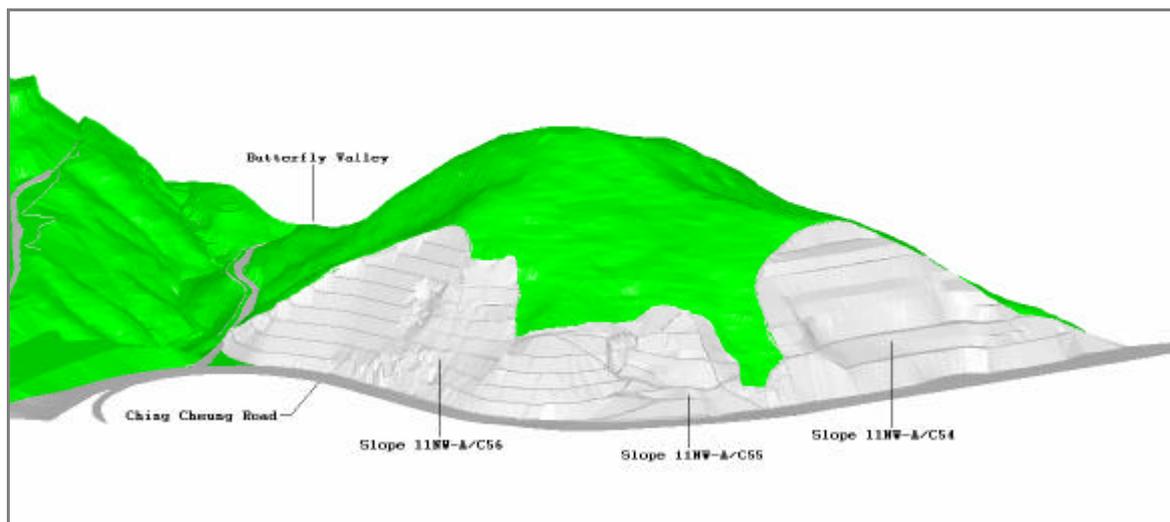
Figure 65 Digital terrain model of Ching Cheung Road

The Ching Cheung Road landslide in 1997 was a serious event. It blocked a major road and was notable in that the slope had been upgraded a few years previously (albeit without any preventive works being carried out in the area that failed). The case is reported in Halcrow Asia Partnership (1998). The failure was the latest of a series of failures that had taken place along that stretch of road over 20 years or so since road construction (Hencher, 1983; Hudson and Hencher, 1985). Figure 65 is a digital terrain model of the area of the 1997 failure which occurred in Slope No. 11NW-A/C55 and Figure 66 is an aerial photograph taken in 1995 before the failure. Figure 67 shows the slope, post failure, with some remedial shotcreting works. Figure 68 is a cross section showing some of the geological features contributing to the failure, including the presence of persistent, adversely-dipping decomposed dolerite dykes. In essence however, the failure was simply a case of an over-steepened slope in weak decomposed granite affected by high water pressures.

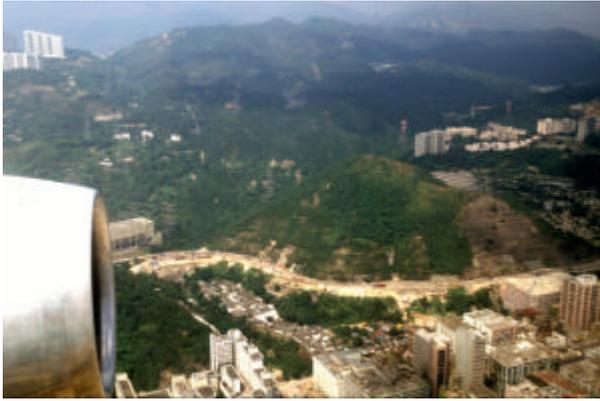
Figure 66 Ching Cheung Road, 1995

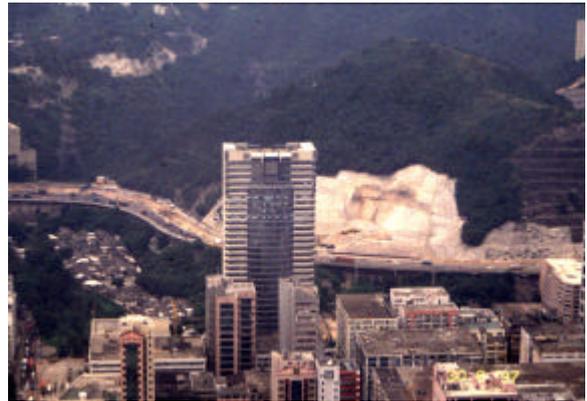
Figure 67 Ching Cheung Road, Aug 1997

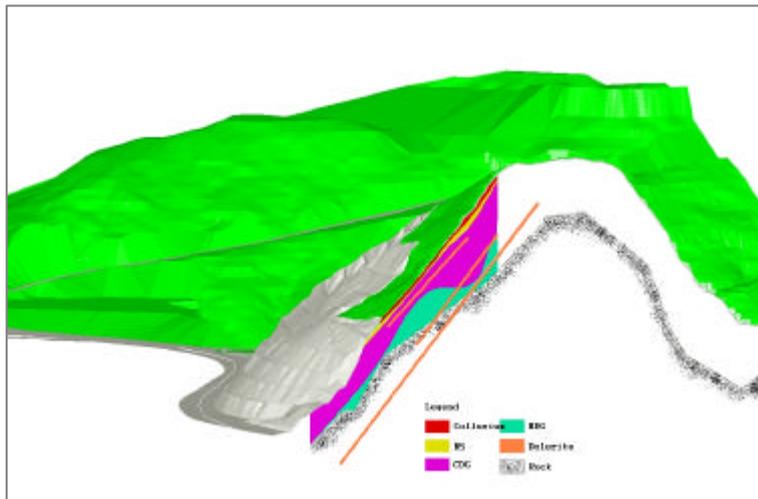
Figure 68 Geological cross section – Ching Cheung Road landslide

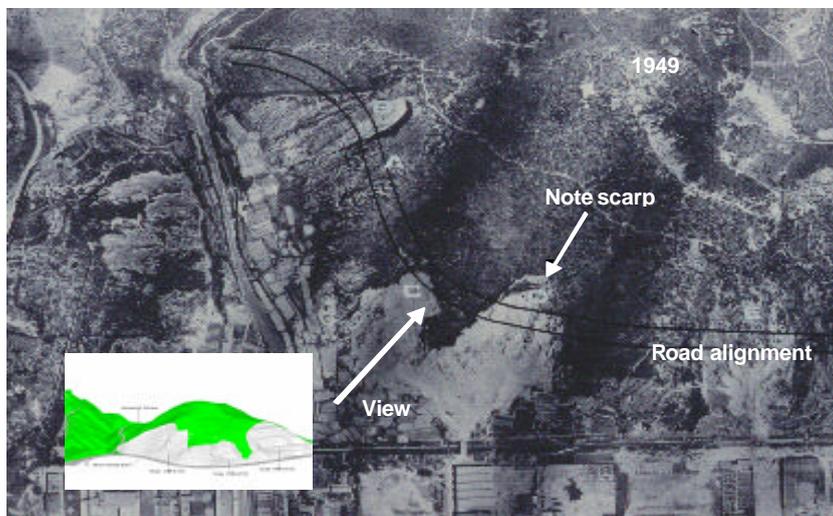
Figure 69 Aerial photograph taken in 1949. The road alignment is marked and the scarp at the location of the 1997 landslide highlighted.

In the context of this paper the interesting aspects are the precursory signs of failure. Desk study for an adjacent failure in 1983 (Henchel, op cit) had identified an old failure at the location of the 1997 failure. Several of the photos showed previous distress; an example is given in Figure 69.
