WEATHERING AND EROSION PROCESSES IN ROCKS – IMPLICATIONS FOR GEOTECHNICAL ENGINEERING

Steve Hencher
Halcrow China Ltd

***Abstract:** This paper provides an introduction into active processes of weathering and how these affect the engineering properties of rocks. Five particular aspects are dealt with in some detail. The first concerns the shear strength of intact materials with particular consideration of the transition from rock-like to soil-like behaviour. The second topic is permeability of weathered rock profiles and in particular the often channelised flow of groundwater. Topic three concerns material disintegration and the growth of joints in the weathered rock mass; a classification of joints based on their “life-cycle” from oriented micro fractures to fully developed planes of weakness is introduced. The fourth topic concerns weathering along joints and the consequences for shear strength of such discontinuities. Finally deterioration of the overall rock mass is considered in a geomorphologic development sense, where such deterioration occurs and how such deterioration may be taken as indicative that failure is developing.*

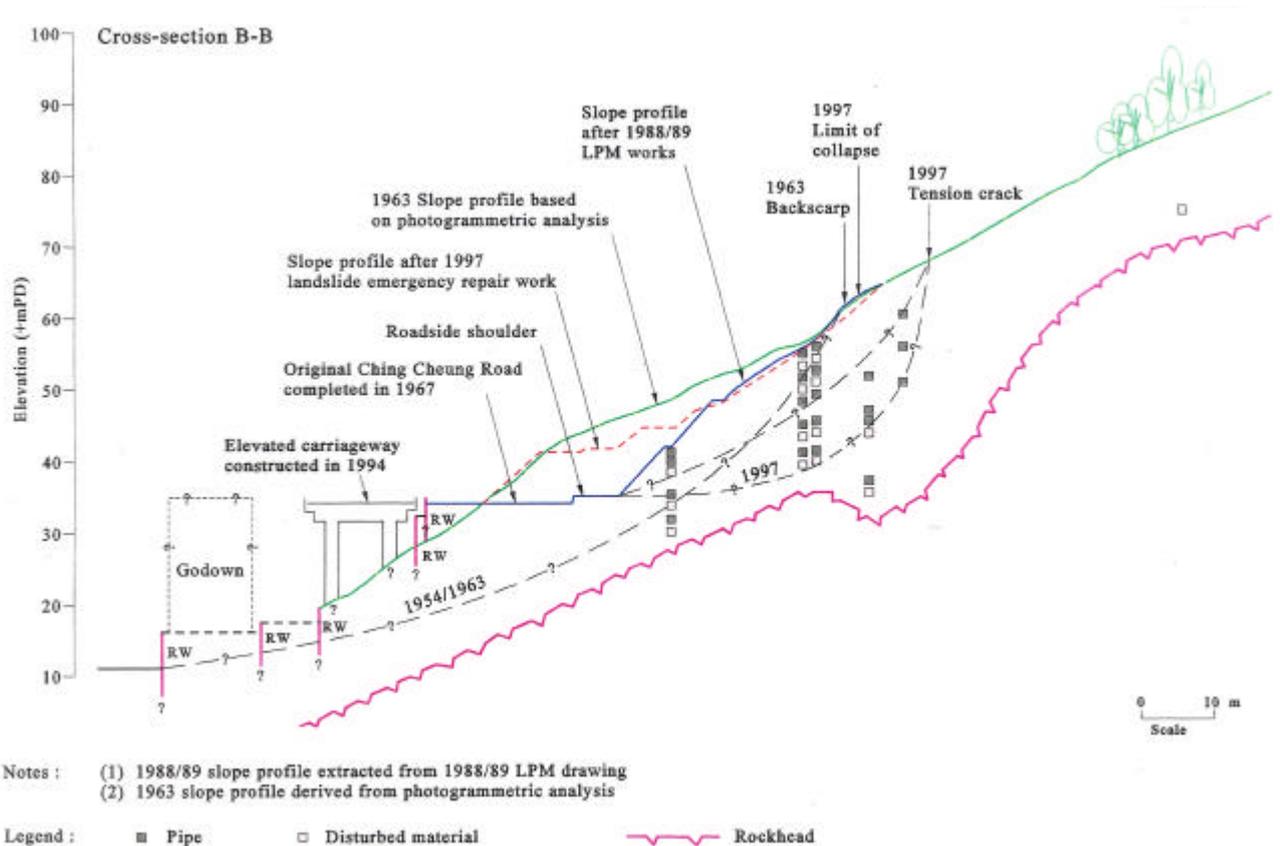
Figure 70 Ground investigation indicating the locations of natural pipes infilled with alluvial sediments

A detailed investigation was carried out after the 1997 failure including numerous boreholes with continuous Mazier sampling and deep trial pits. Abundant evidence was found of precursory distress and associated geological features. One of the most interesting was the presence of numerous sediment-choked natural pipes in all boreholes. Almost certainly most of these had developed to exploit the natural channels within the dilated rock mass following the initial failure in the 1940s, initiated by quarrying below the natural slope. Locations of pipes logged in some of the boreholes are shown in Figure 70. Examples of the pipe sediments are shown in Figure 71.

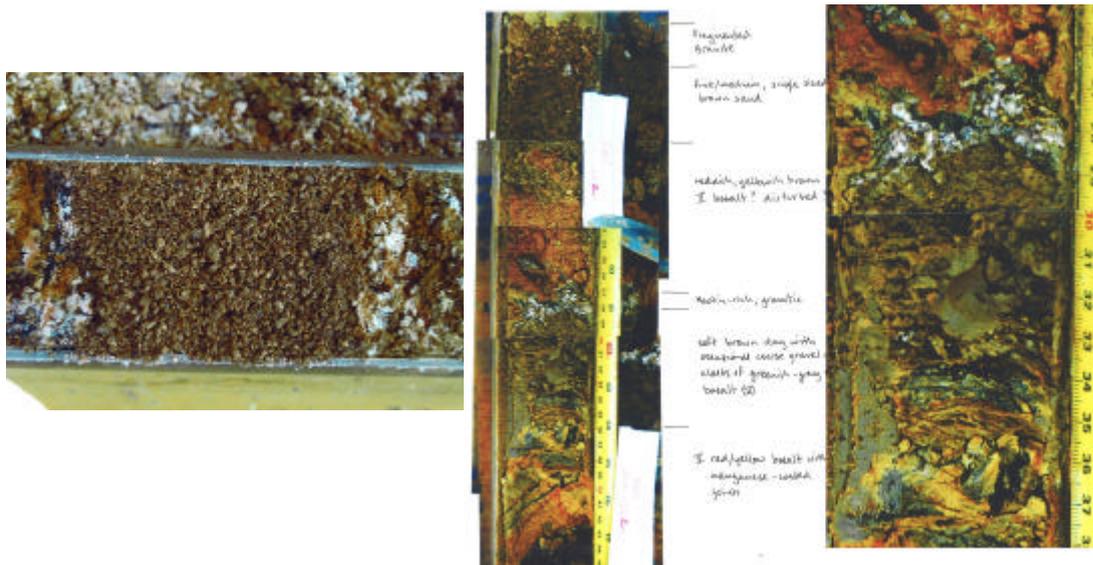
Figure 71 Left side above, single-sized sand with decomposed granite above and below. Right side, gap-graded clay with gravel, overlying decomposed basalt dyke.

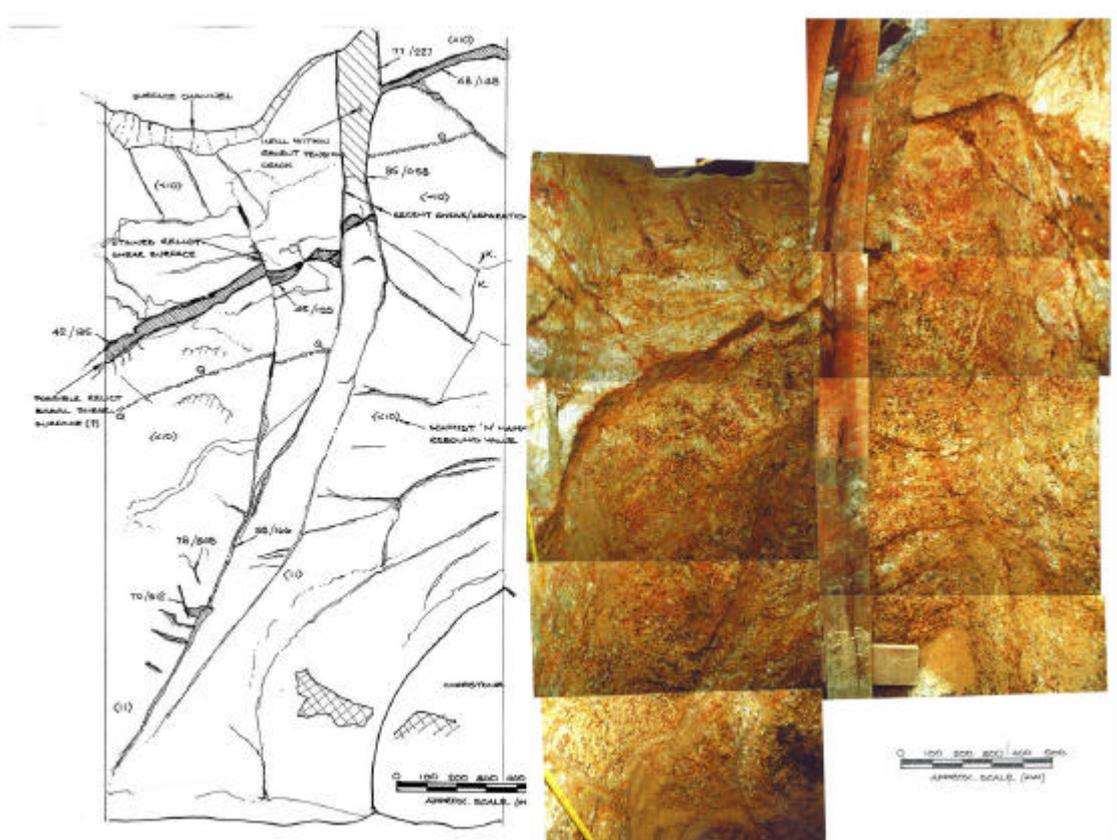
Figure 72 Old, displaced discontinuities within the failed mass at the Ching Cheung Road landslide. Note lack of reactivation of these displaced features during the 1997 failure.

As well as the extensive natural pipe system, evidence of previous movement was seen in exposures. Sketches of old displaced features are given in Figures 72 and 73 (sketches by Dr Paul Jennings). It is of interest that the 1997 failure did not follow the previous failure surfaces (probably reflecting that the residual strength of displaced grade V granite is not much lower than that of intact material).

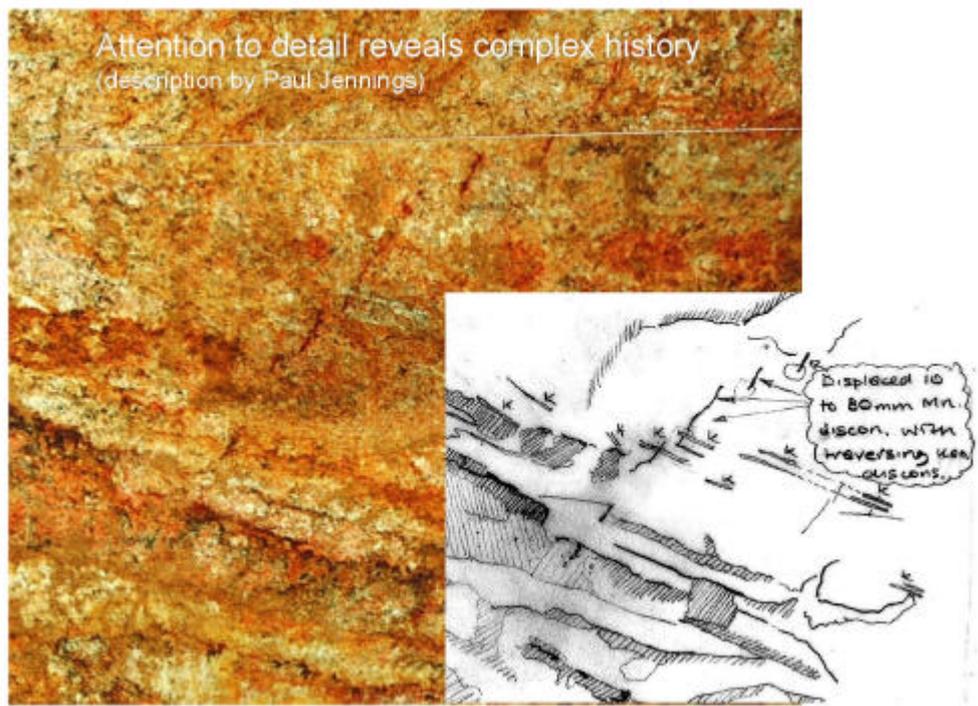
Figure 73 Further evidence of previous movements within the failed rock mass
